2016 UNDERWATER BRIDGE INSPECTION REPORT

BRIDGE # 01508 CSAH 5 over RICE RIVER

Date of Inspection: 06/07/2016

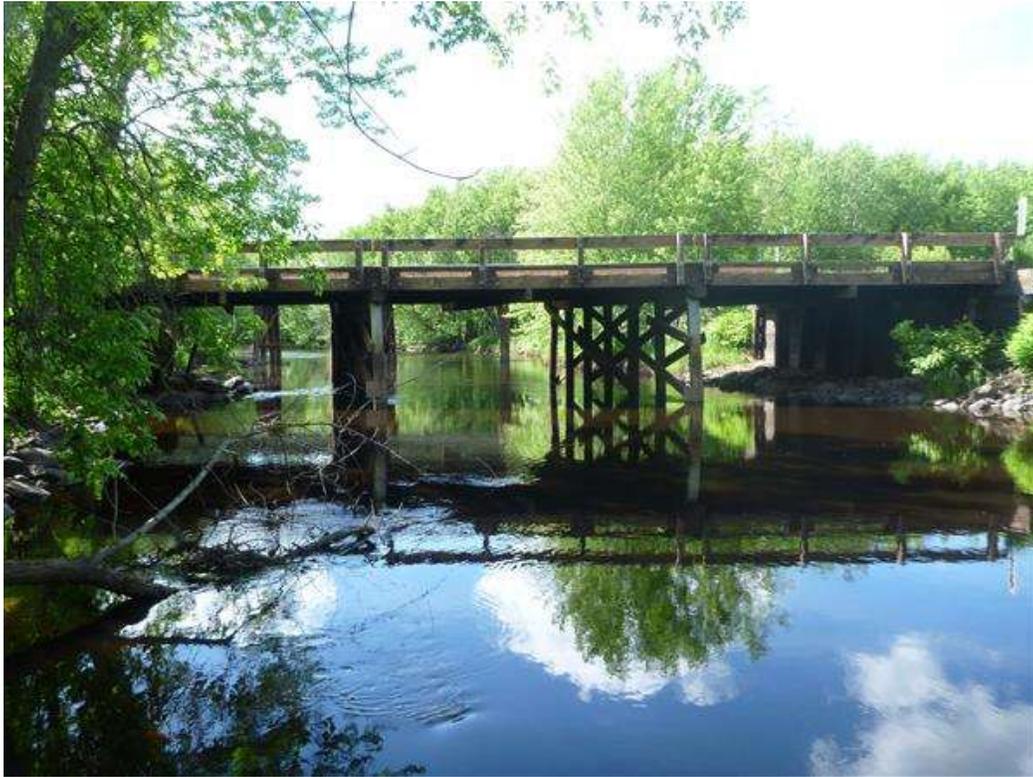
Photo 1 - Upstream Fascia, Looking West

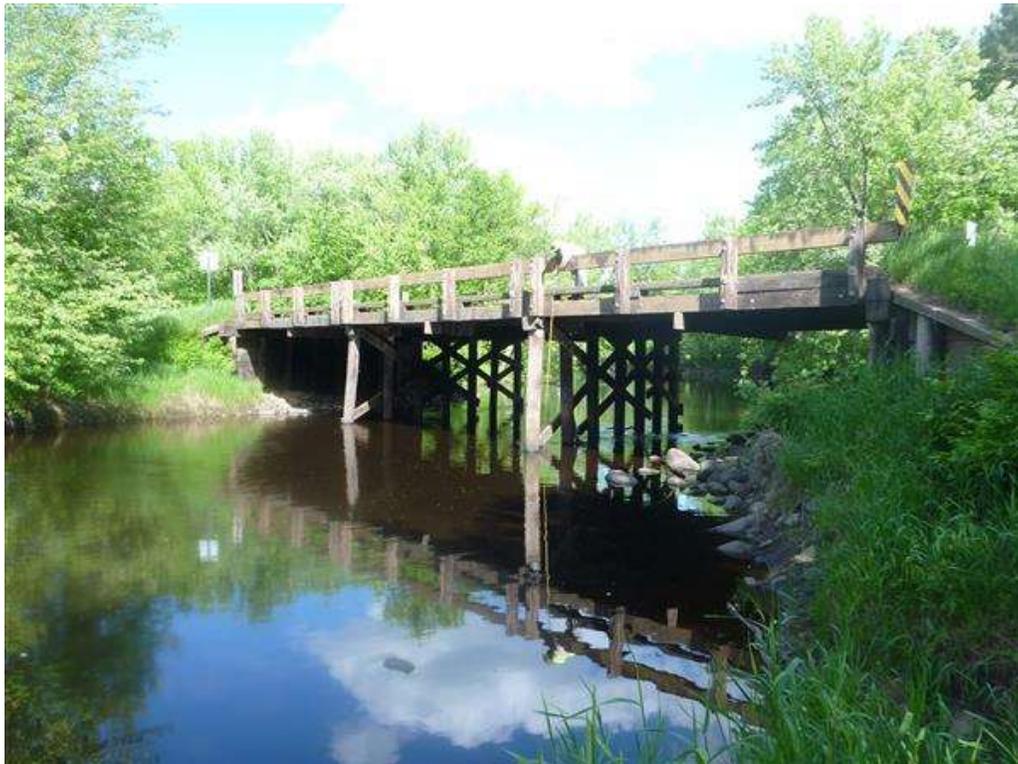
Photo 2 - Downstream Fascia, Looking Northeast

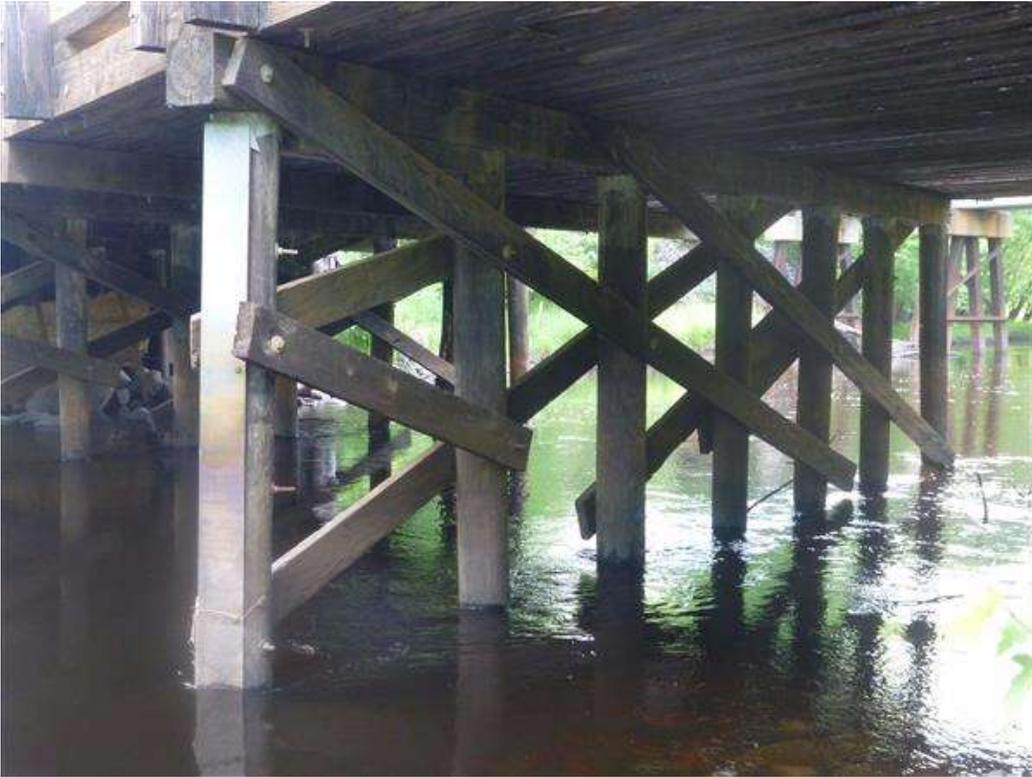
Photo 3 - Pier 1, Looking Southwest

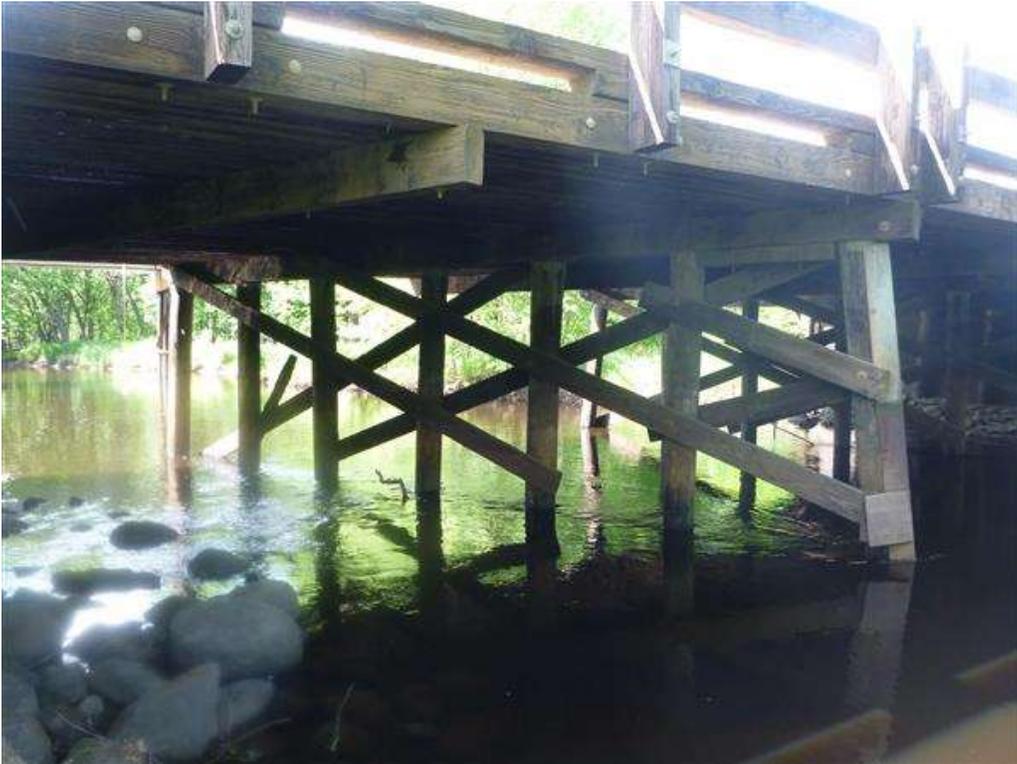
Photo 4 - Pier 2, Looking Northwest

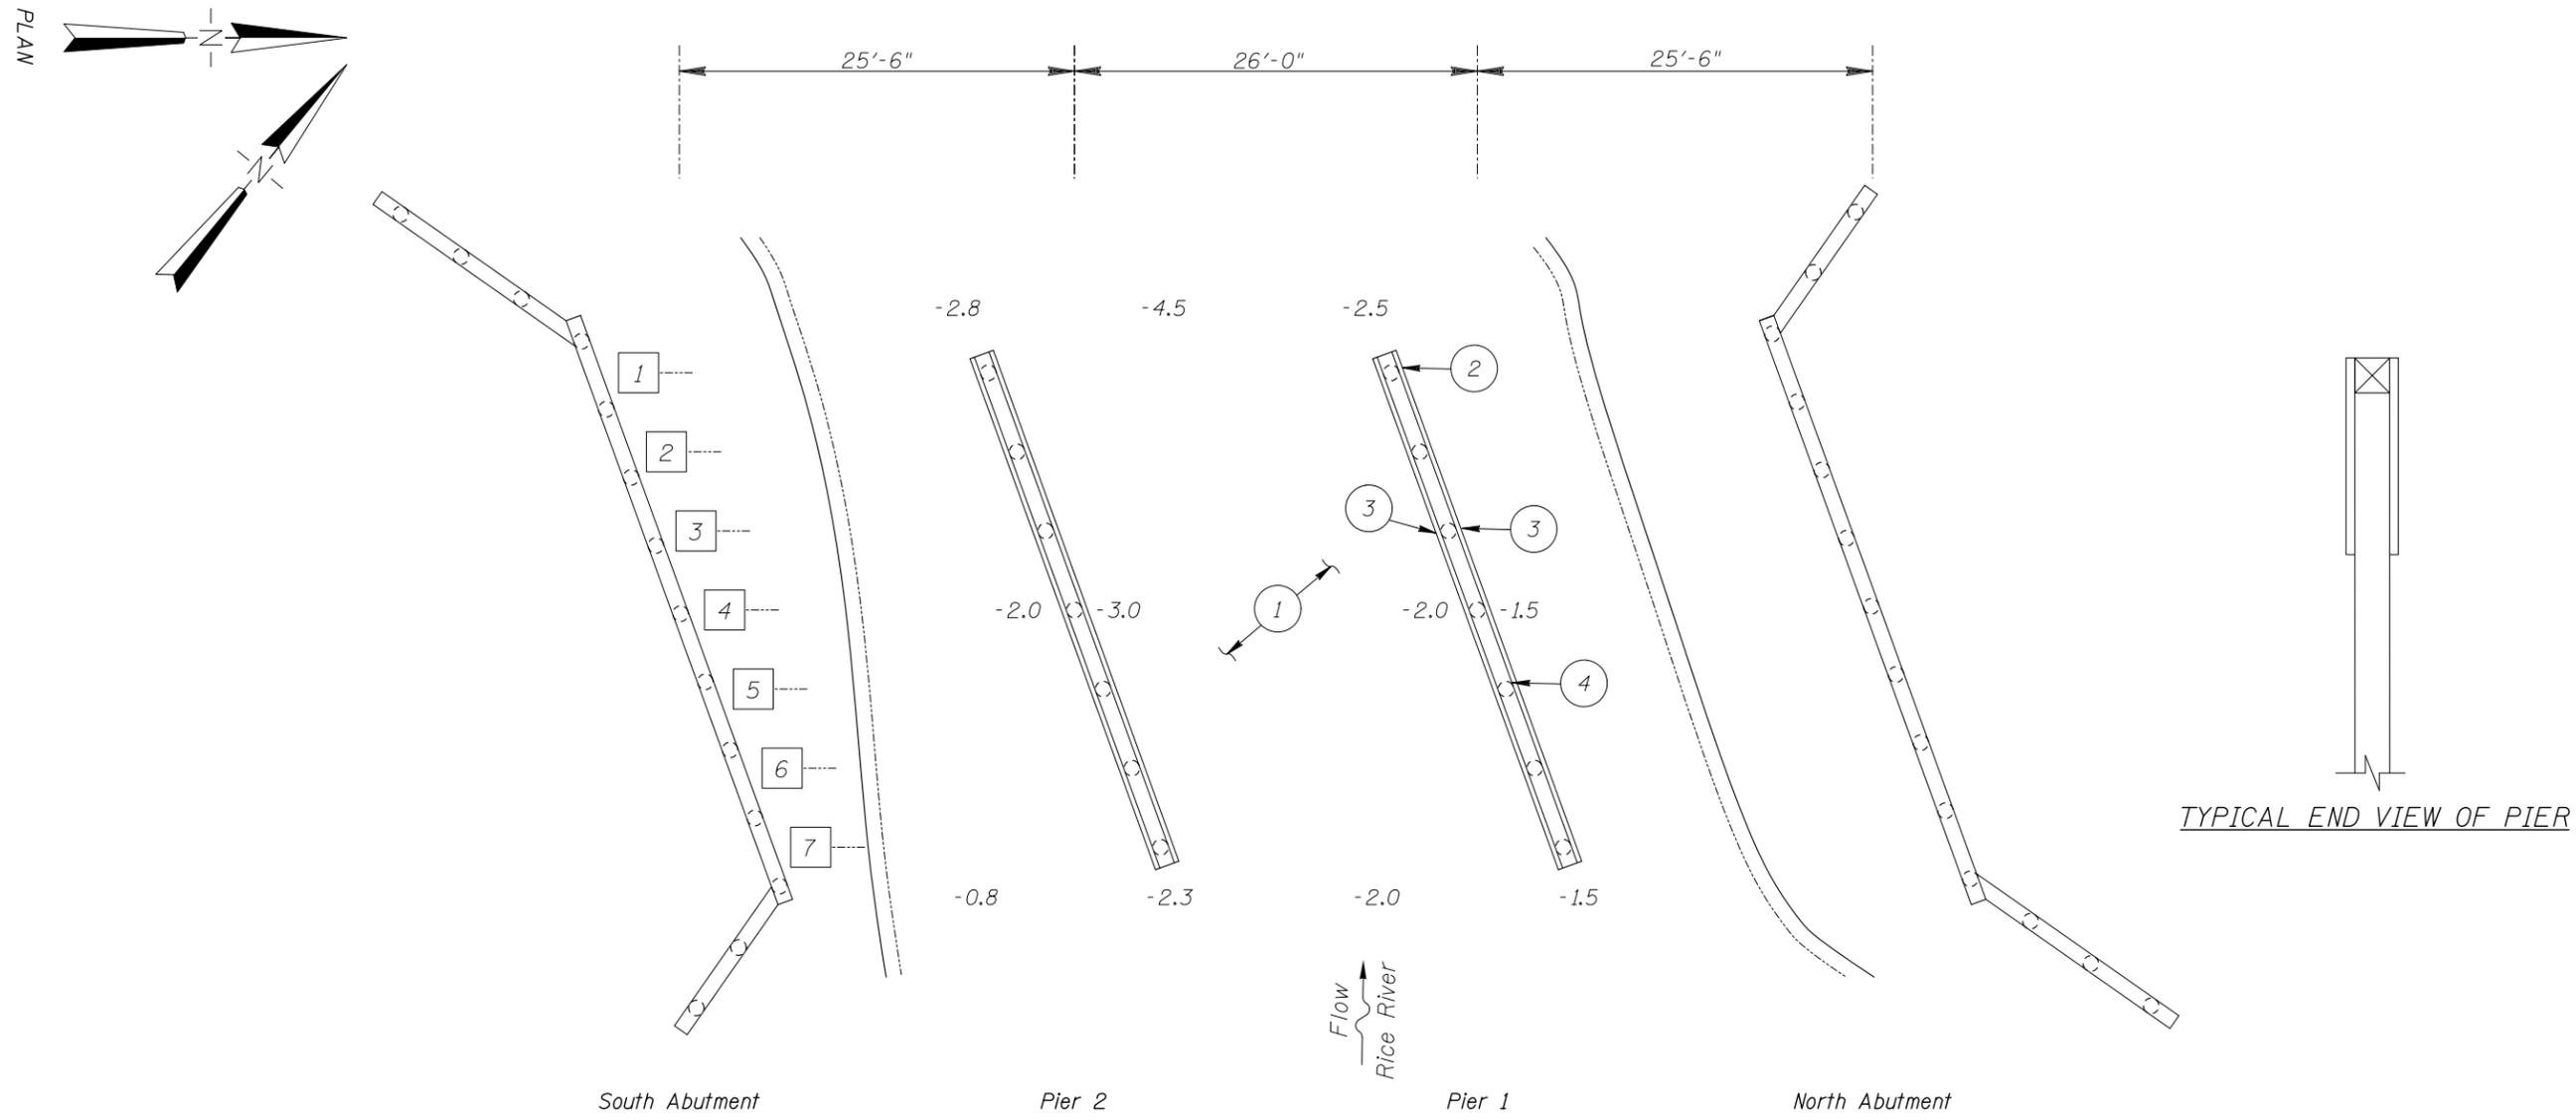
| INSPECTION AND SOUNDING PLAN | | |

- ① The channel bottom material consisted of rock up to 2 feet in diameter with gravel infill allowing no probe rod penetration.
- ② The diagonal brace on the north side of Pile 1 at Pier 1 exhibited a 1/4 inch wide split that was 4 feet long through the fastener, but the connection was still effective.
- ③ The diagonal brace on both sides of Pile 3 at Pier 1 exhibited two 1/4 inch wide splits that were 4 feet long on both sides of the fastener, but the connection remains sound.
- ④ On the northeast side of Pile 5 at Pier 1 an area of decay, section loss (up to 5% of pile), and soft wood was present from 0.5 feet above the waterline to 0.5 feet below, for a width of 1 foot allowing 1.5 inches of penetration.
