2016 UNDERWATER BRIDGE INSPECTION REPORT

BRIDGE # 18506 CSAH 31 over RABBIT LAKE NARROWS

DISTRICT: District 3 COUNTY: Crow Wing CITY/TOWNSHIP: RABBIT LAKE
STATE: Minnesota

Date of Inspection: 06/06/2016

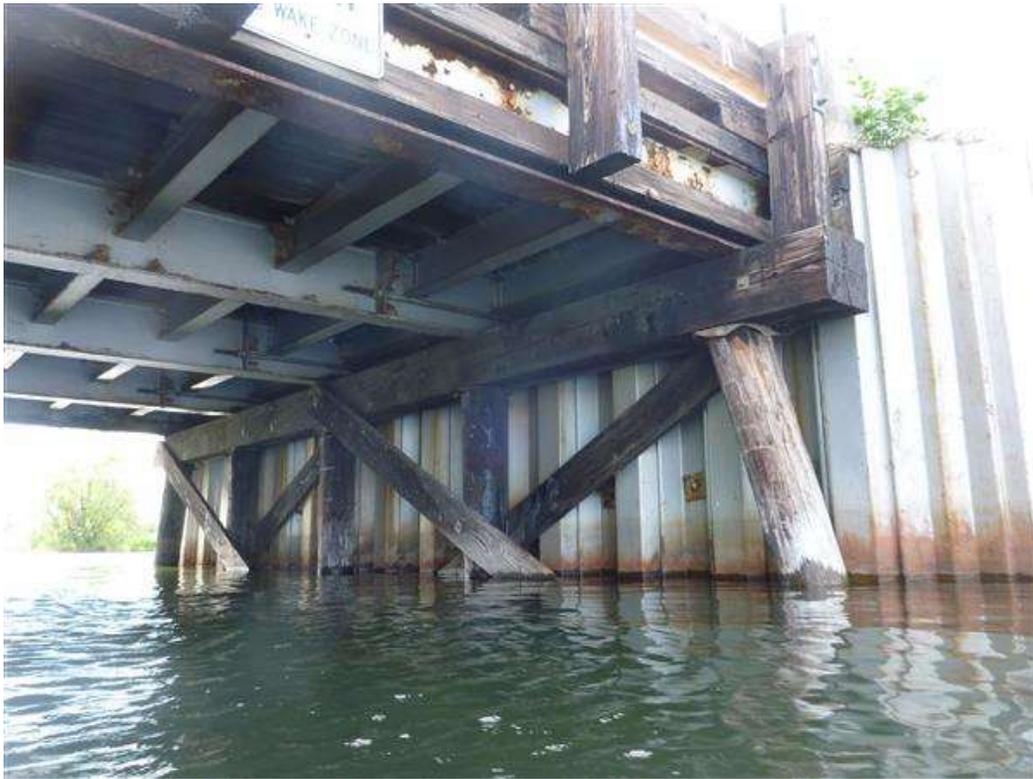
Photo 3 - North Abutment, Looking Northwest

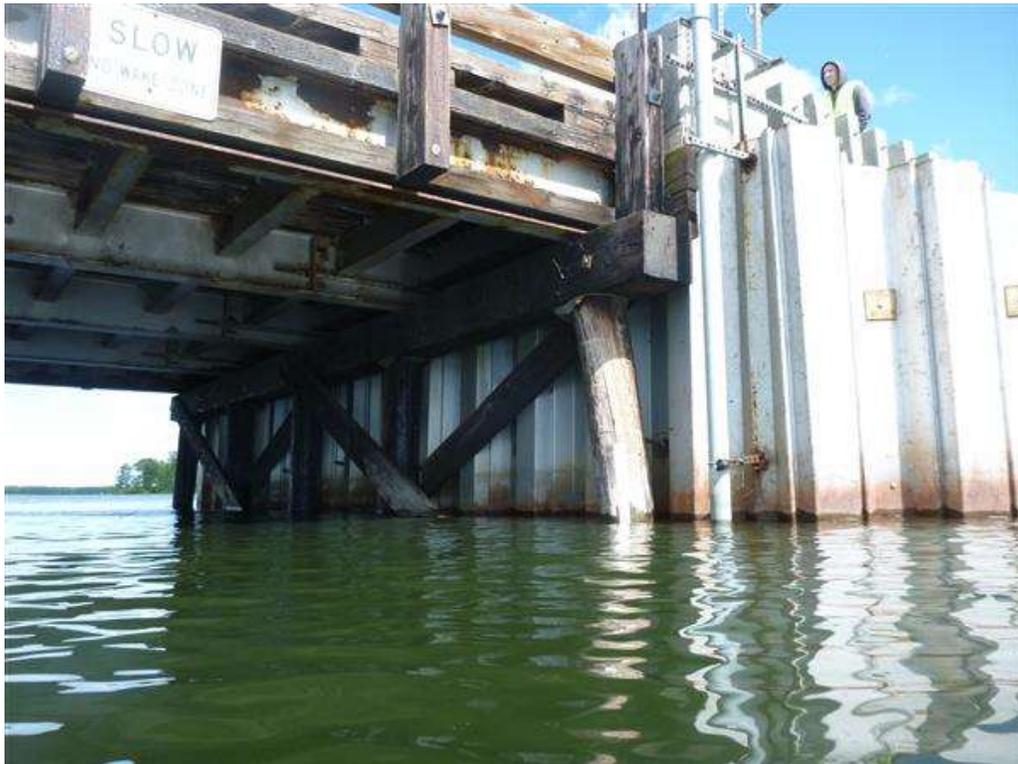
Photo 4 - South Abutment, Looking Southeast

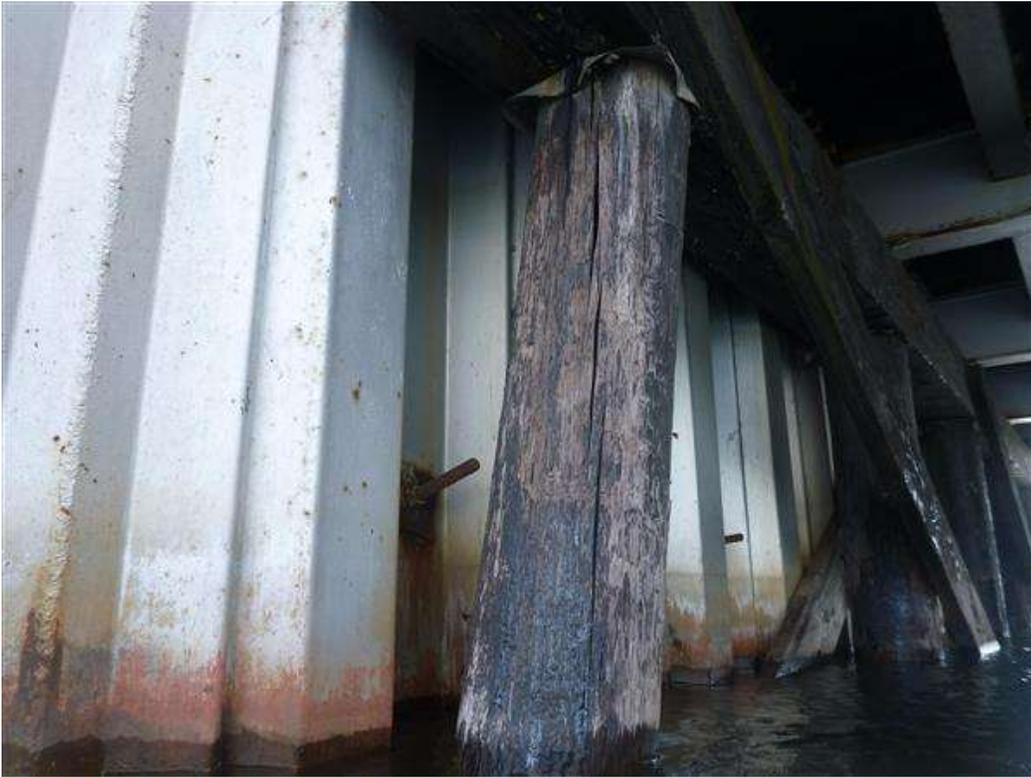
(E) The south upstream and south downstream piles exhibited a 1/2 inch split from the top of the pile down 4 feet allowing 3 to 4 inches of penetration.

Photo 5 - South Abutment Downstream Pile Split, Looking Southwest

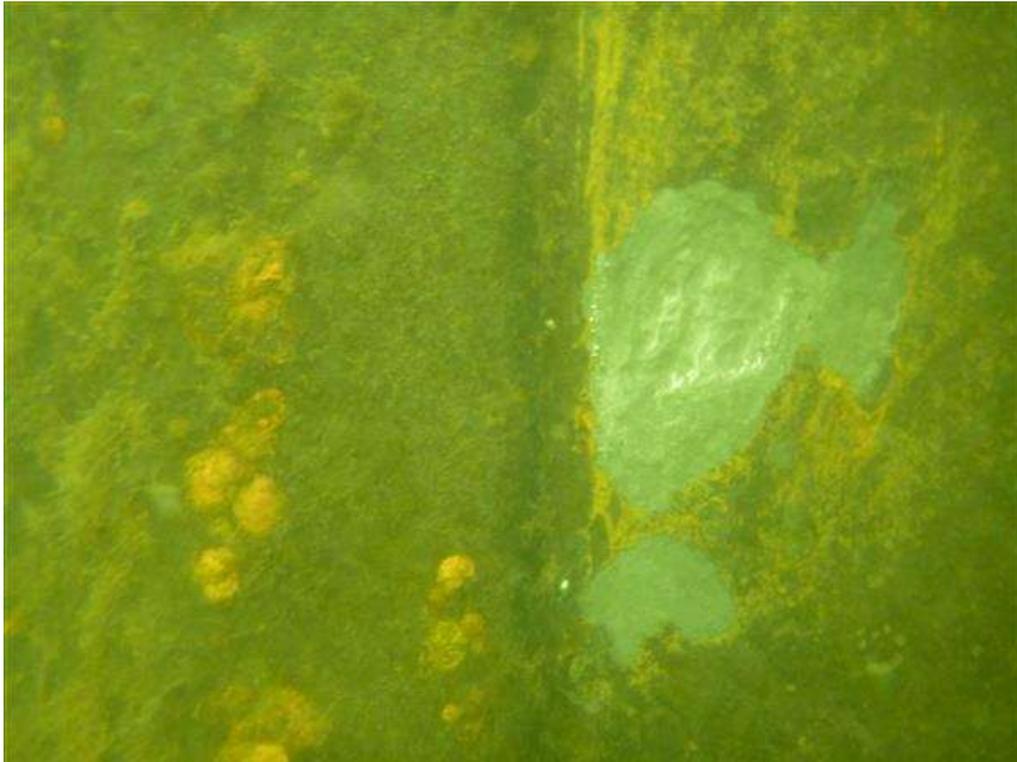
(D) The steel sheeting exhibited coating failure and surface corrosion on 50 to 100 percent of its surface area from 1 foot above to 1.5 feet below the waterline with minor rust delaminations and section loss up to 1/32 inch in depth. From 1.5 feet below the waterline to the channel bottom the steel sheeting exhibited random rust nodules with up to 1/16 inch deep pitting on less than 15 percent of its surface area.

Photo 6 - Typical Backwall Rust Nodules and Pitting (South Backwall Shown), Looking South

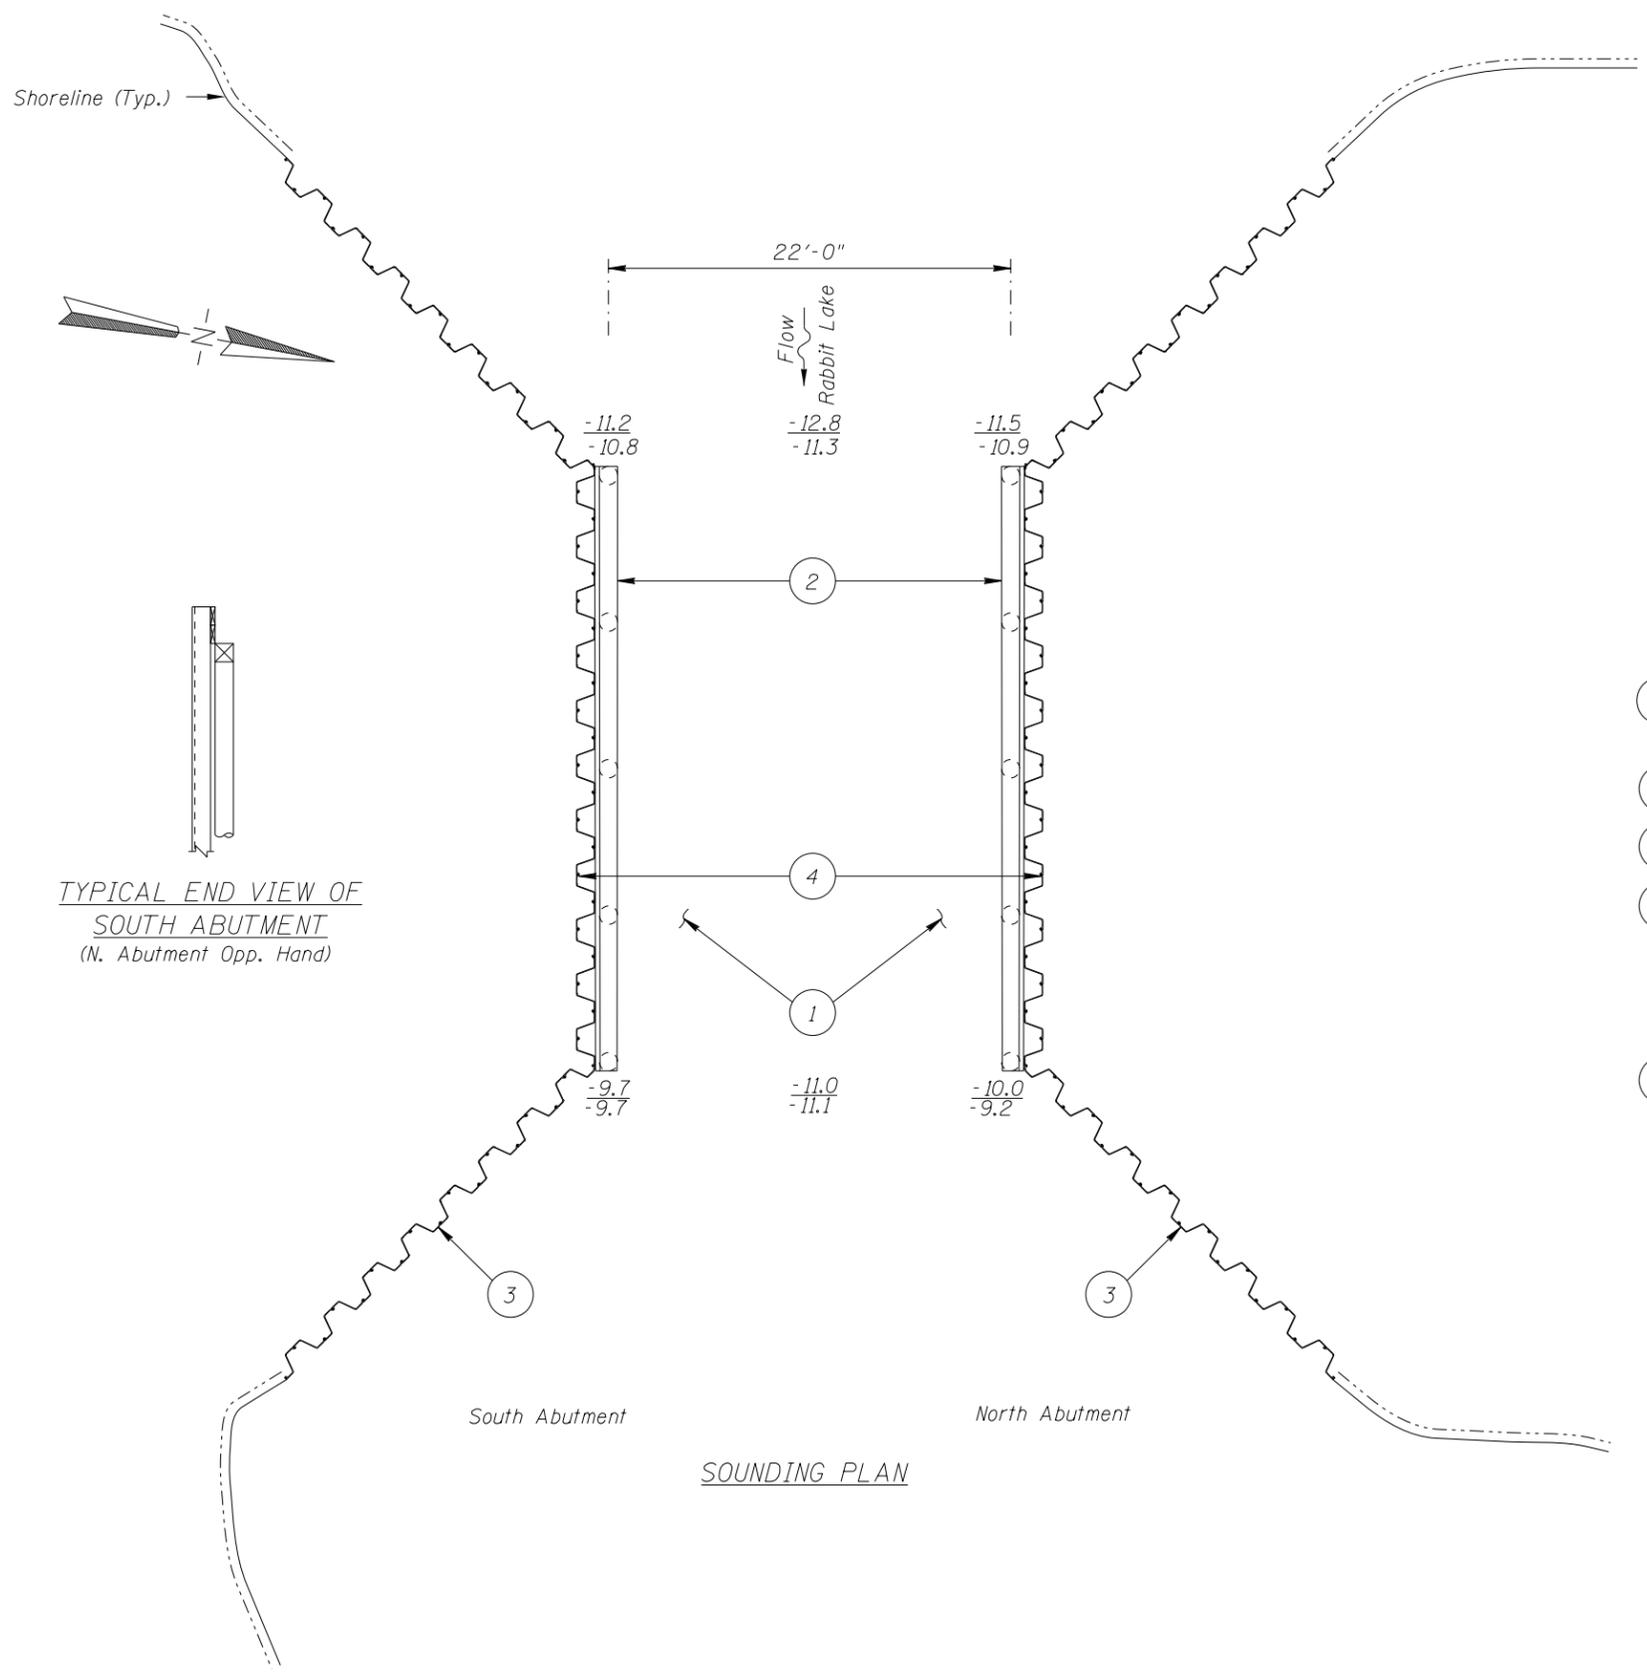
- 1 The channel bottom consisted of scattered 1 foot diameter and smaller rock with silty sand infill allowing 2 to 4 inches of probe rod penetration.
- 2 The timber members exhibited random minor checking up to 1/4 inch wide.
- 3 Light aquatic growth was observed on the steel sheeting below the waterline.
- 4 The steel sheeting exhibited coating failure and surface corrosion on 50 to 100 percent of its surface area from 1 foot above to 1.5 feet below the waterline with minor rust delaminations and section loss up to 1/32 inch in depth. From 1.5 feet below the waterline to the channel bottom the steel sheeting exhibited random rust nodules with up to 1/16 inch deep pitting on less than 15 percent of its surface area.
- 5 The south upstream and south downstream piles exhibited a 1/2 inch split from the top of the pile down 4 feet allowing 3 to 4 inches of penetration.
