2016 UNDERWATER BRIDGE INSPECTION REPORT

BRIDGE # 30505 CSAH 14 over RUM RIVER

Date of Inspection: 09/21/2016

Contractor: Collins Engineers, Inc.

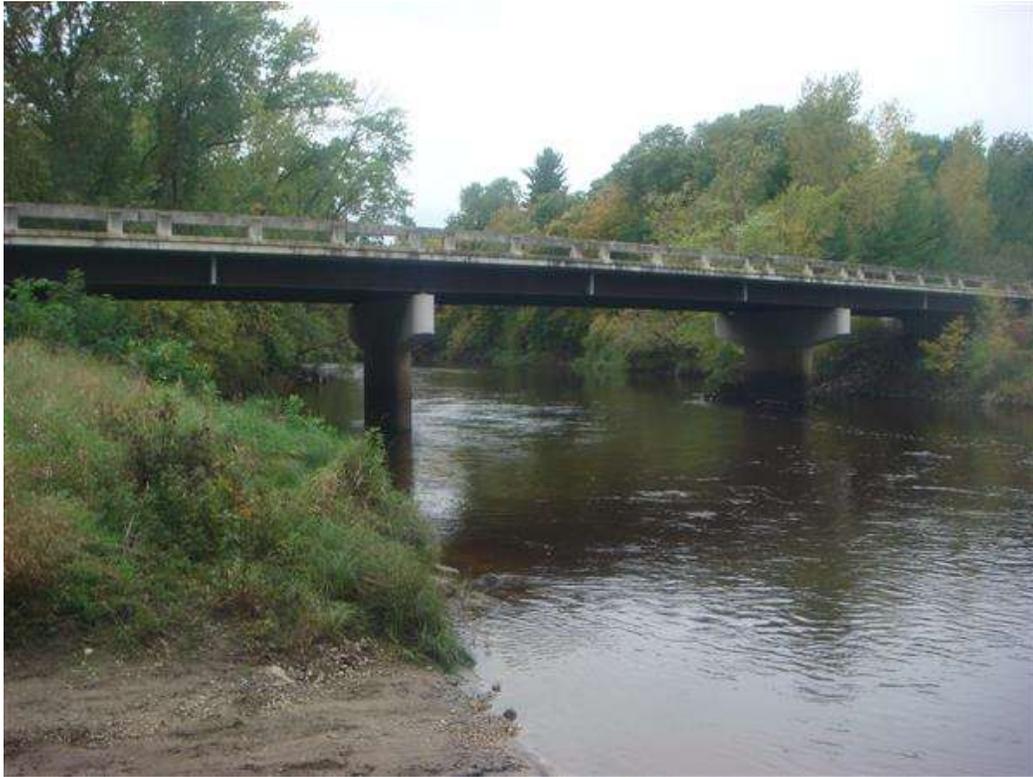
Photo 1 - Overall View of Downstream Fascia, Looking South

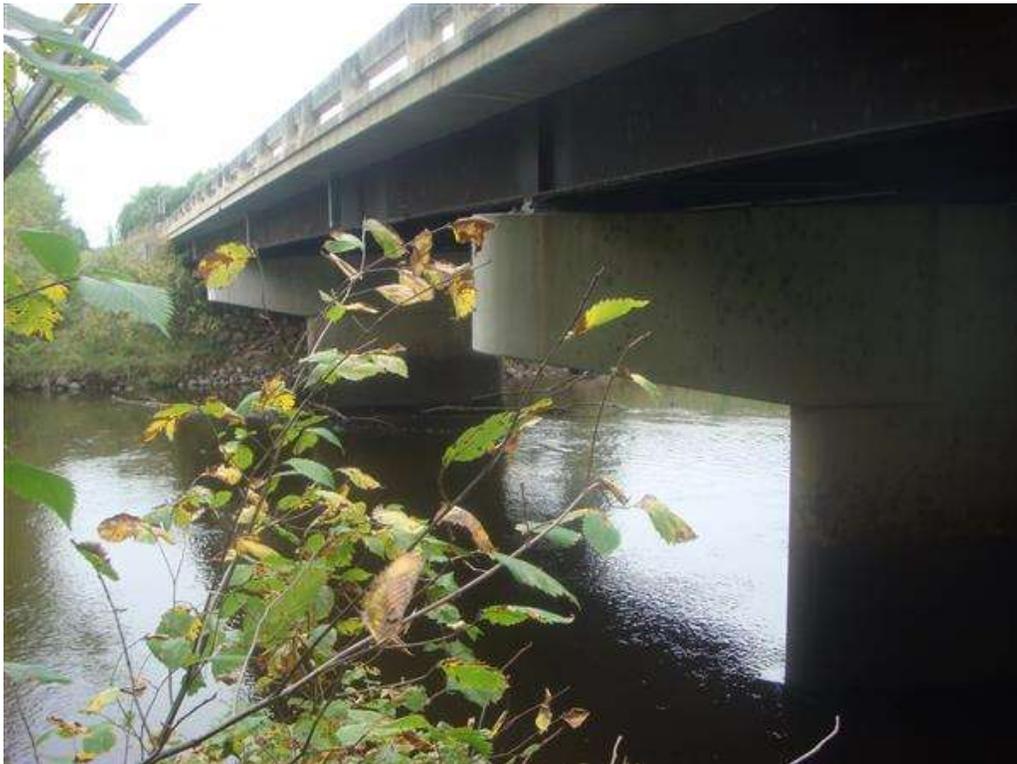
Photo 2 - Overall View of Upstream Fascia, Looking Northwest

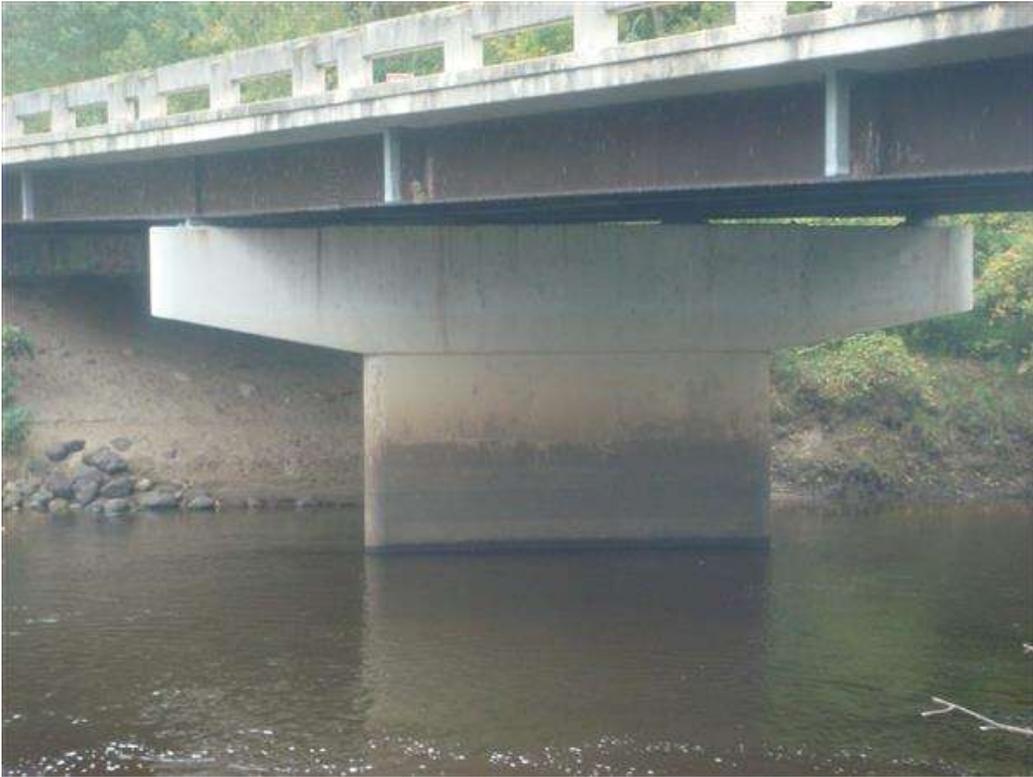
- C. A band of light scaling was observed around the entire perimeter of Piers 1 and 2 extending from the waterline to the channel bottom with typical penetrations of 1/8 inch and maximum penetrations of up to 1/4 inch at the upstream noses.

- E. A log up to 1 foot in diameter was present along the east face of Pier 2 extending from 1 foot below the waterline to 1 foot above the waterline.
- F. A minor accumulation of timber debris, consisting of smaller sticks and branches, was observed at the upstream nose of Pier 1 and extended from the channel bottom to approximately 6 inches above the channel bottom.

Photo 3 - View of Pier 1, Looking East

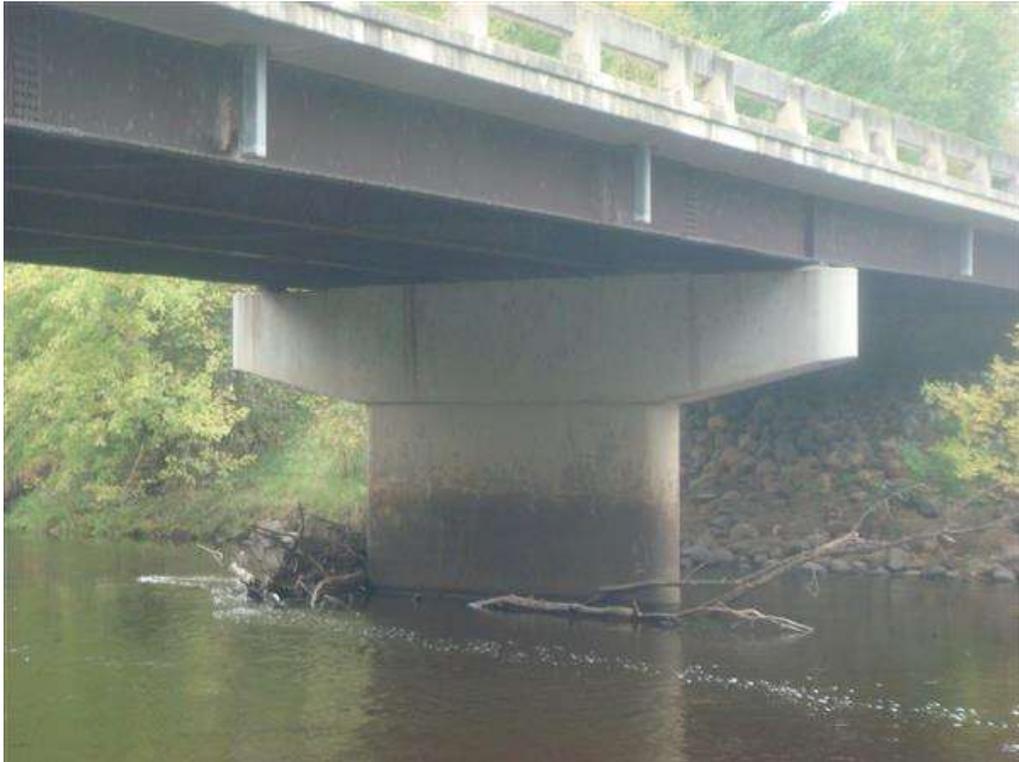
- D. A moderate accumulation of timber debris, consisting of 9-inch-diameter and smaller logs and branches, was observed along the upstream nose and west face of Pier 2 and extended from the channel bottom to 3 feet above the waterline and up to 5 feet out from the pier.

Photo 4 - View of Pier 2, Looking West

- (A) Remove timber debris accumulation at Pier 2. Removal of the timber debris will reduce excessive lateral loads on the pier, limit further debris accumulation, and reduce the likelihood of channel bottom degradation resulting from obstructed flow. Until the timber debris can be removed, monitor for any increase in accumulation and/or scour at the pier.
- (B) Reinspect the submerged substructure units at the normal maximum recommended (NBIS) interval of sixty (60) months.

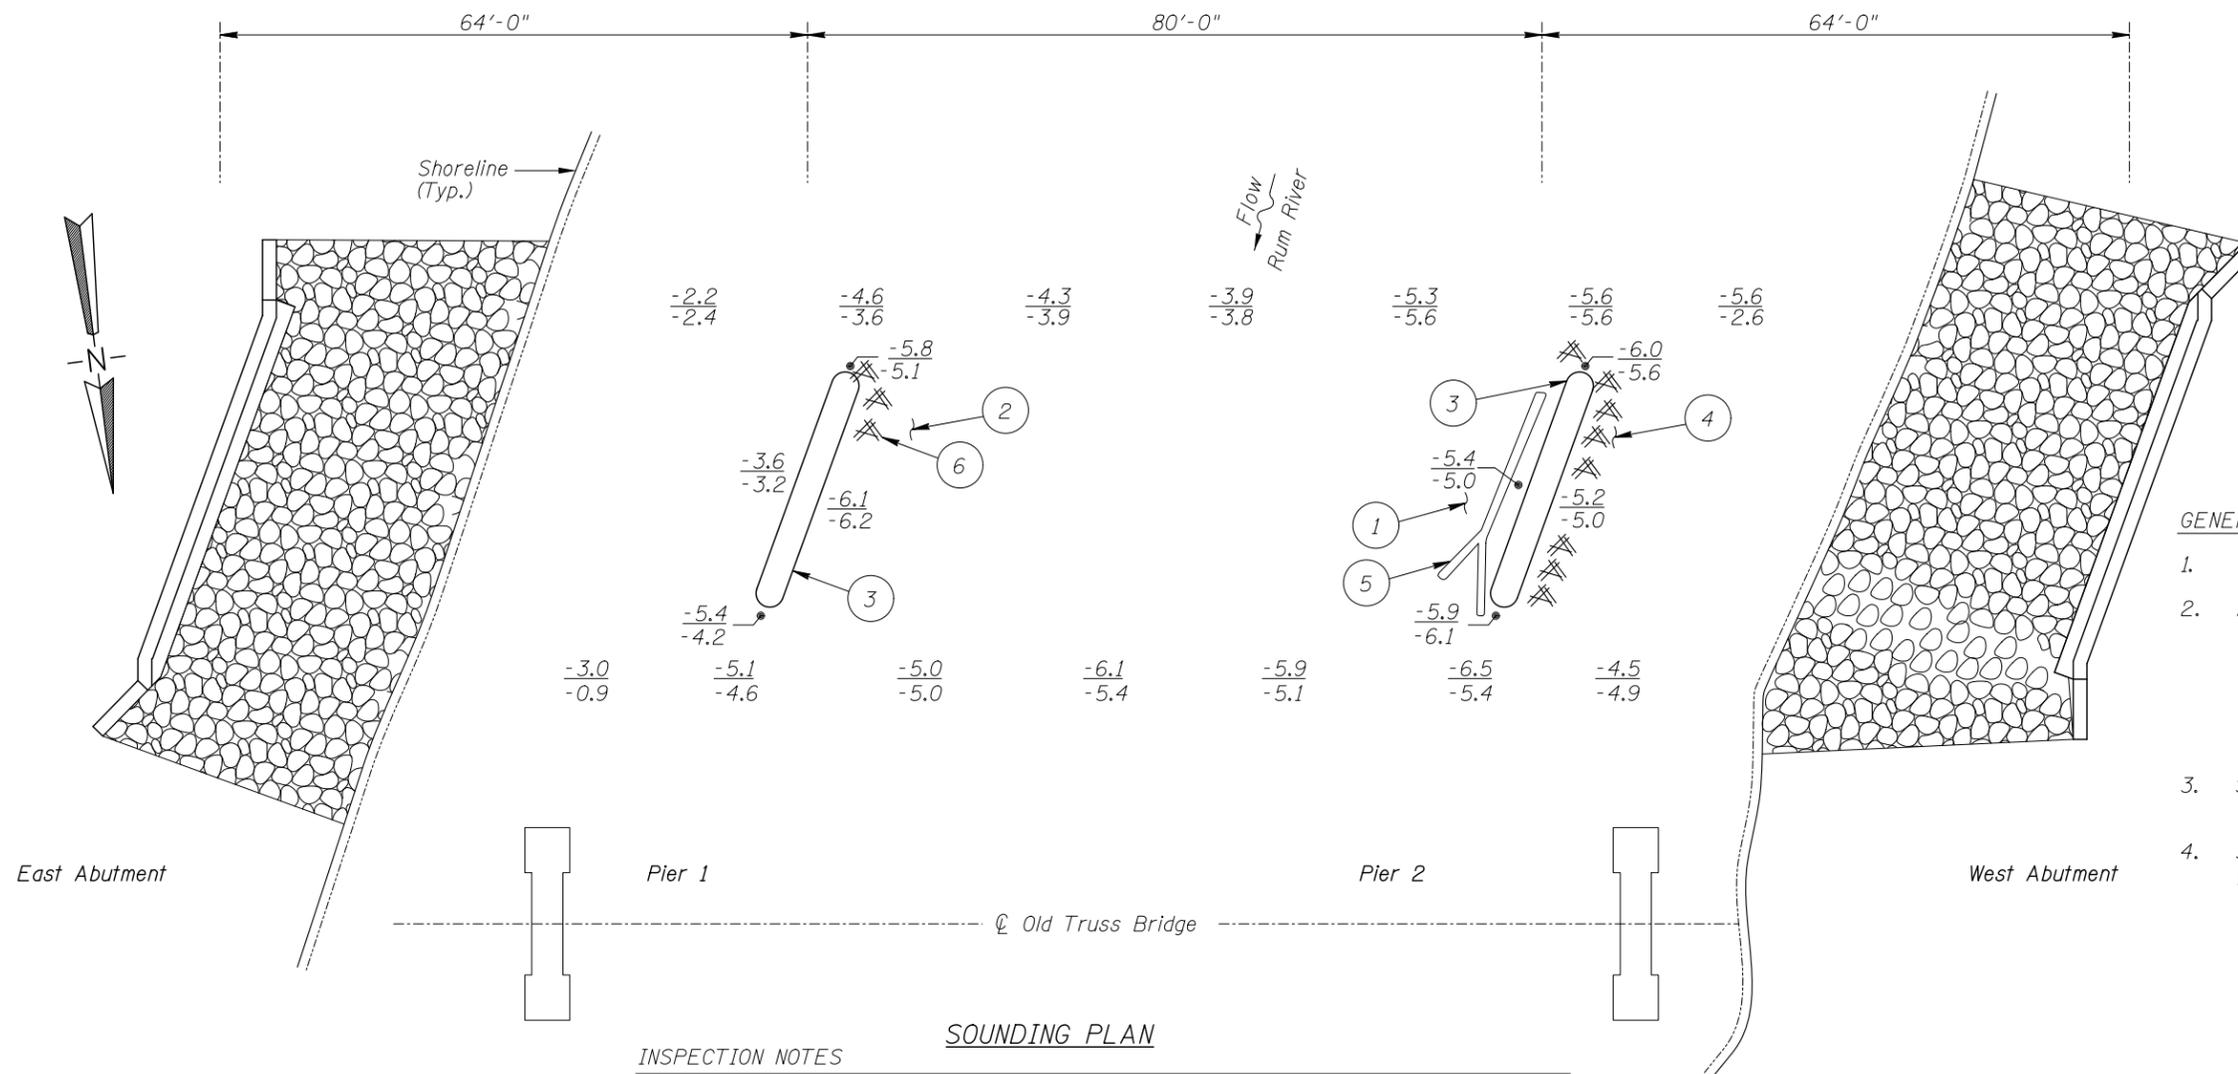
- 1 The channel bottom consisted of sand, gravel, and 4-inch-diameter cobbles allowing up to 1 inch of probe rod penetration.
- 2 The channel bottom consisted of silty sand allowing up to 3 inches of probe rod penetration.

- 3 A band of light scaling was observed around the entire perimeter of Piers 1 and 2 extending from the waterline to the channel bottom with typical penetrations of 1/8 inch and maximum penetrations of up to 1/4 inch at the upstream noses.

- 4 A moderate accumulation of timber debris, consisting of 9-inch-diameter and smaller logs and branches, was observed along the upstream nose and west face of Pier 2 and extended from the channel bottom to 3 feet above the waterline and up to 5 feet out from the pier.

- 5 A log up to 1 foot in diameter was present along the east face of Pier 2 extending from 1 foot below the waterline to 1 foot above the waterline.
- 6 A minor accumulation of timber debris, consisting of smaller sticks and branches, was observed at the upstream nose of Pier 1 and extended from the channel bottom to approximately 6 inches above the channel bottom.
