# 2016 UNDERWATER BRIDGE INSPECTION REPORT

## BRIDGE # 30507 CSAH 5 over RUM RIVER

Date of Inspection: 05/24/2016

Contractor: Collins Engineers, Inc.

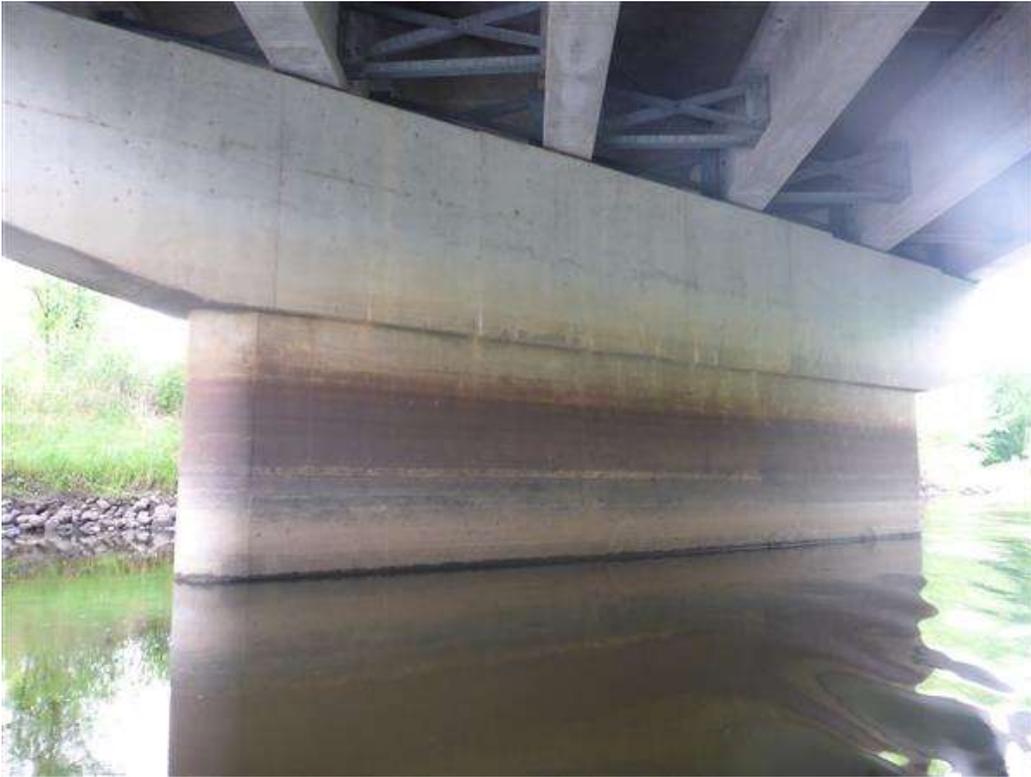
Photo 3 - Typical View of Pier 1, Looking West

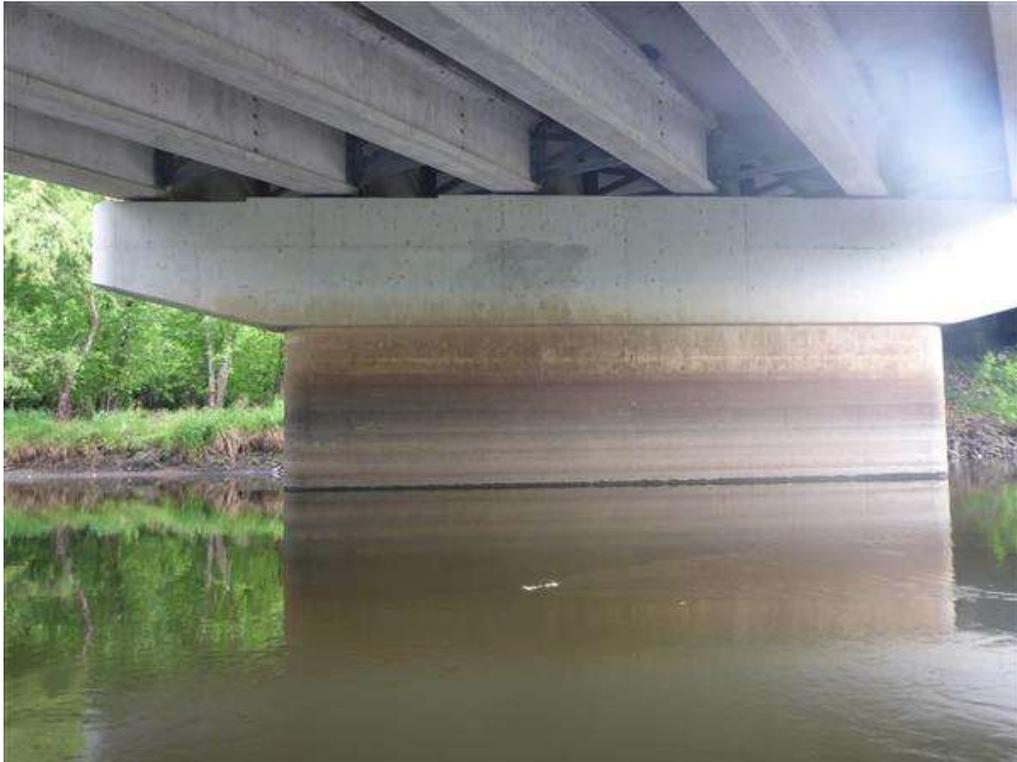
Photo 4 - Typical view of Pier 2, Looking East

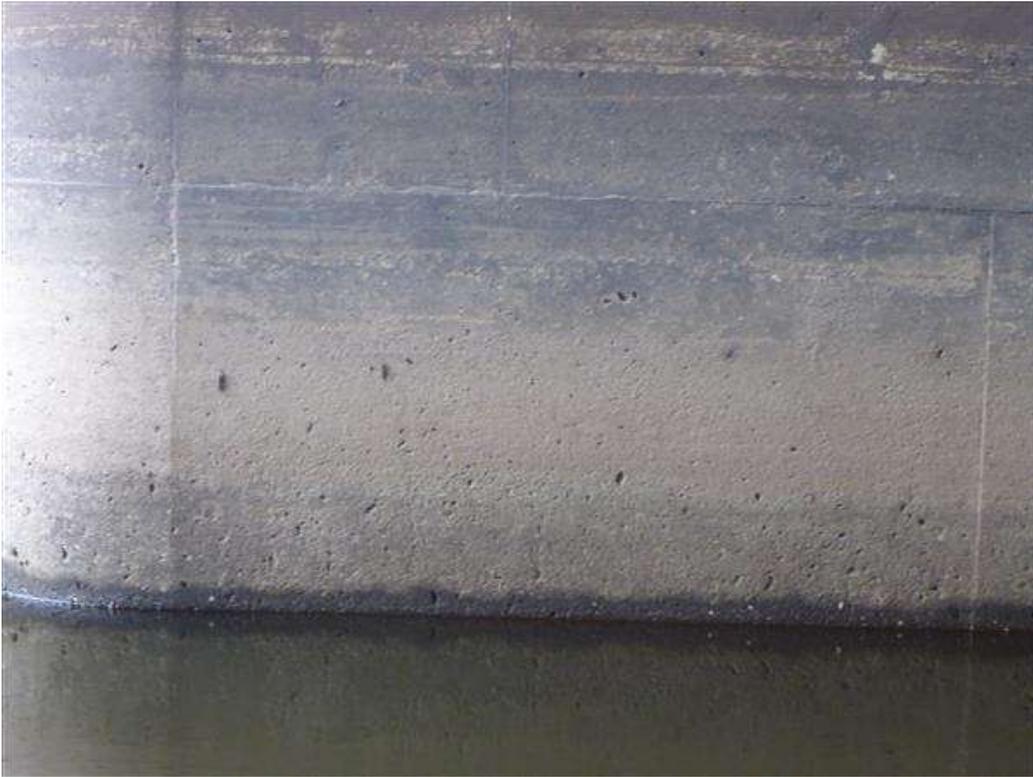
(A) All concrete surfaces from 4 feet below to 3 feet above the waterline exhibited light scaling with random pockets of poor consolidation with typical penetrations of 1/8 to 1/4 inch in depth.

Photo 7 - Typical Concrete Scaling at Waterline

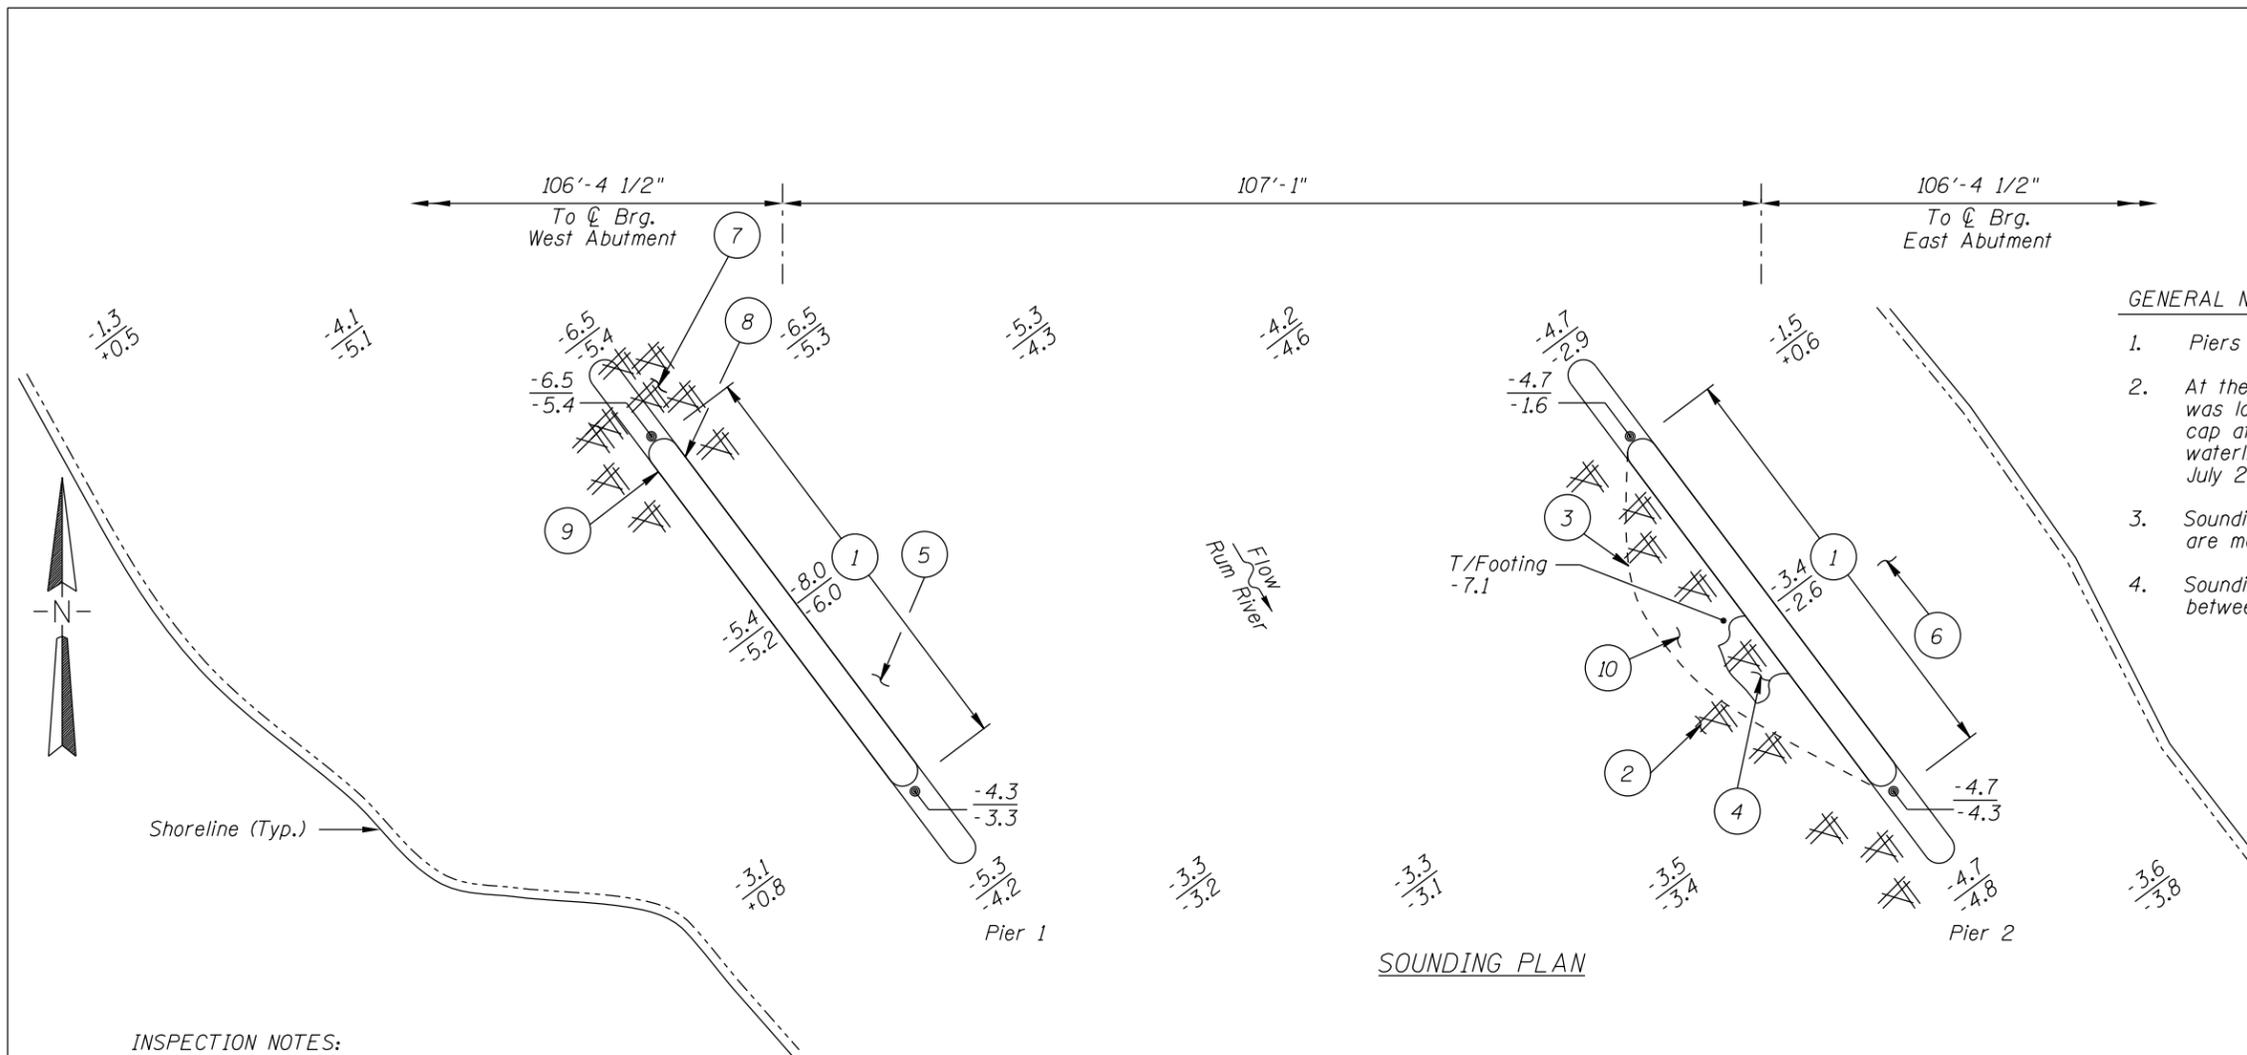
- All concrete surfaces from 4 feet below to 3 feet above the waterline exhibited light scaling with random pockets of poor consolidation with typical penetrations of 1/8 to 1/4 inch in depth.

- A light accumulation of timber debris consisting of 4-inch-diameter and smaller logs and branches extended along the entire west face of Pier 2 and from the channel bottom up 2 feet.

- A 5-foot-wide, 3-foot-deep scour pocket was observed along the entire west side of Pier 2.
- The top of the footing was partially exposed along the west side of Pier 2 from the midpoint of the shaft to the downstream 1/4 point, and the exposed surface exhibited light scaling with typical penetrations of 1/8 to 1/4 inch in depth.

- The channel bottom consisted of silty sand with 3 inches of probe rod penetration with scattered random riprap around the perimeter of Pier 1.
- The channel bottom consisted of 1-foot-diameter riprap with some sand and gravel with no appreciable probe rod penetration.

- A light to moderate accumulation of 8-inch-diameter and smaller timber debris was observed at the upstream nose of Pier 1 and extended from the channel bottom up 4 feet.

- Two 1-foot-high areas of moderate scaling were located on the east face of Pier 1 at the waterline. One area was 2 feet long with up to 1 inch of penetration and was located 6 feet south of the upstream nose. The other area was 1 foot long with up to 1/2 inch of penetration and was located 14 feet south of the upstream nose.

- A 2-foot-long area of moderate scaling was located at the western upstream side of Pier 1 at the waterline with up to 1/2 inches of penetration.
- The channel bottom consisted of sand with up to 3 inches of probe rod penetration.

(A) Monitor the timber drift that has accumulated around the piers, and if found to be progressing to the point of influencing or becoming excessive, then removal operations may become necessary.

(B) Reinspect the submerged substructure units at the normal maximum recommended (NBIS) interval of sixty (60) months. Continue to monitor the footing exposure at Pier 2 during future inspections.
