2017 UNDERWATER BRIDGE INSPECTION REPORT

BRIDGE # 33506 CSAH 8 over KNIFE RIVER

Date of Inspection: 04/06/2017

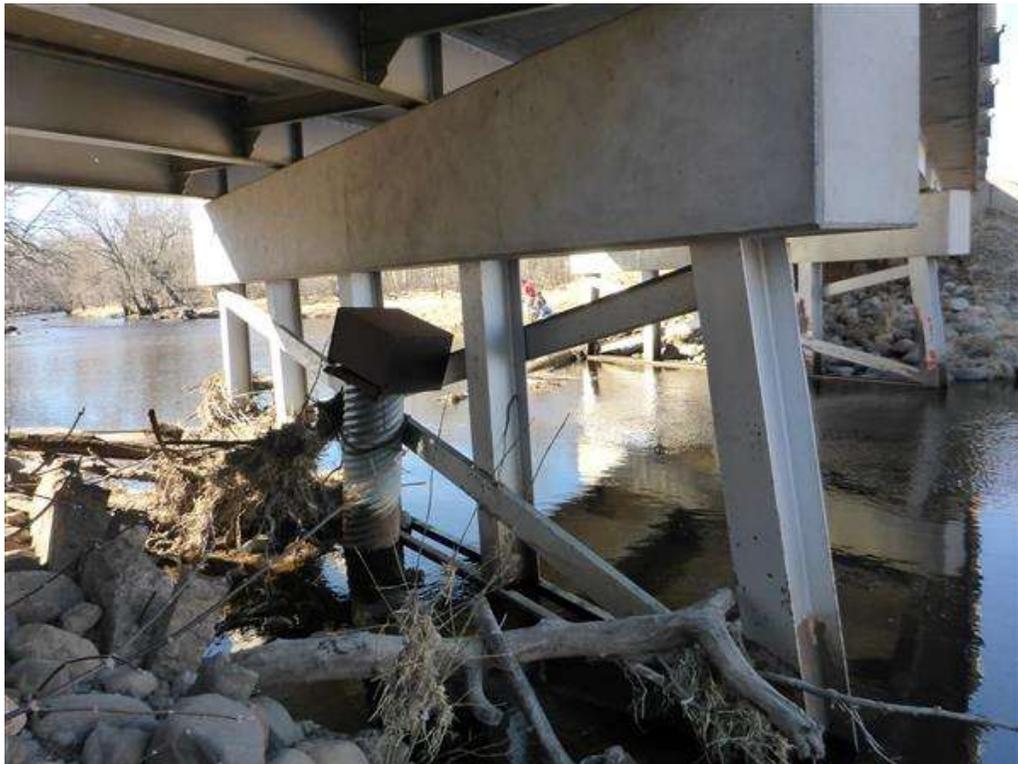
Photo 2 - Pier 1 Looking Northwest

(A) Overall, the steel of the H-piles of both piers was sound, while the paint system has failed from two feet above the waterline to the channel bottom.

(B) Severe timber debris, up to 1 foot diameter, and garbage have accumulated between Pier 1 and the south shoreline. Garbage includes a large corrugated steel pipe with a steel box attached.

(A) Monitor the timber debris accumulation at both Piers during future inspections, and if found to be increasing to a more detrimental extent, removal operations may become warranted at that time.

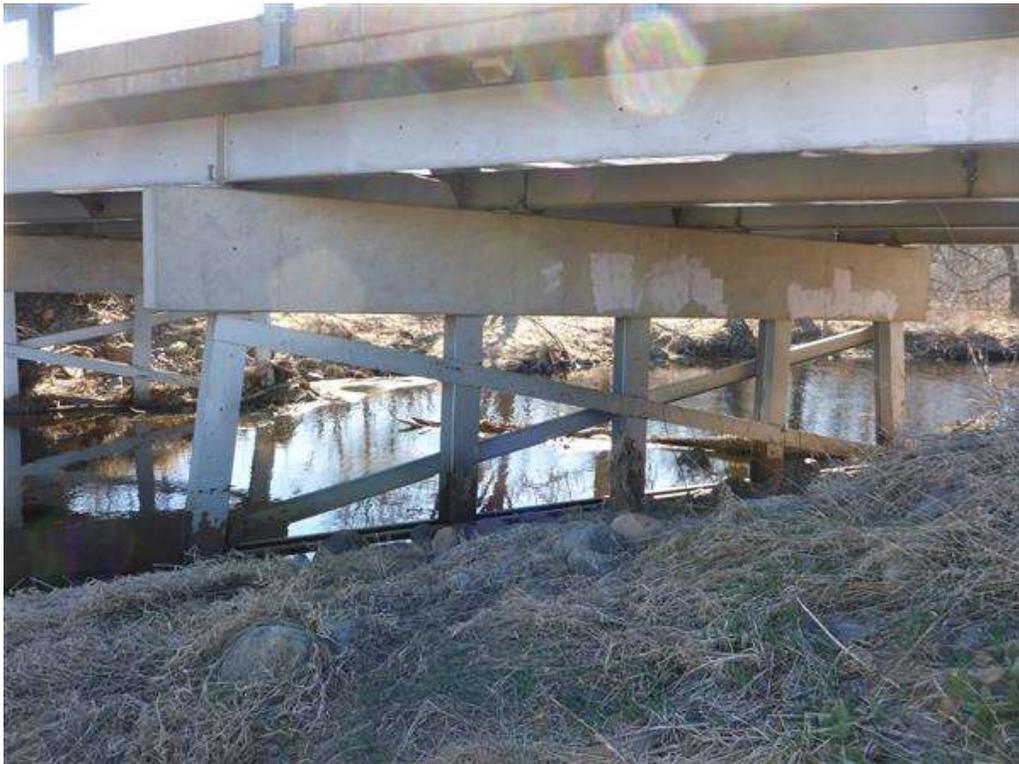
Photo 4 - Pier 2 Looking South

(C) Submerged log, up to 16 inches in diameter, observed from the upstream nose of Pier 2 extending halfway into the main span channel.

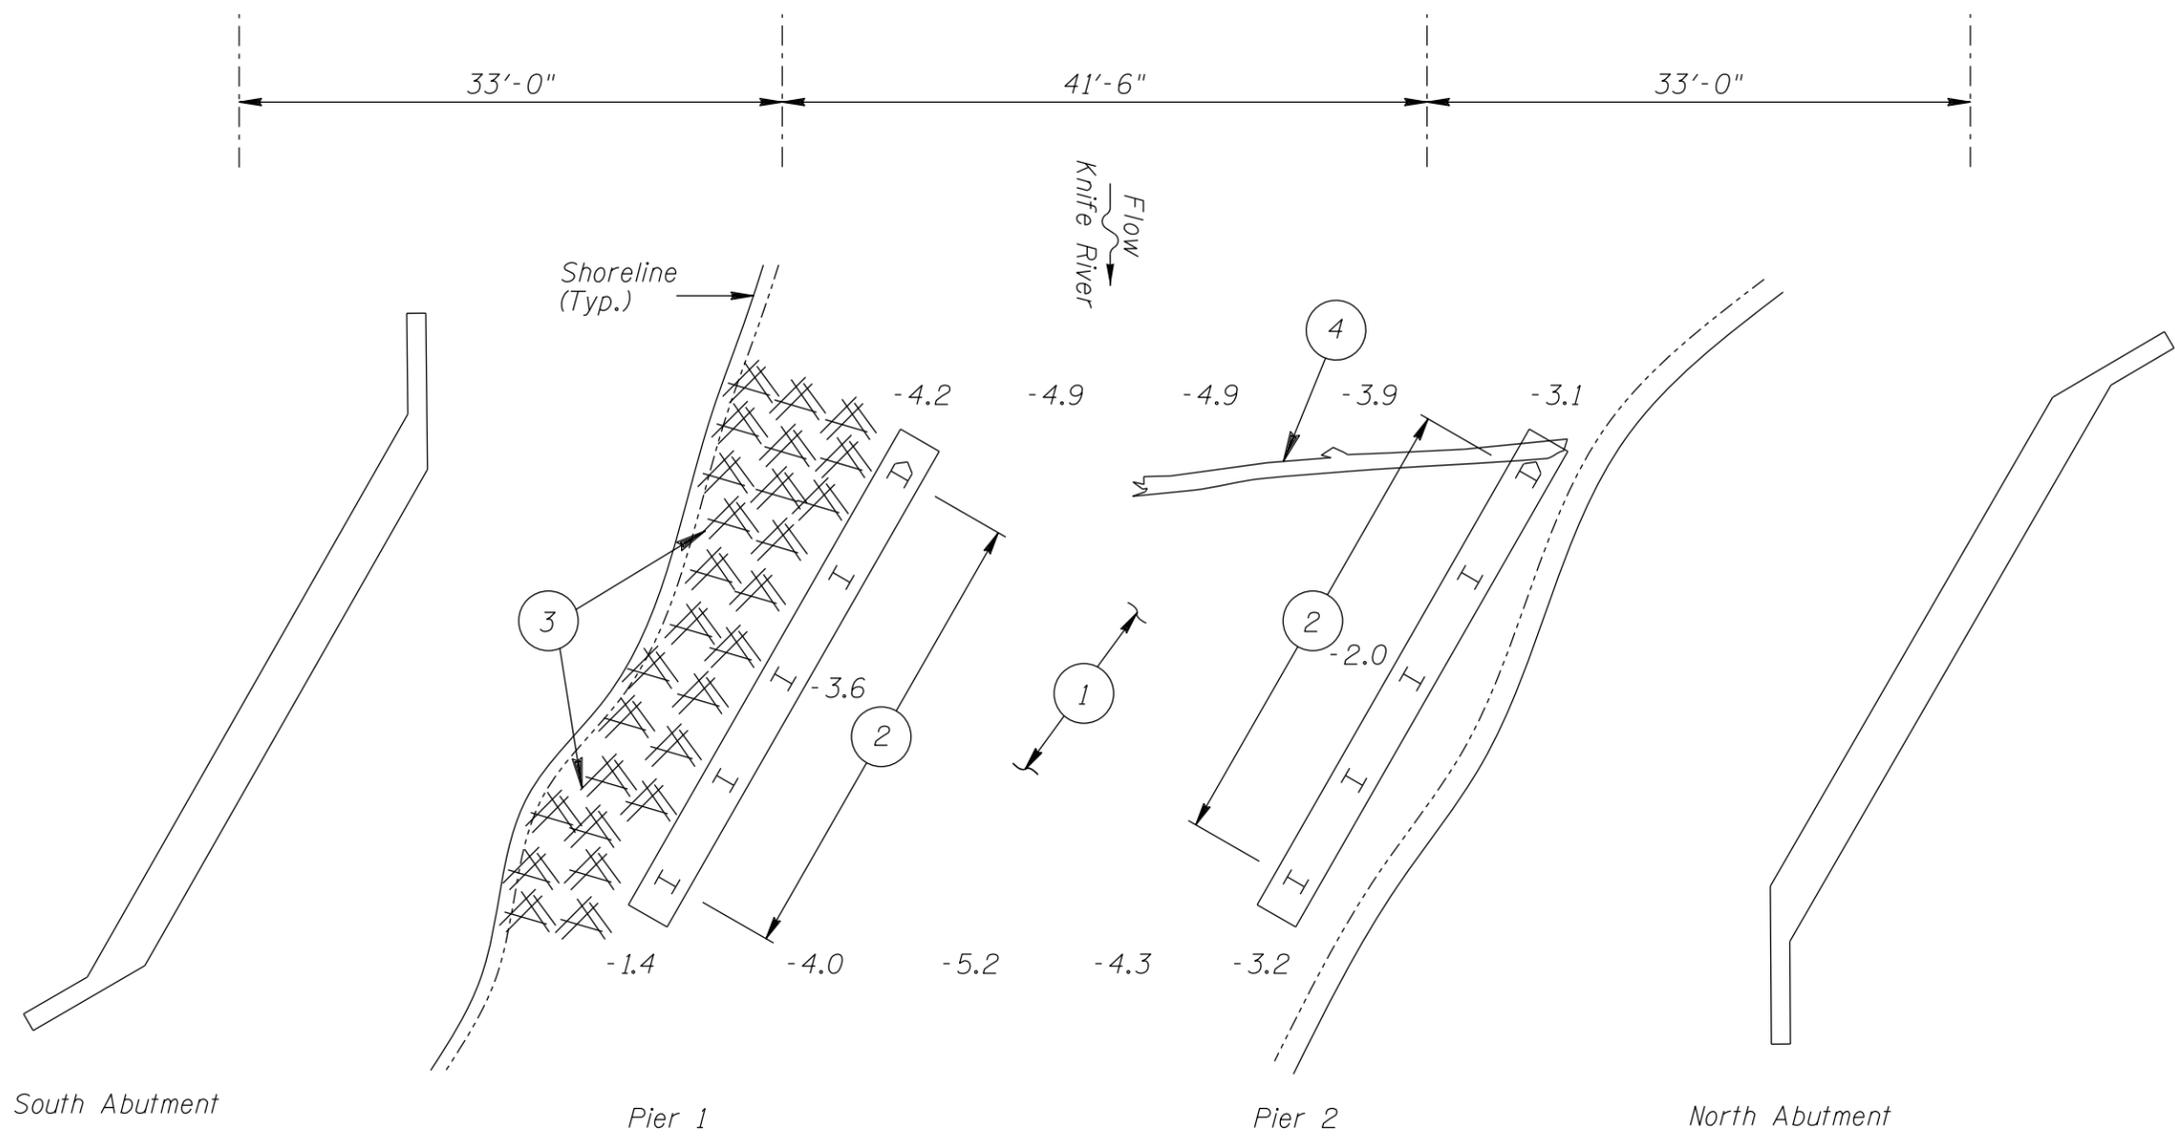
SOUNDING PLAN

- 1 Channel bottom material consisted of cobbles, up to 2 feet in diameter.
- 2 Steel H-piles typically exhibited paint system failure from 2 feet above the waterline to the channel bottom.
- 3 Heavy timber debris, up to 1 foot diameter, and garbage have accumulated between Pier 1 and the south shoreline. Garbage includes a large corrugated steel pipe with a steel box attached, photos included in inspection report.
- 4 Submerged log, up to 16 inches in diameter, observed from the upstream nose of Pier 2 extending halfway into the main span channel.
