2017 UNDERWATER BRIDGE INSPECTION REPORT

BRIDGE # 33528 TWP 1 over SNAKE RIVER

Date of Inspection: 04/13/2017

Contractor: Collins Engineers, Inc.

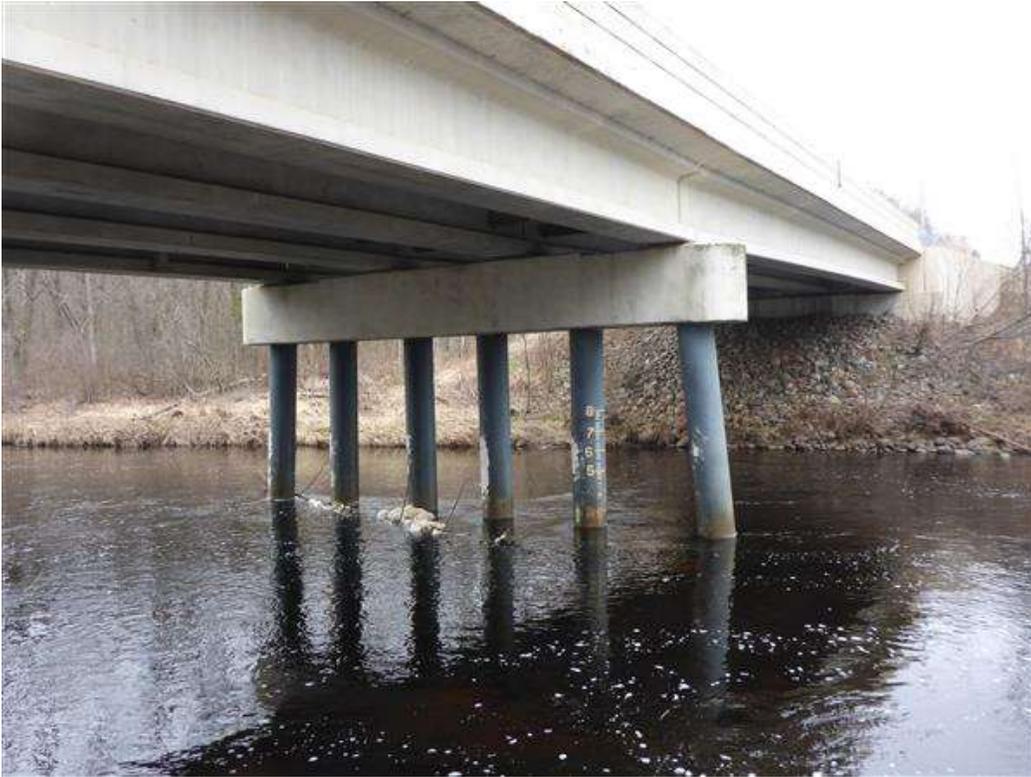
Photo 3 - Pier 1 Looking North

(B) Paint system of CIP piles failed at approximately 10% of surface area, with rust staining observed at the waterline.

(C) Scour depression observed on the upstream nose with a 6 inch depth and a 2 foot radius.

(D) Moderate timber debris accumulation, up to 6 inch diameters, was observed from the channel bottom to the waterline beginning at the upstream pile and extending to the downstream 1/4 point of the west side of the pier and into the main channel.

(A) Reinspect the submerged substructure units at the normal maximum recommended (NBIS) interval of sixty (60) months.

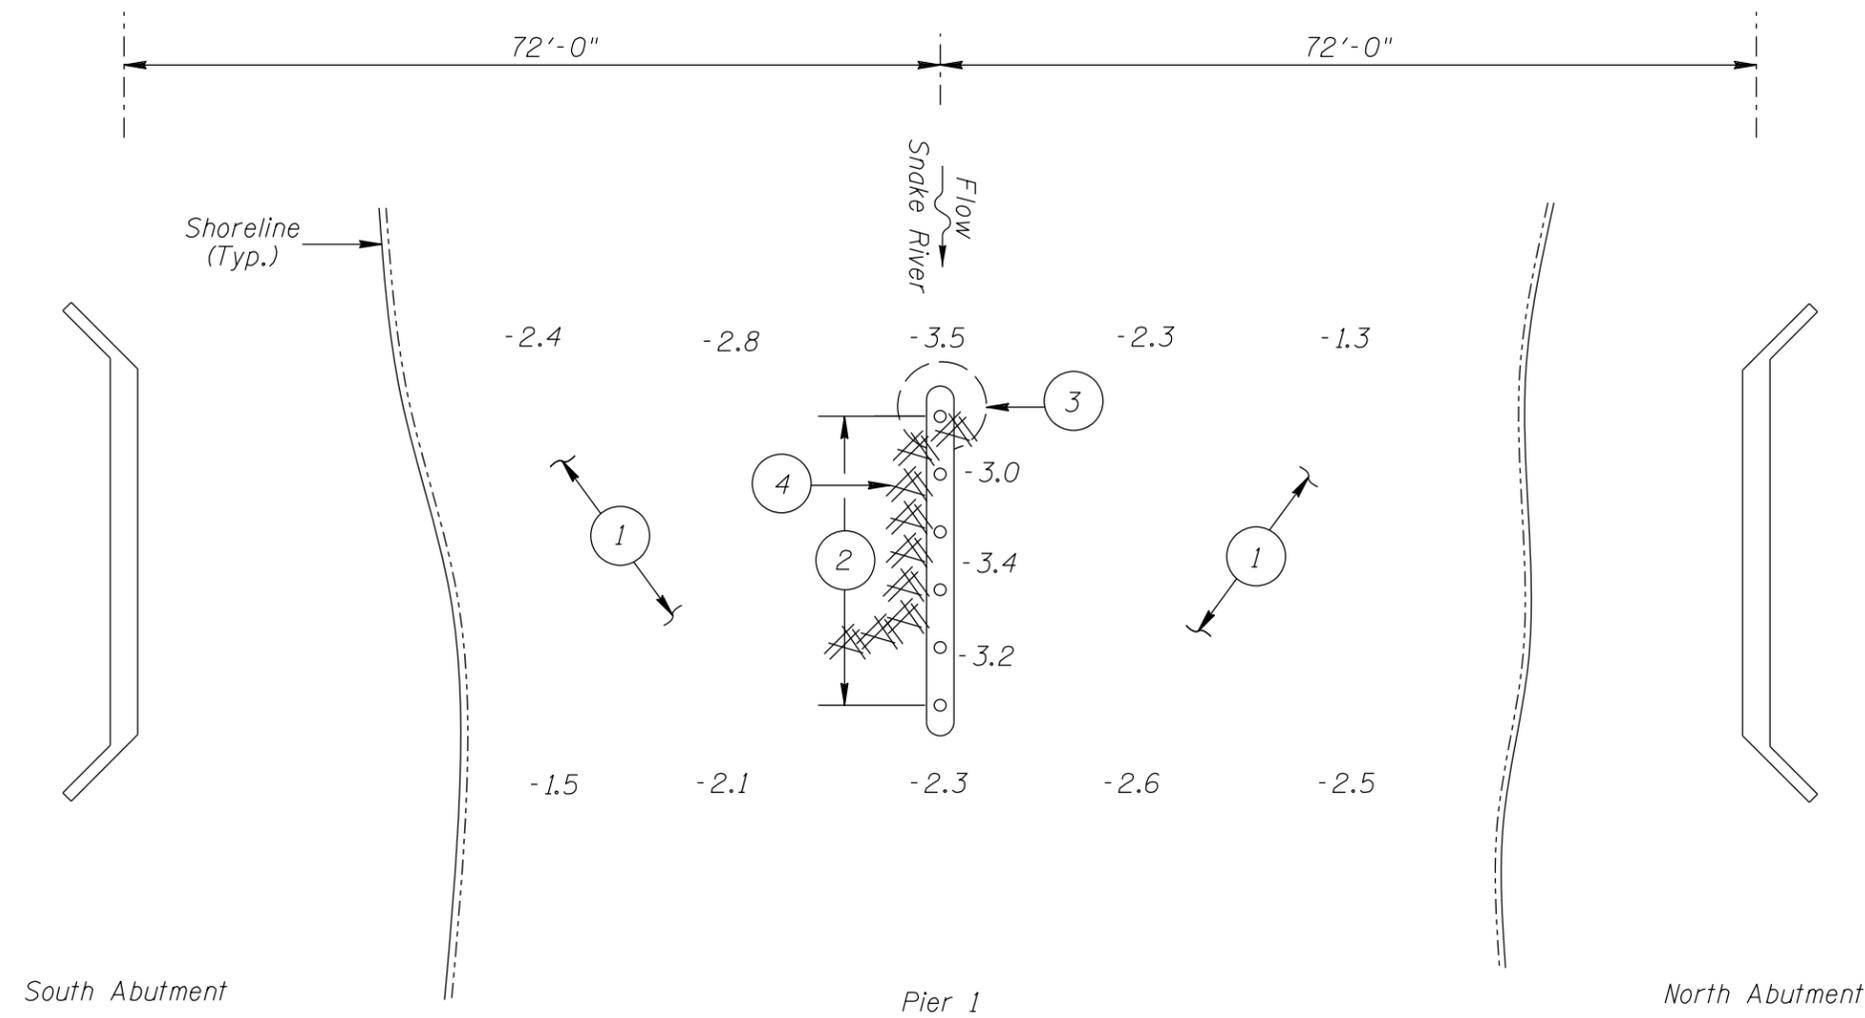
| INSPECTION AND SOUNDING PLAN | | |

1. Channel bottom material consisted of a gravelly sand with cobbles, up to 18 inches in diameter.
2. Paint system of CIP piles failed at approximately 10% of surface area, with rust staining observed at the waterline.
3. Scour depression observed on the upstream nose with a 6 inch depth and a 2 foot radius.
4. Moderate timber debris accumulation, up to 6 inch diameters, was observed from the channel bottom to the waterline beginning at the upstream pile and extending to the downstream 1/4 point of the west side of the pier and into the main channel.
