2016 UNDERWATER BRIDGE INSPECTION REPORT

BRIDGE # 49521 CSAH 52 over PIKE CREEK

Date of Inspection: 06/10/2016

UNDERWATER INSPECTION

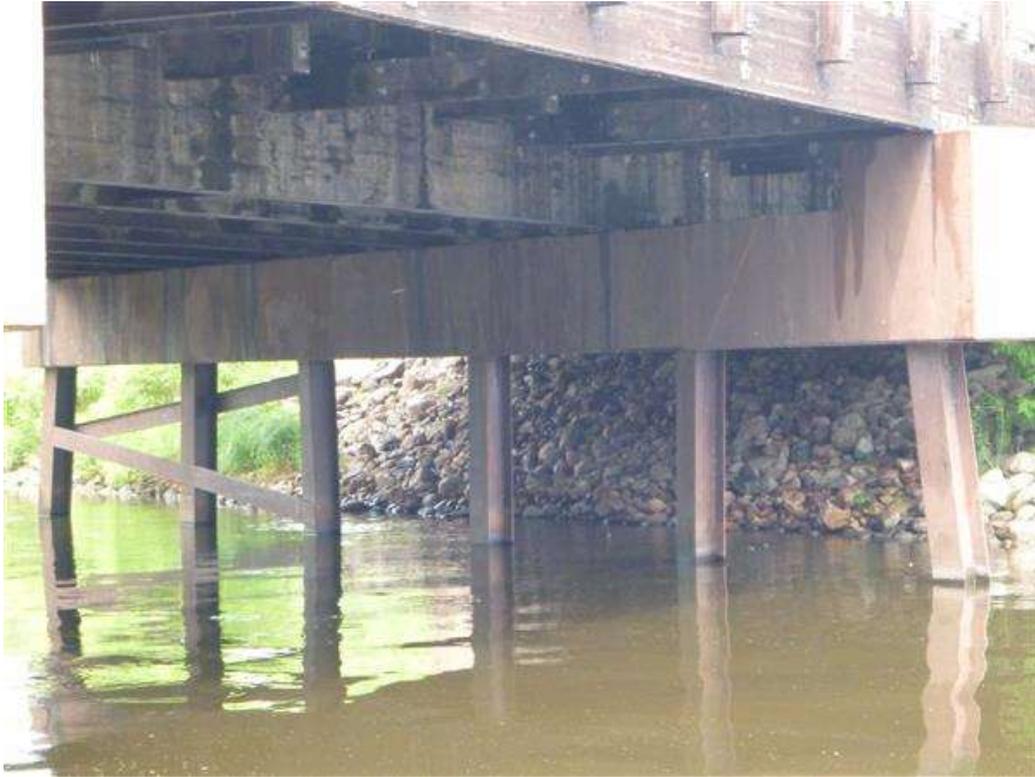
Photo 3 - Pier 1, Looking Northwest

(B) The steel HP piles were in satisfactory condition with up to 50% of coating loss and light to moderate corrosion from the channel bottom to 1 foot above the waterline. Below water rust nodules up to 1/2 inch in diameter and minor pitting up to 1/16 inch deep were present on all piles.

(C) The channel bottom at Pier 1 consisted of scattered riprap up to 2 foot diameter and soft silt allowing up to 6 inches of probe rod penetration.

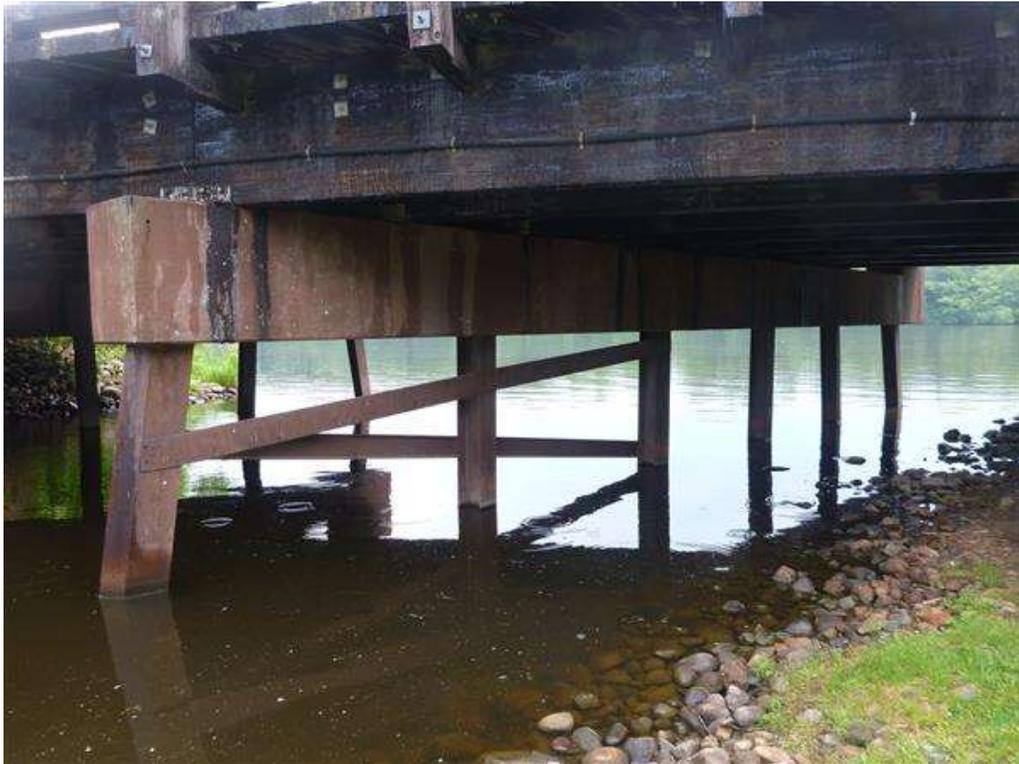
Photo 4 - Pier 2, Looking Northeast

(D) The channel bottom at Pier 2 consisted of riprap up to 2 foot diameter with silt infill and no probe rod penetration.

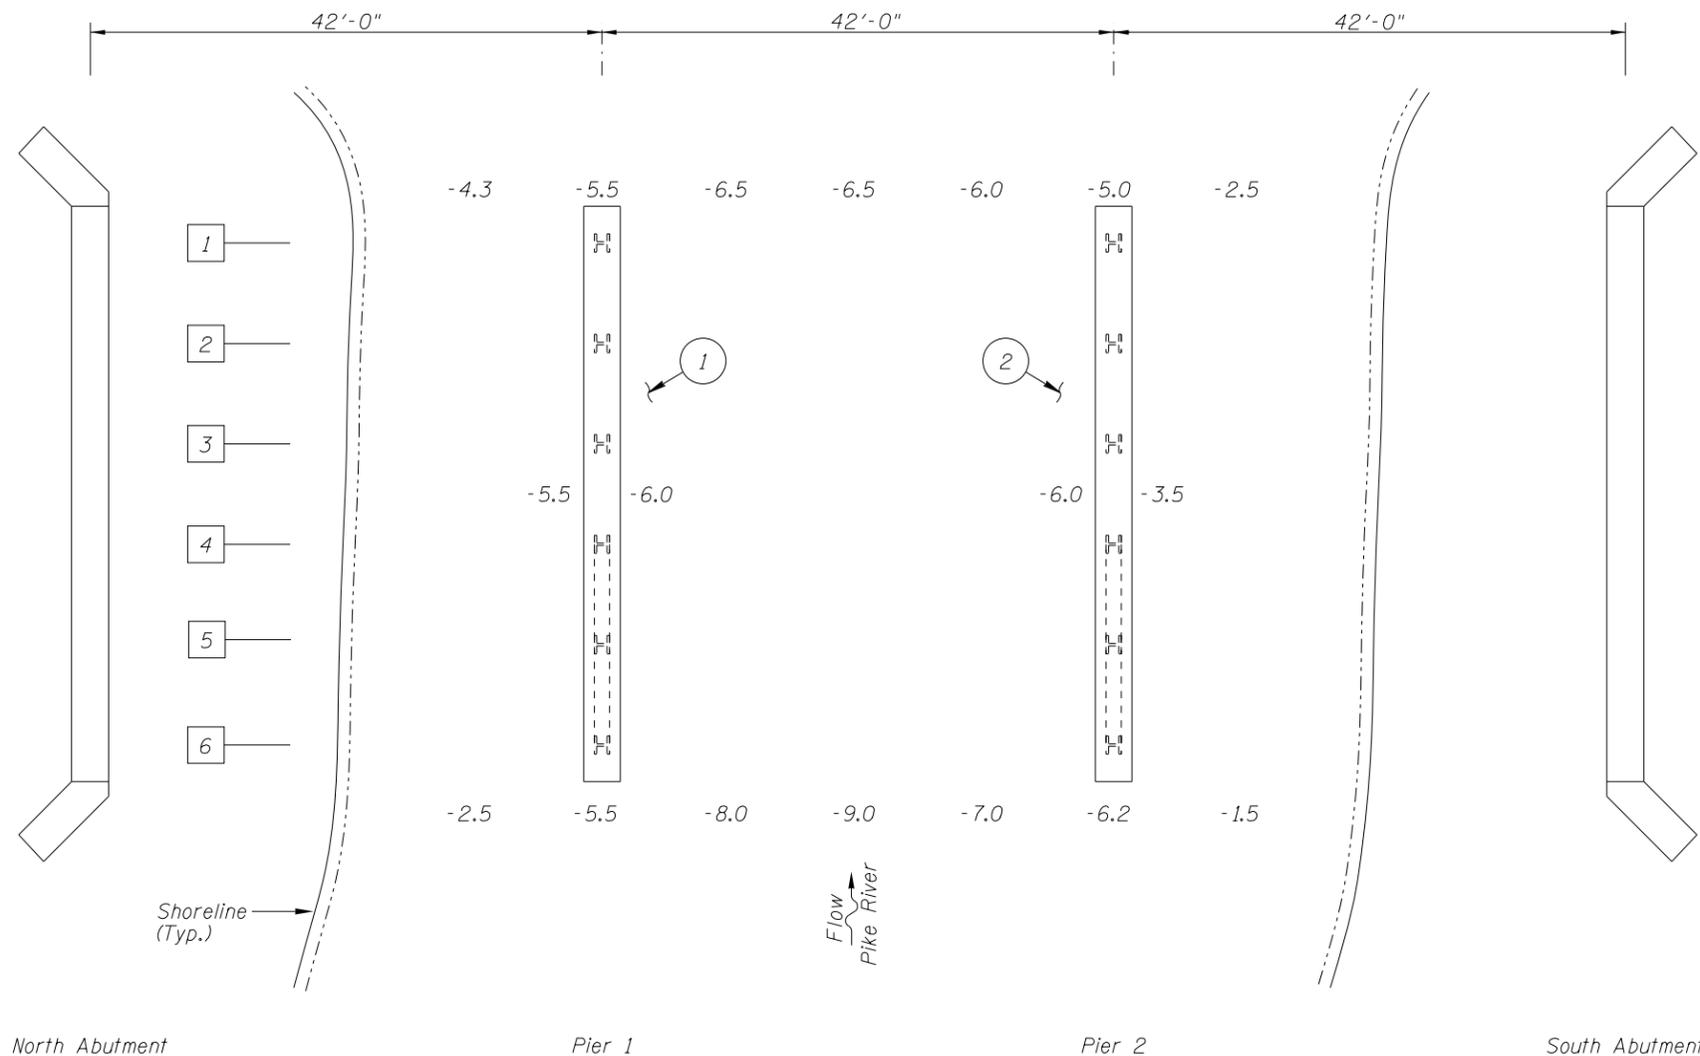
SOUNDING PLAN

- The steel HP piles were in satisfactory condition with up to 50% of coating loss and light to moderate corrosion from the channel bottom to 1 foot above the waterline. Below water rust nodules up to 1/2 in inch diameter and minor pitting up to 1/16 inch deep were present on all piles.

- The abutment slopes were generally well armored with riprap up to 1 foot in diameter, but there was less coverage on the south slope.
- Soundings indicate the water depth at the time of inspection and are measured in feet.

- The channel bottom at Pier 1 consisted of scattered riprap up to 2 foot diameter and soft silt allowing up to 6 inches of probe rod penetration
- The channel bottom at Pier 2 consisted of riprap up to 2 foot diameter with silt infill and no probe rod penetration.
