# 2016 UNDERWATER BRIDGE INSPECTION REPORT

## BRIDGE # 7164 CSAH 5 over N FK CROW RIVER

Date of Inspection: 05/27/2016

Contractor: Collins Engineers, Inc.

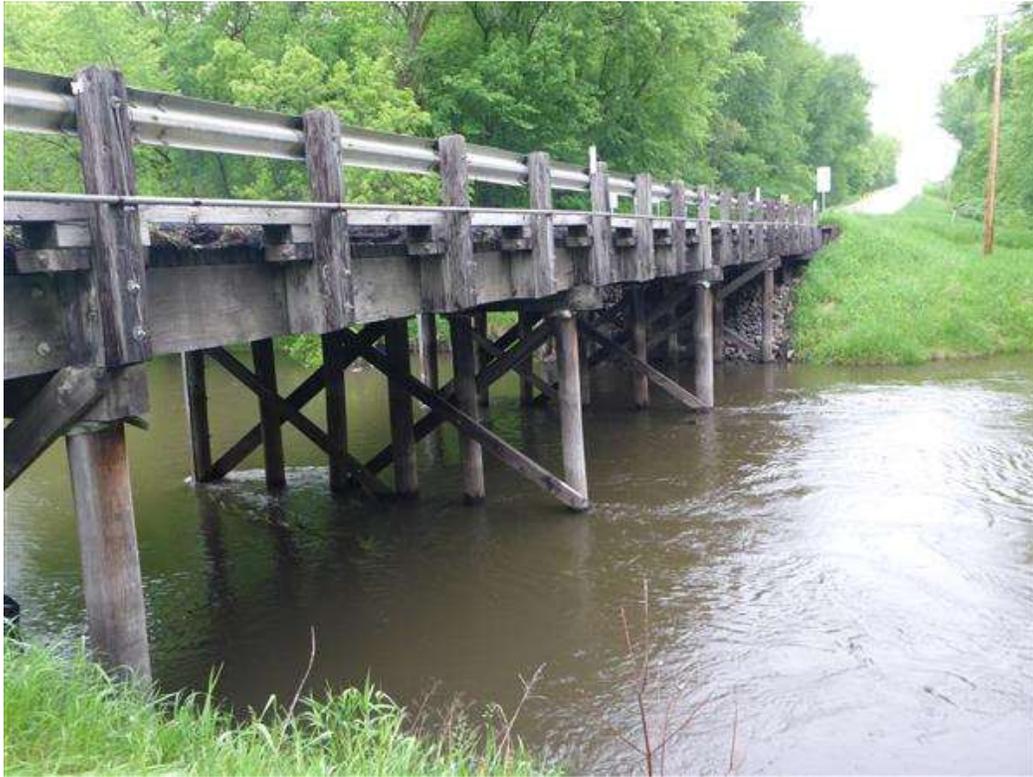
Photo 1 - East Elevation, Looking Northwest

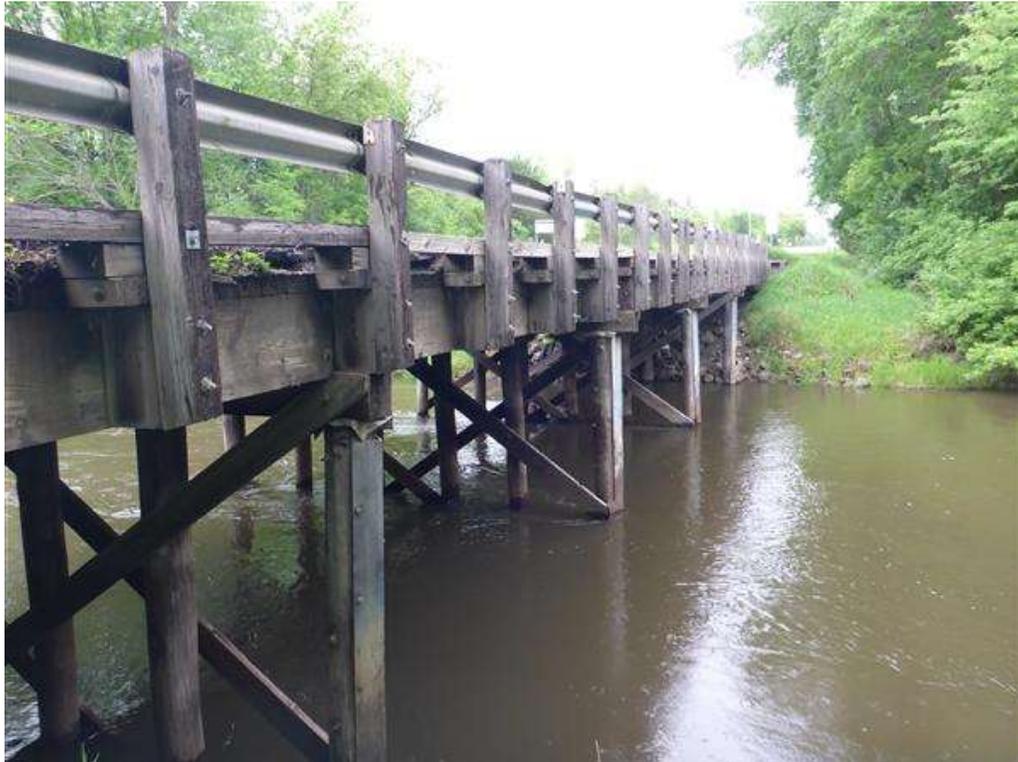
Photo 2 - West Elevation, Looking Southeast

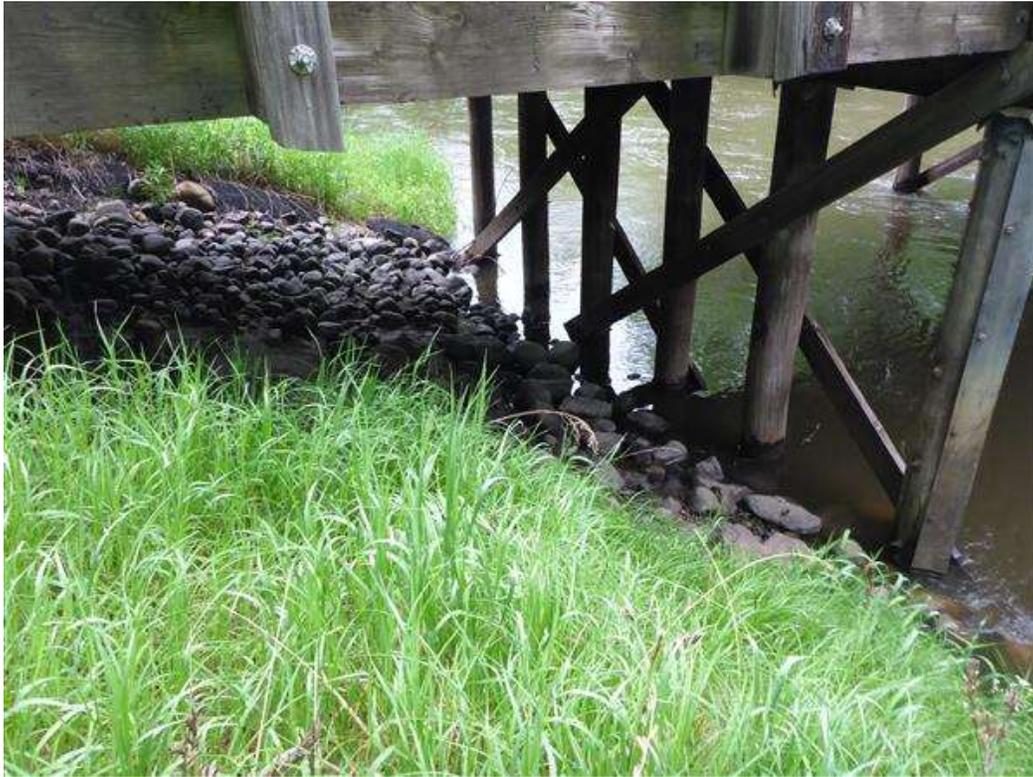
Photo 3 - View of North Shoreline and Pier 4, Looking Southeast

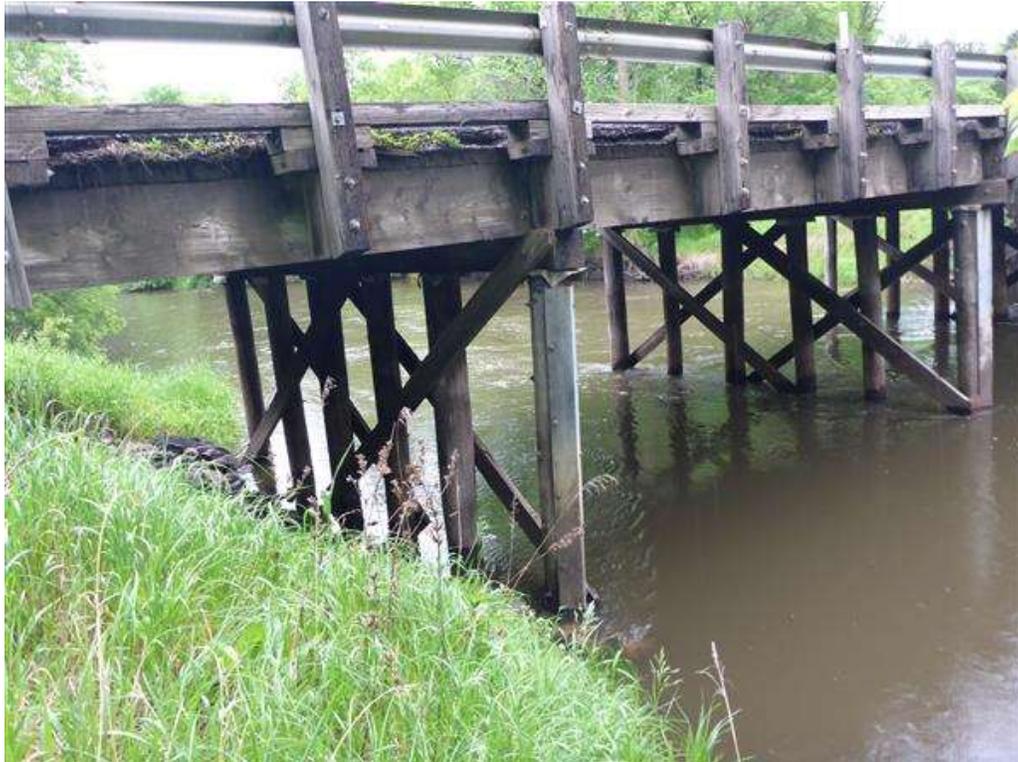
(C) Light timber debris was found along the south face of both Piers 2 and 3.

Photo 4 - View of Pier 3, Looking South

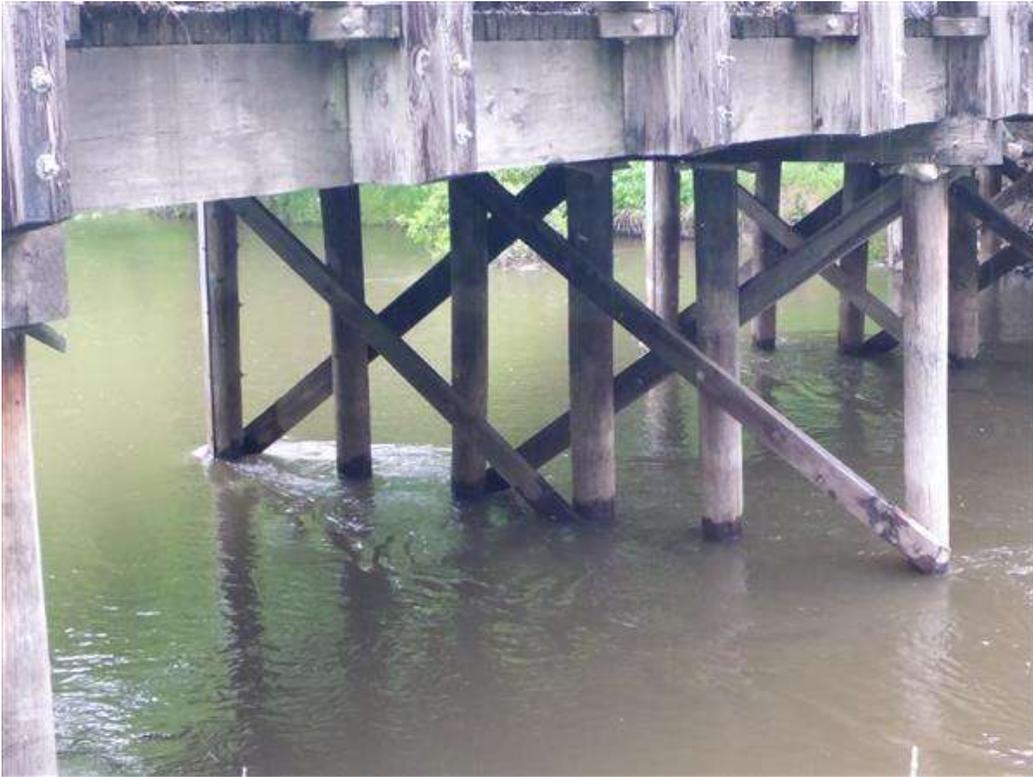
Photo 5 - View of Pier 2, Looking North

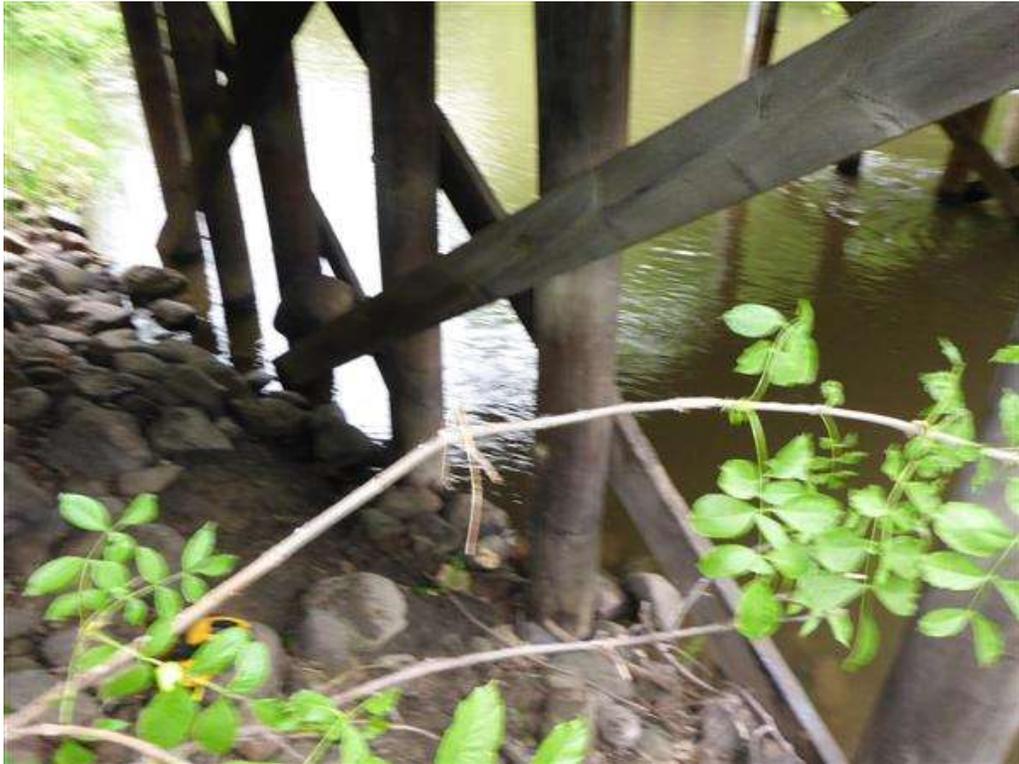
Photo 6 - View of South Shore and Pier 1, Looking North

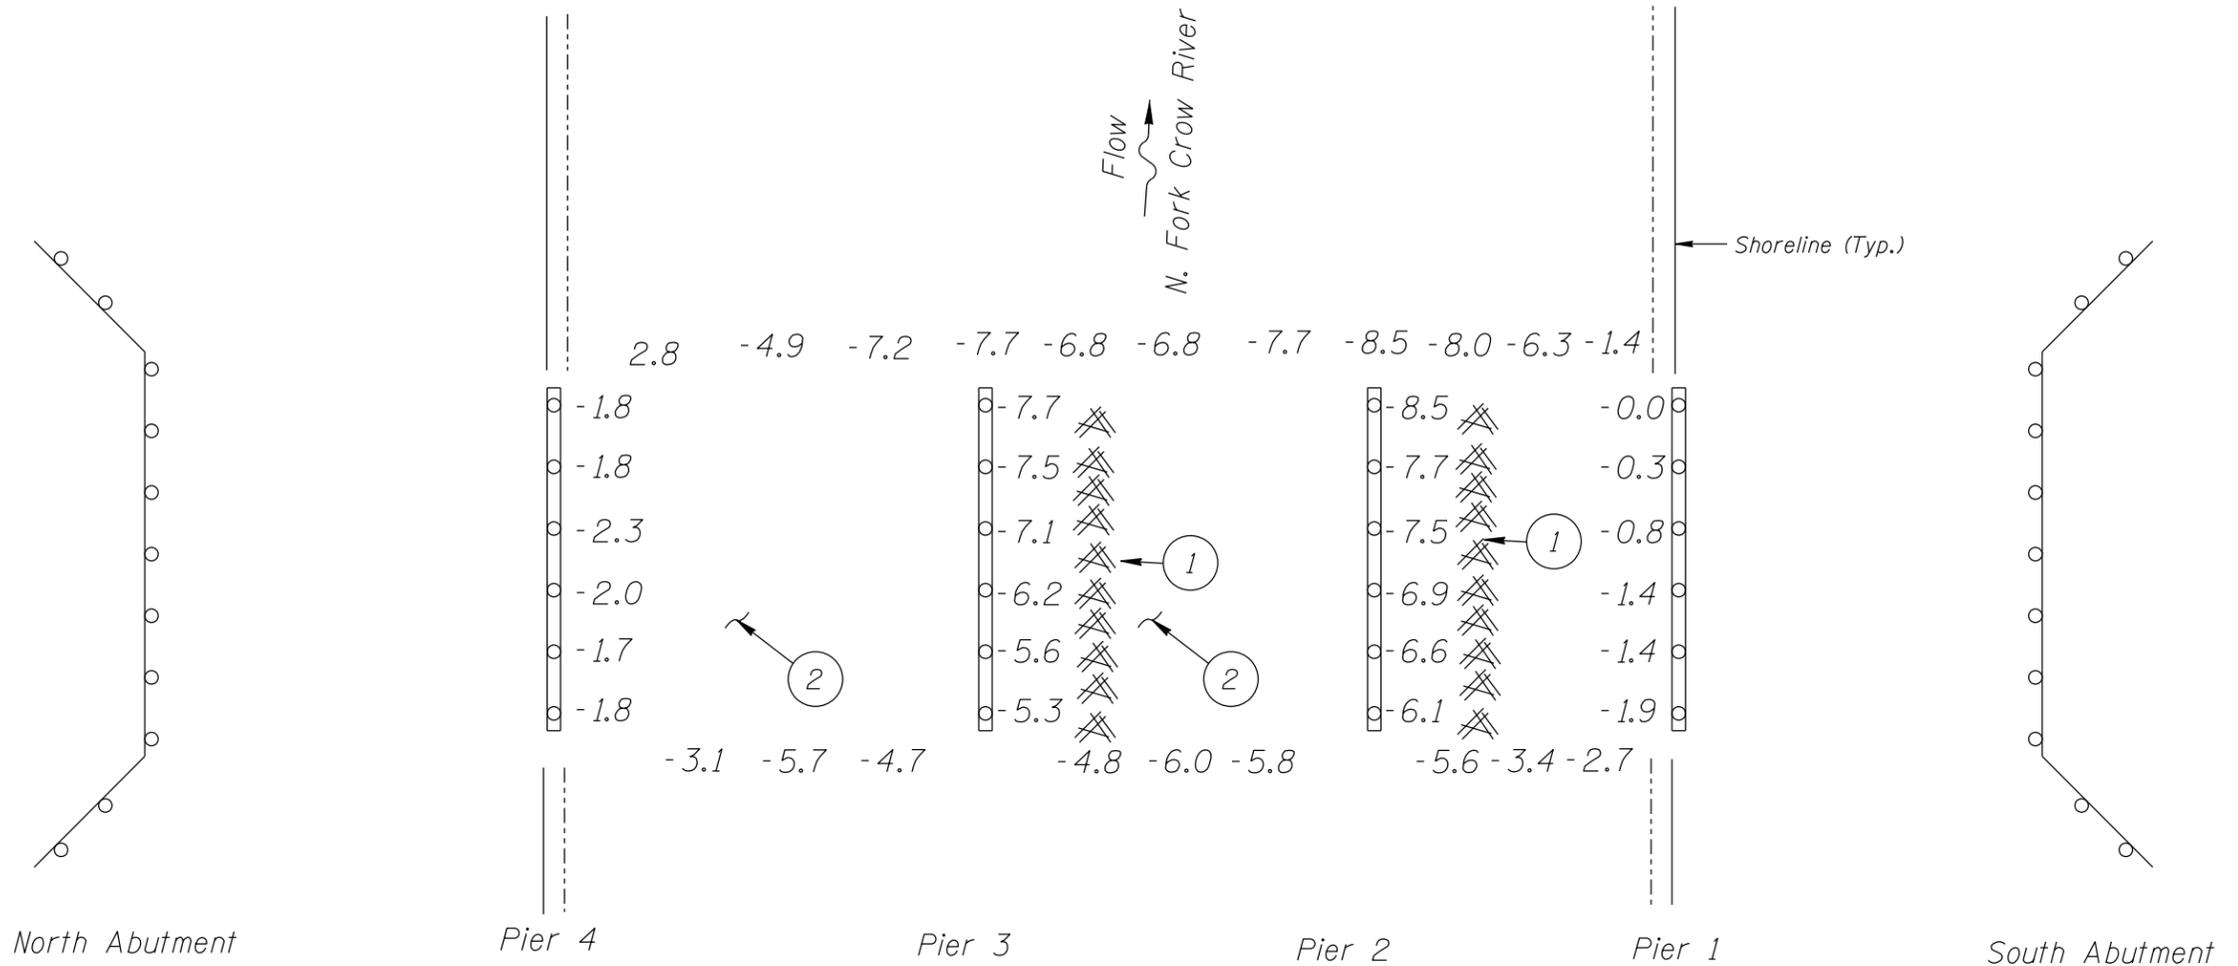
INSPECTION AND SOUNDING PLAN

- ① Light timber debris is present along the south face of Pier 2 and Pier 3.
- ② The bottom consists of sand and organic material with up to 12 inches of penetration.
