# 2016 UNDERWATER BRIDGE INSPECTION REPORT

## BRIDGE # 7170 CSAH 12 over CROW WING RIVER

Date of Inspection: 06/05/2016

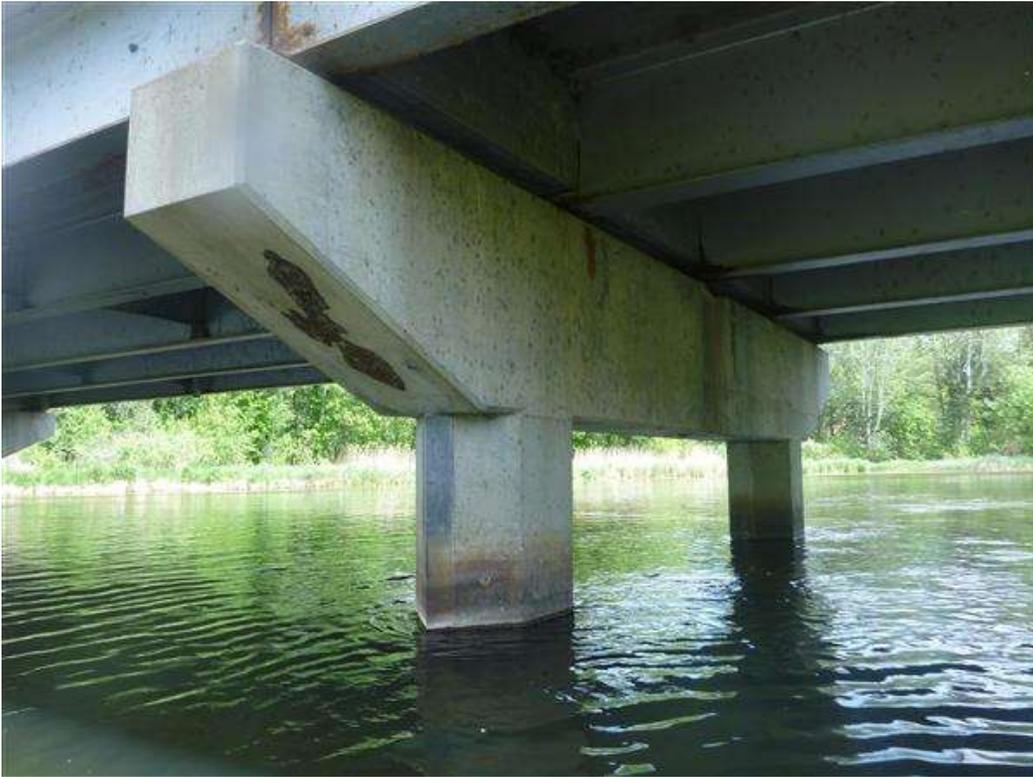
Photo 3 - Pier 1, Looking Southeast

(A) The concrete pier columns exhibited scaling from the waterline to 2 feet below the waterline with up to 1 inch of penetration and exposed aggregate.

(B) The channel bottom consisted of 1 foot diameter and smaller rock allowing no probe rod penetration at Pier 1. The channel bottom at Pier 2 consisted of sandy gravel allowing up to 3 inches of probe rod penetration.

(C) A scour depression with a radius of 5 feet and up to 2 feet deep was present at the upstream column nose of Pier 1.

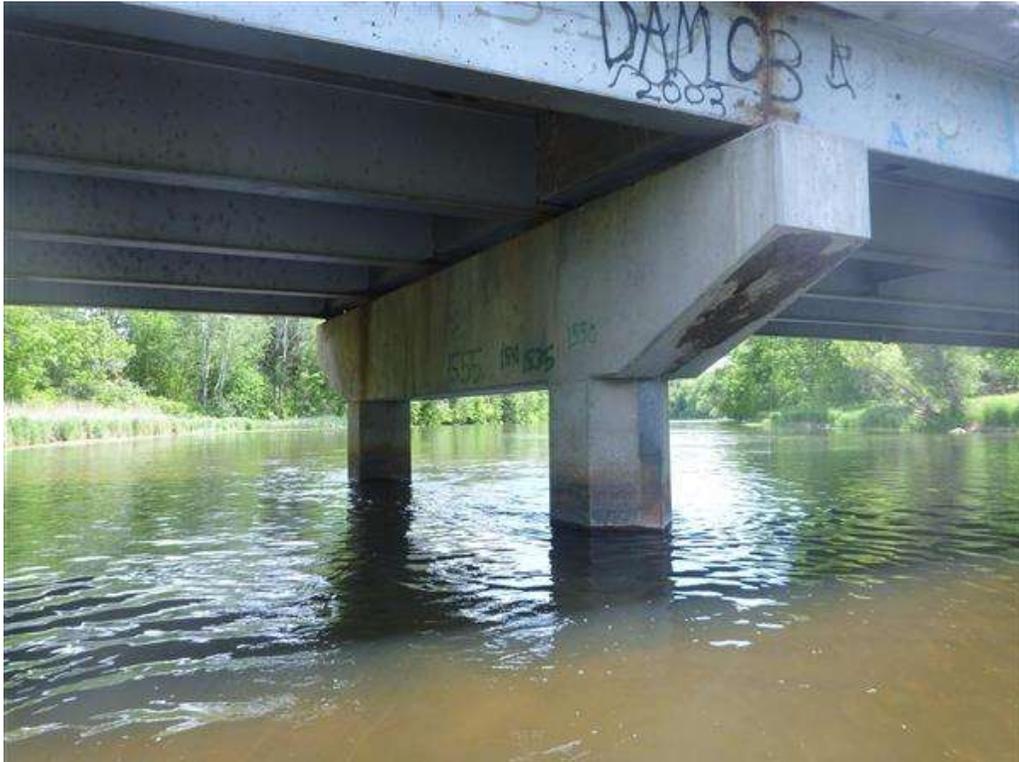
Photo 4 - Pier 2, Looking Southwest

(D) Scour depressions with radii up to 5 feet and up to 2 feet deep were present at the upstream and downstream columns of Pier 2.

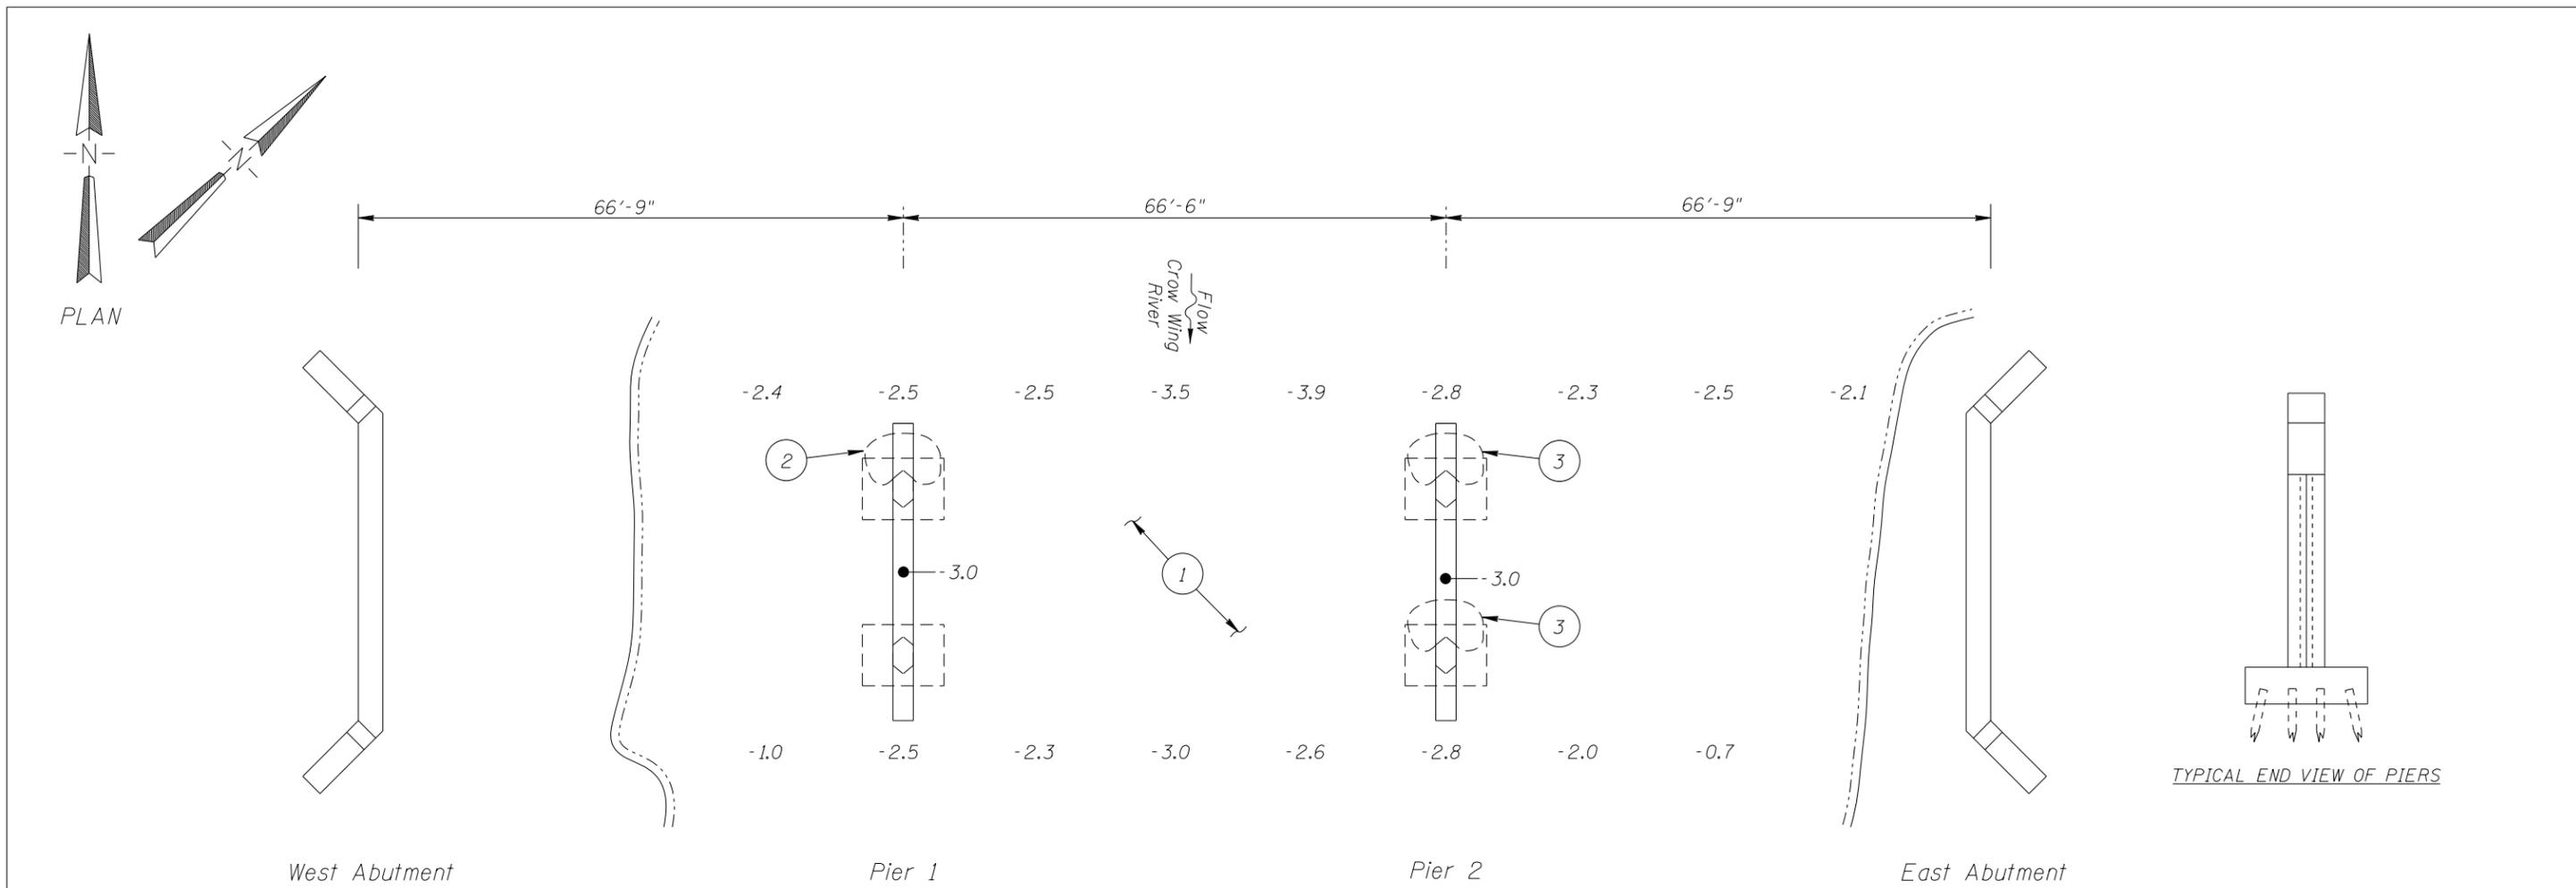
SOUNDING PLAN

- The channel bottom consisted of 1 foot diameter and smaller rock allowing no probe rod penetration at Pier 1. The channel bottom at Pier 2 consisted of sandy gravel allowing up to 3 inches of probe rod penetration.
- A scour depression with a radius of 5 feet and up to 2 feet deep was present at the upstream column nose of Pier 1.
- Scour depressions with radii up to 5 feet and up to 2 feet deep were present at the upstream and downstream columns of Pier 2.
