# 2016 UNDERWATER BRIDGE INSPECTION REPORT

## BRIDGE # 90700 CSAH 7 over N FK CROW RIVER

Date of Inspection: 05/27/2016

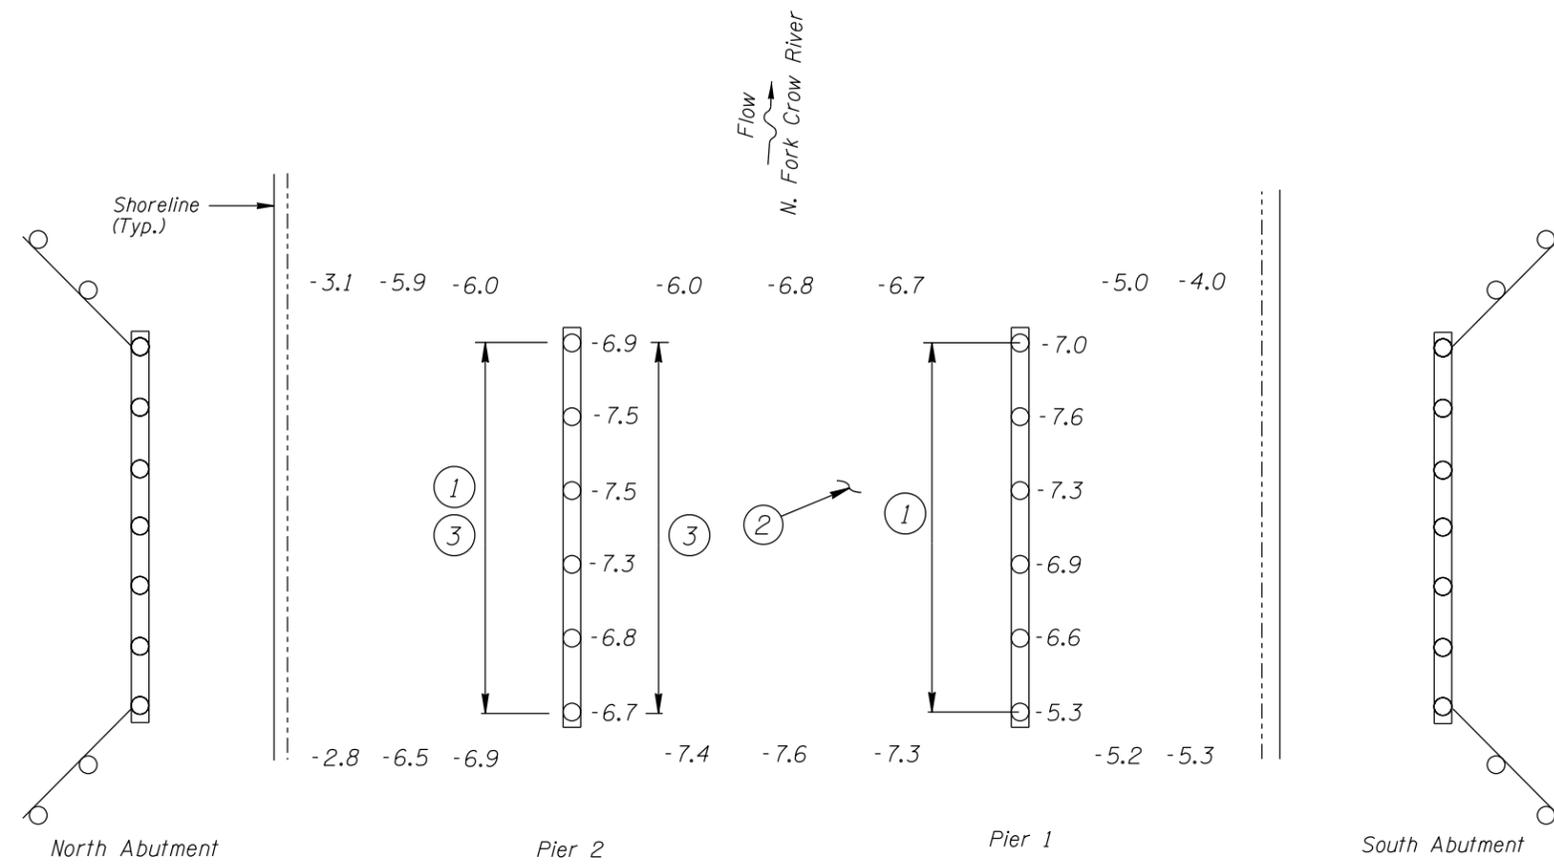
SOUNDING PLAN

- Inspection Notes:
- ① 1 foot deep scour is typical around each pile.
  - ② The channel bottom consists of sand with up to 6 inches of penetration.
  - ③ Up to 6 inch diameter timber debris on both sides of Pier 2, extending from channel bottom to 3 feet below water line.
