2017 UNDERWATER BRIDGE INSPECTION REPORT

BRIDGE # L9181 CR 67 over WILLOW RIVER

Date of Inspection: 09/26/2016

Contractor: Collins Engineers, Inc.

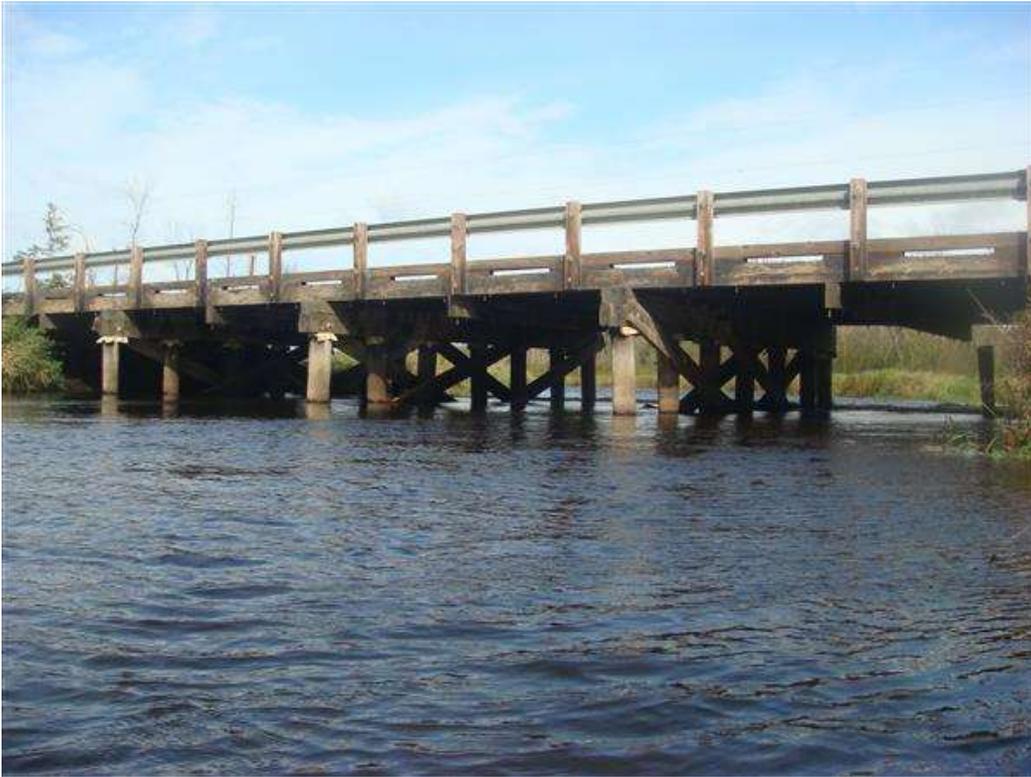
Photo 1 - Overall View of Downstream Fascia, Looking North.

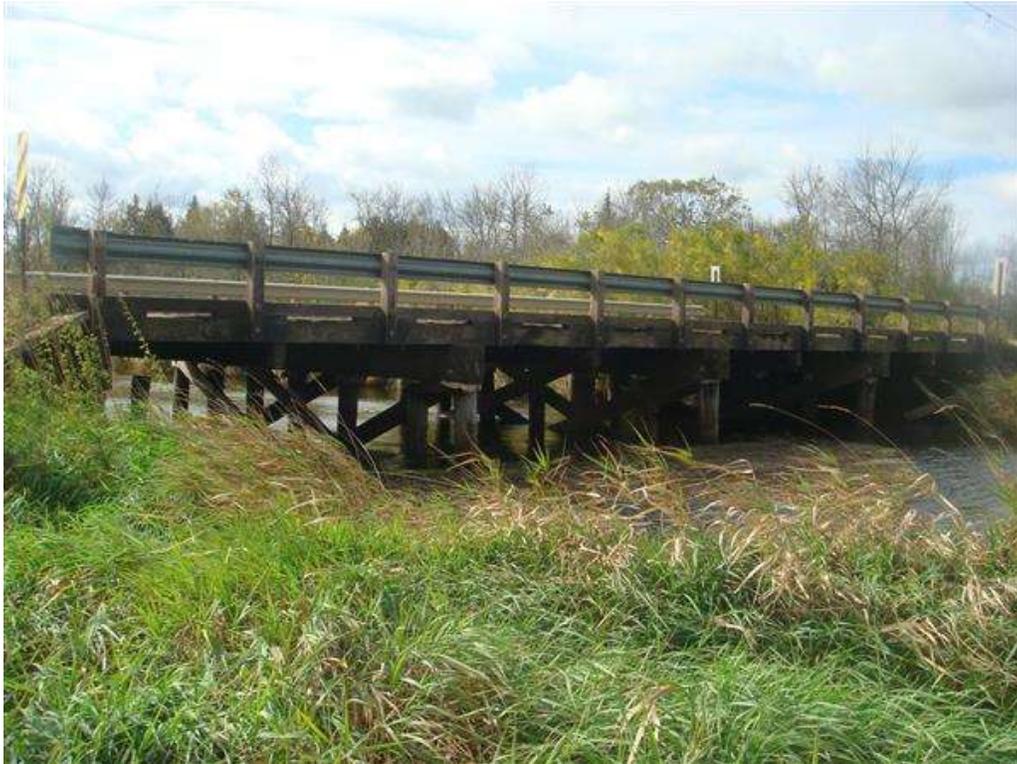
4. Light timber debris consisting of branches extended from the channel bottom up 2 feet along the east side of Piers 2 and 3 from Pile 3 to Pile 6.
5. Timber debris consisting of branches up to 9 inches in diameter extended from the channel bottom to the waterline for a width of 5 feet along the entire upstream fascia of the bridge.

Photo 2 - Overall View of Upstream Fascia, Looking Southwest.

(A) Remove timber debris accumulations at upstream fascia and along east sides of Piers 2 and 3. Removal of the timber debris will reduce excessive lateral loads on the pier, limit further debris accumulation, and reduce the likelihood of channel bottom degradation resulting from obstructed flow. Until the timber debris can be removed, monitor for any significant increases in accumulation and/or scour at the bridge.

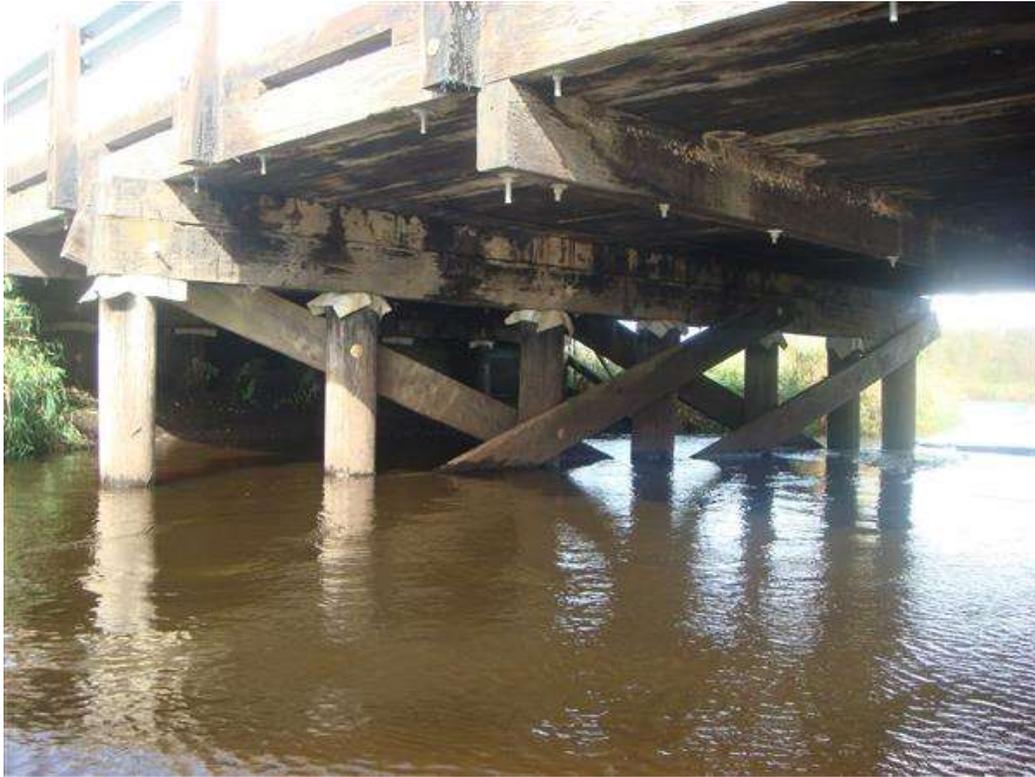
8. Minor timber rot was observed at the waterline on Pile 1 at the upstream end of Pier 3.
9. Timber cross brace was split at the connection at Pile 2 on the west side of Pier 1.

Photo 3 - View of Pier 1, Looking Northwest.

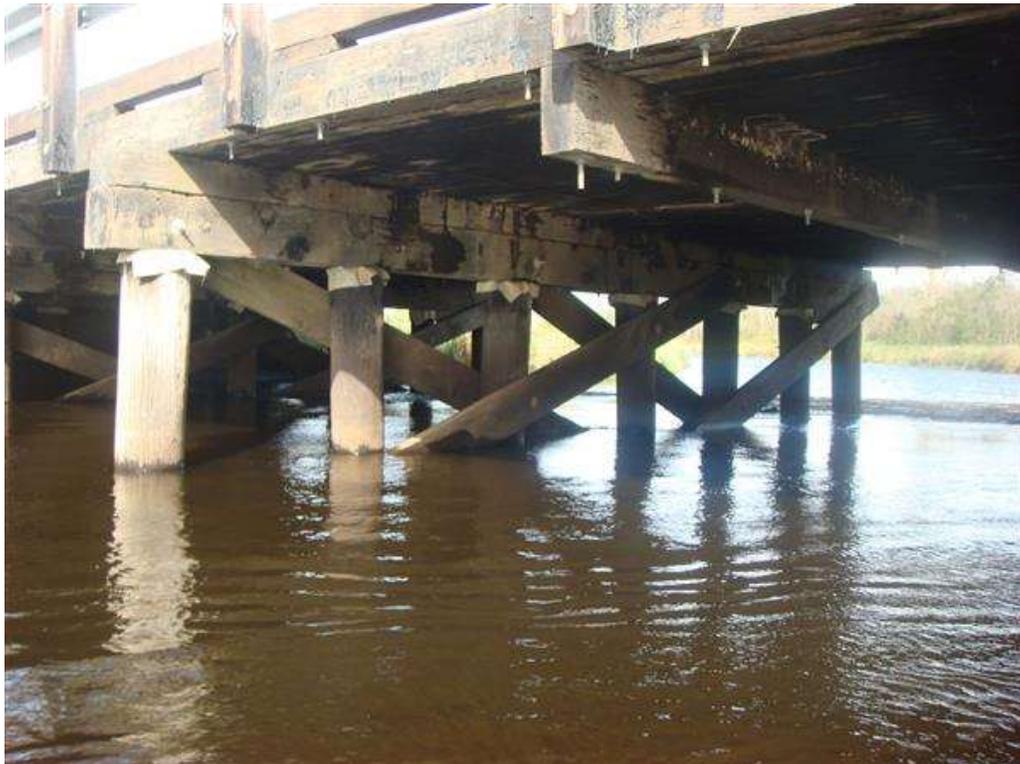
Photo 4 - View of Pier 2, Looking Northwest.

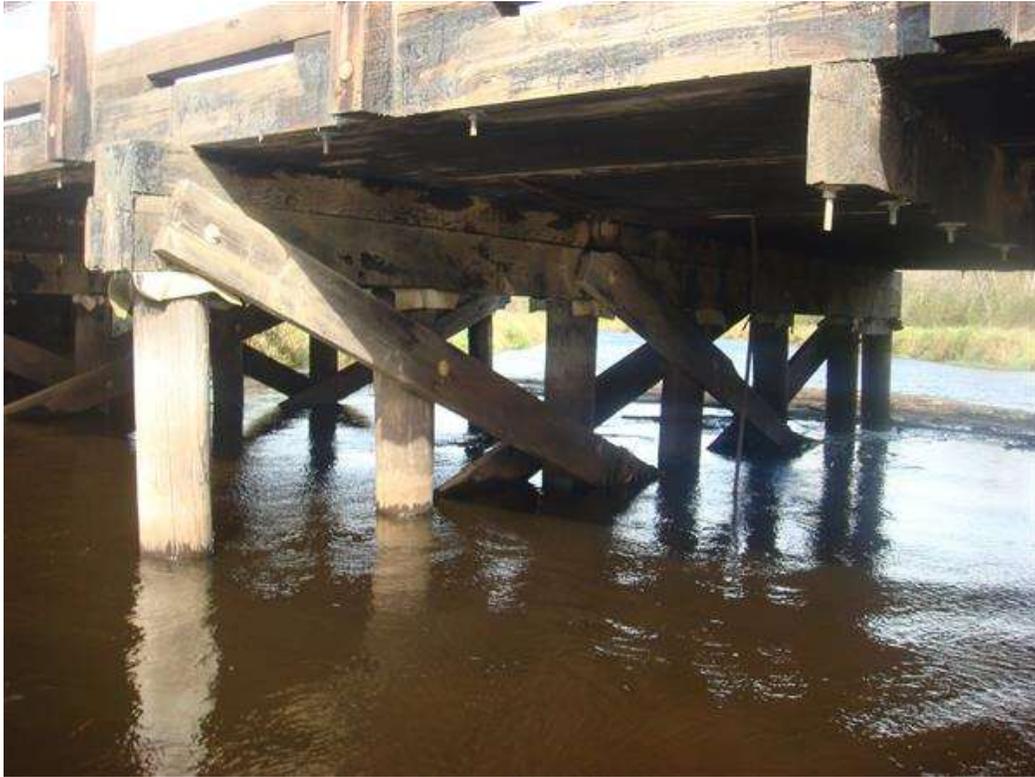
6. All timber piles typically exhibited minor decay and checking up to 1/8 inch wide.
7. Loss of section from the waterline up 2 feet measured 3 inches wide by 1/2 inch deep on Piles 1 and 2 at Pier 3.

10. Timber cross brace connection was failed at Pile 7 on the west side of Pier 3.
11. Timber cross brace was split at Pile 3 and not connected along the east side of Pier 3 from Pile 3 to the downstream end of the pier.

Photo 5 - View of Pier 3, Looking Northwest.

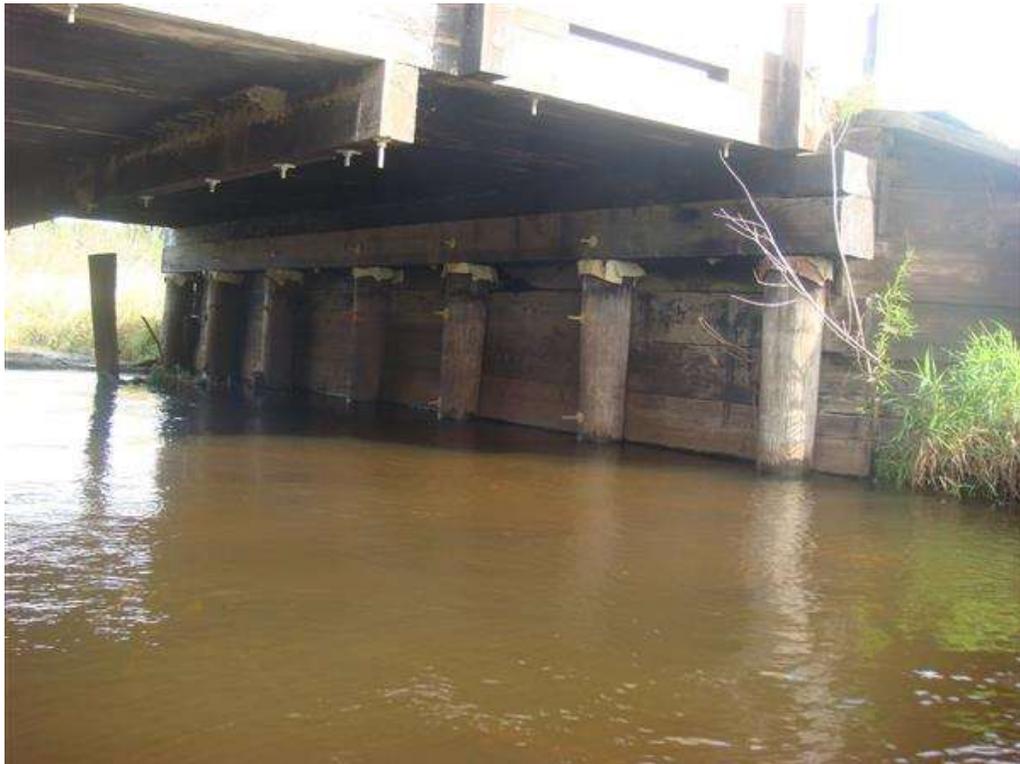
3. Channel bottom material along the entire face of the East Abutment and extending 5 feet into the channel consisted of sand and gravel allowing 1 inch of probe rod penetration.

Photo 6 - View of East Abutment, Looking Northeast.

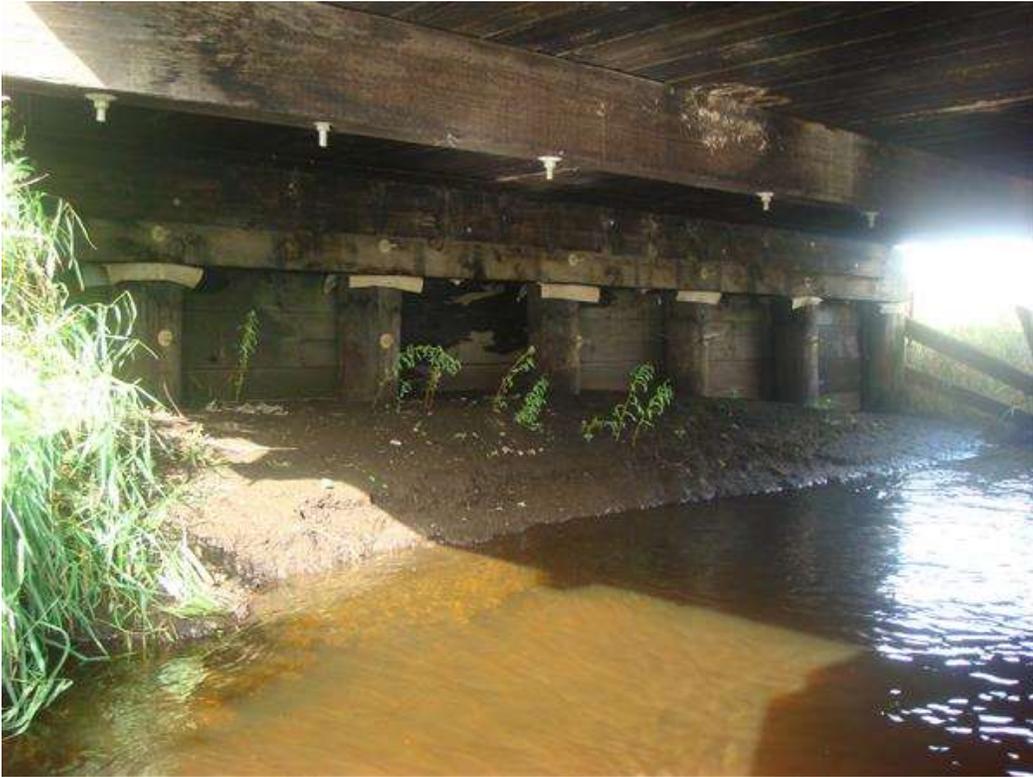
Photo 7 - View of West Abutment, Looking Northwest.

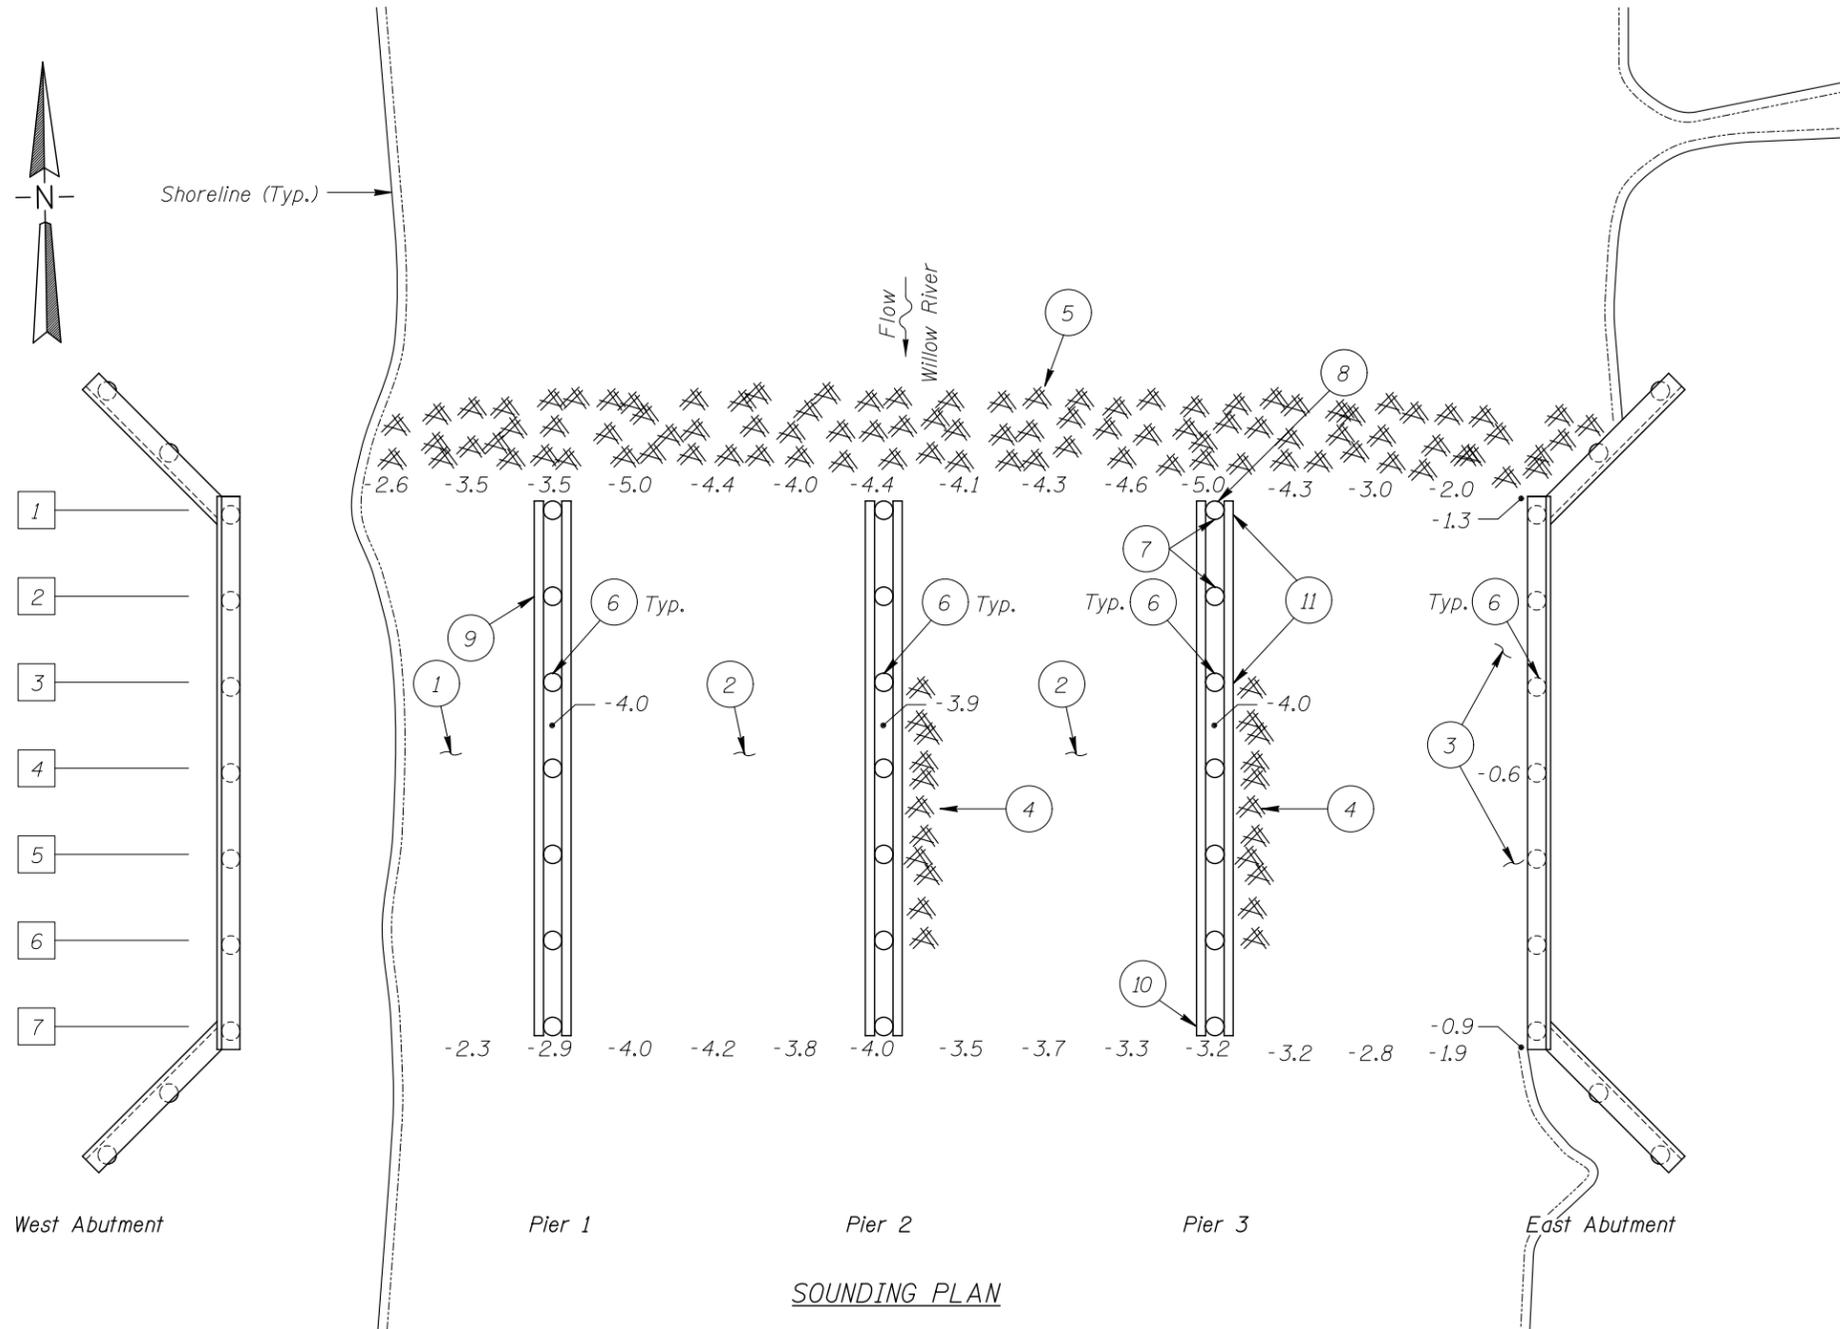
- INSPECTION NOTES:**
- 1 Channel bottom material west of Pier 1 consisted of silt allowing 9 inches of probe rod penetration.
 - 2 Channel bottom material consisted of sand and organics allowing 6 inches of probe penetration.

- 3 Channel bottom material along the entire face of the East Abutment and extending 5 feet into the channel consisted of sand and gravel allowing 1 inch of probe rod penetration.

- 4 Light timber debris consisting of branches extended from the channel bottom up 2 feet along the east side of Piers 2 and 3 from Pile 3 to Pile 6.
 - 5 Timber debris consisting of branches up to 9 inches in diameter extended from the channel bottom to the waterline for a width of 6 feet along the entire upstream fascia of the bridge.

- 6 All timber piles typically exhibited minor decay and checking up to 1/8 inch wide.
 - 7 Loss of section from the waterline up 2 feet measured 3 inches wide by 1/2 inch deep on Piles 1 and 2 at Pier 3.

- 8 Minor timber rot was observed at the waterline on Pile 1 at the upstream end of Pier 3.
 - 9 Timber cross brace was split at the connection at Pile 2 on the west side of Pier 1.

- 10 Timber cross brace connection was failed at Pile 7 on the west side of Pier 3.
 - 11 Timber cross brace was split at Pile 3 and not connected along the east side of Pier 3 from Pile 3 to the downstream end of the pier.
