UNDERWATER BRIDGE INSPECTION REPORT

STRUCTURE NO. 6646  
CSAH NO. 36  
OVER THE  
RED RIVER OF THE NORTH  
DISTRICT 4 - CLAY COUNTY

PREPARED FOR THE  
MINNESOTA DEPARTMENT OF TRANSPORTATION  
BY  
COLLINS ENGINEERS, INC.  
JOB NO. 5221 (CEI 44)

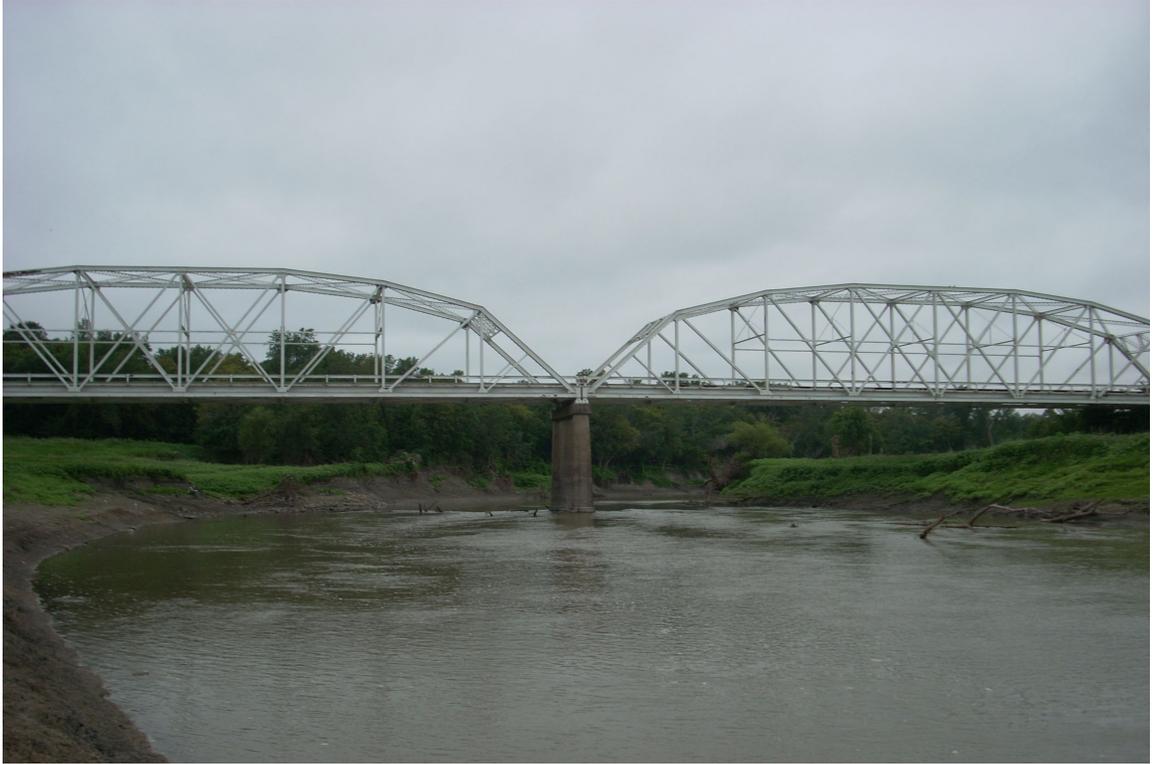
Photograph 1. View of Pier 1, Looking South.

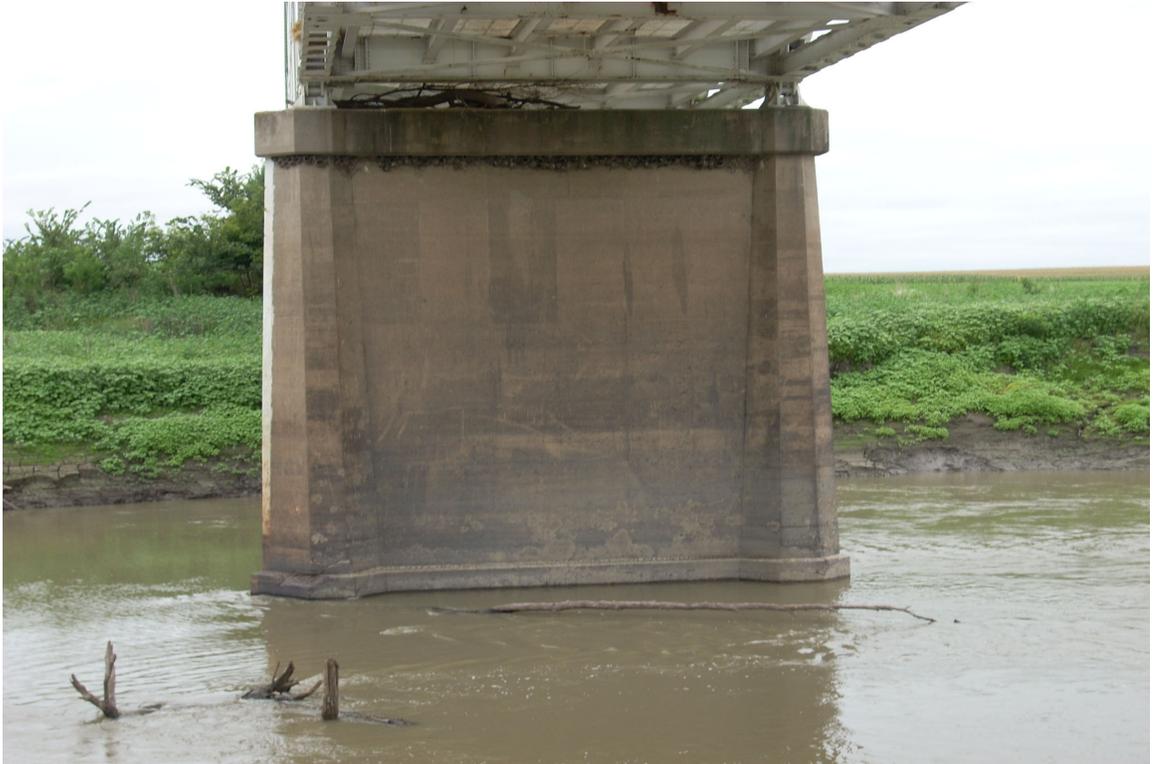
Photograph 2. View of Pier 1, Looking West.

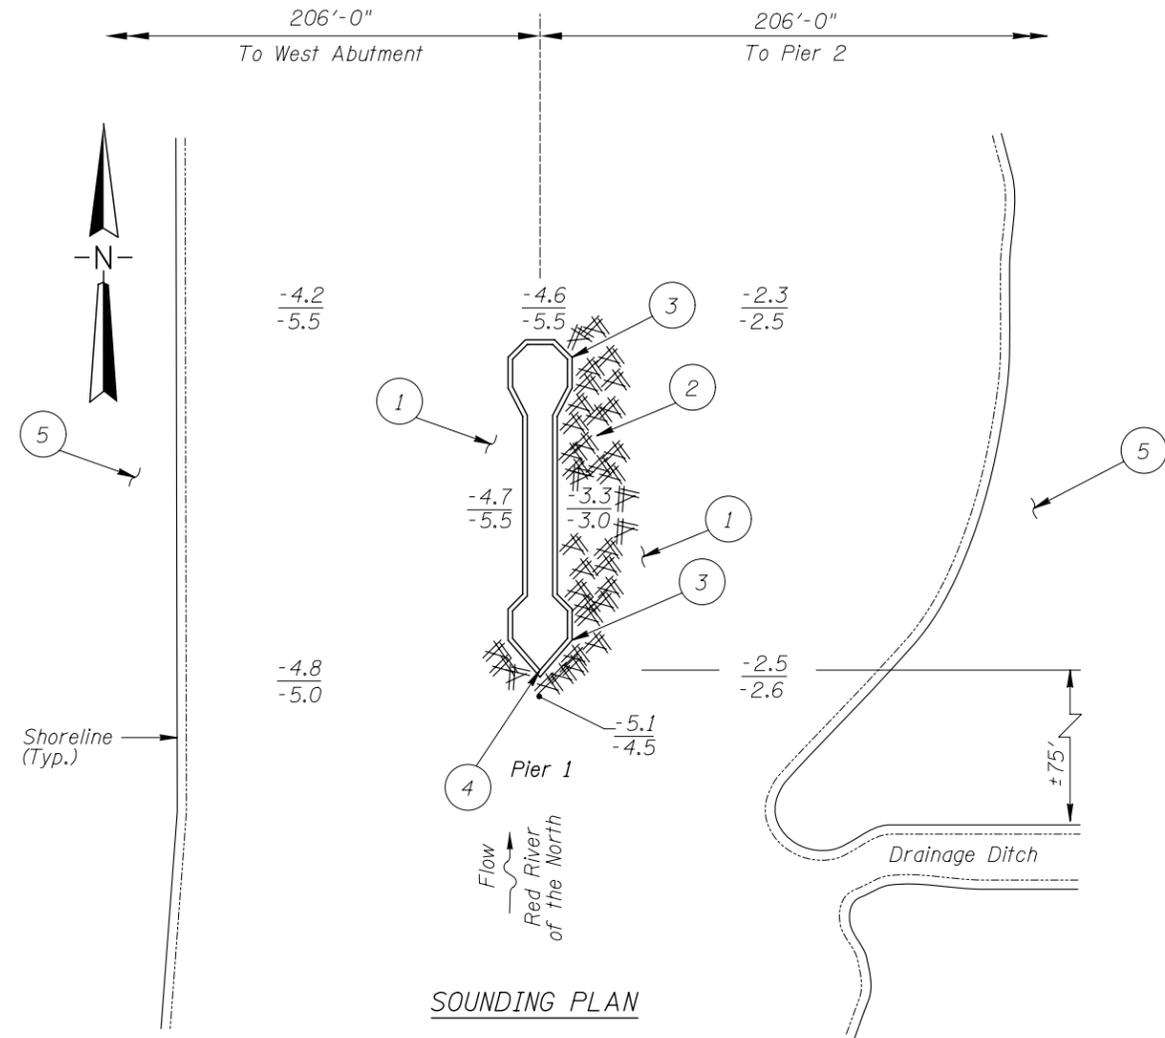
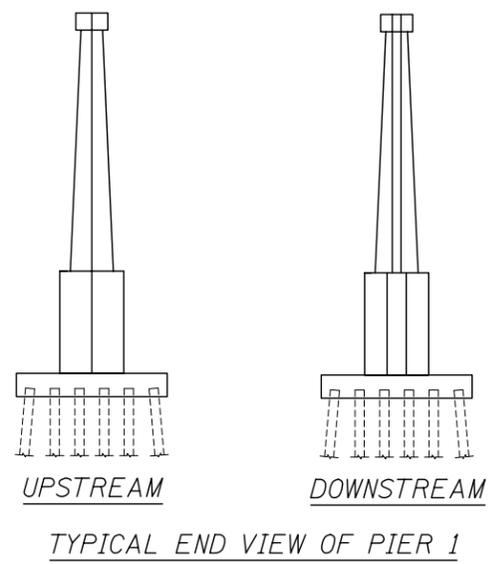
**SOUNDING PLAN**

- 1 The channel bottom around the entire perimeter of Pier 1 consisted of gravel with 2 inch diameter cobbles allowing up to 3 inches of probe rod penetration. In addition, an 18 inch thick layer of soft silty clay was observed on top of the channel bottom along the entire east face.

- 2 A moderate accumulation of timber debris, consisting of 18 inch diameter and smaller logs and branches, was observed at the upstream nose and along the entire east face of Pier 1. The debris extended from channel bottom to waterline, 6 feet off nose and 15 feet off face.

- 3 4 feet long by 2 feet high areas of section loss and impending section loss were observed at the northeast and southeast corners of Pier 1 centered on the shaft step located at 1.5 feet above waterline. The section loss exhibited up to 8 inches maximum penetration and exposed rebar with up to 5% loss of section.

- 4 The steel icebreaker angle exhibited 1/2-inch-diameter rust nodules with moderate pitting up to 1/4 inch deep from 1 foot below waterline to 1.5 foot above waterline.

- 5 Both embankments exhibited heavy erosion in the vicinity of the structure with steeply cut banks up to 20 feet high.
