2016 UNDERWATER BRIDGE INSPECTION REPORT

BRIDGE # 14510 CSAH 12 over RED RIVER OF THE NORTH

Date of Inspection: 11/01/2016

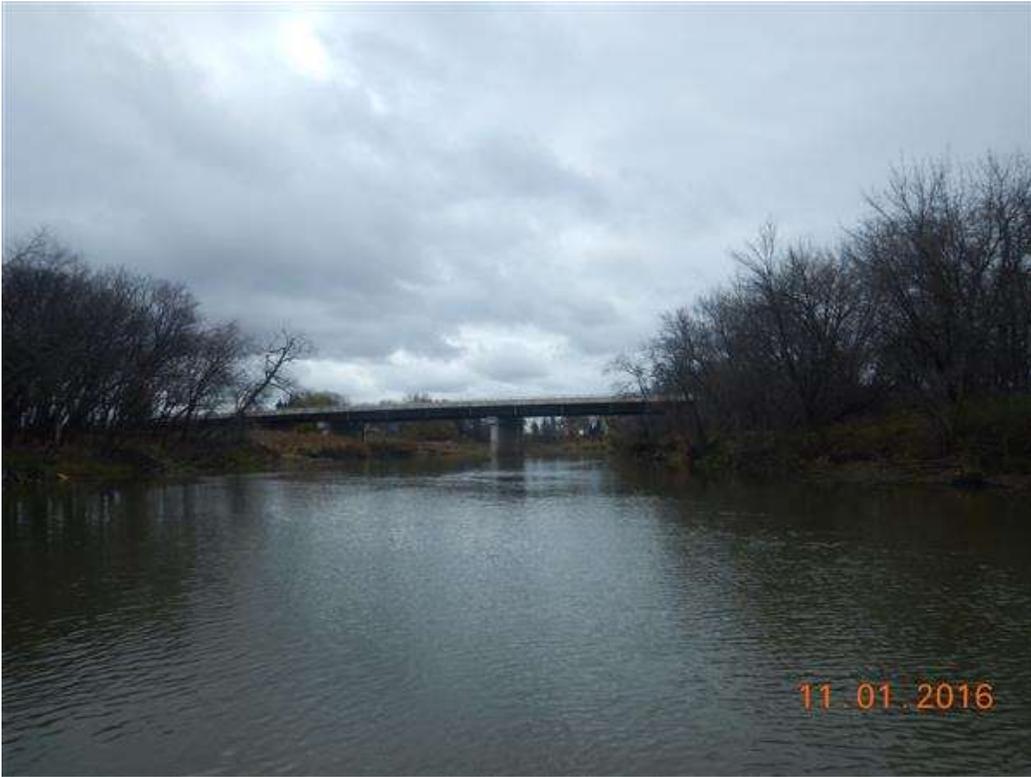
Photo 1 - North Profile

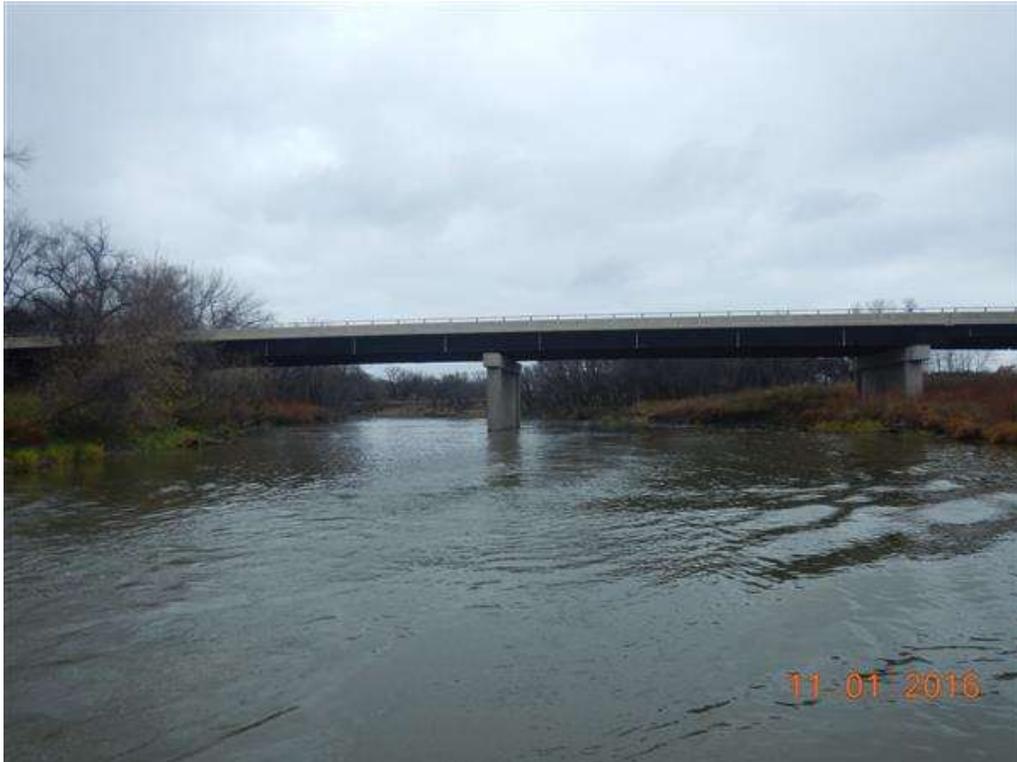
Photo 2 - South Profile

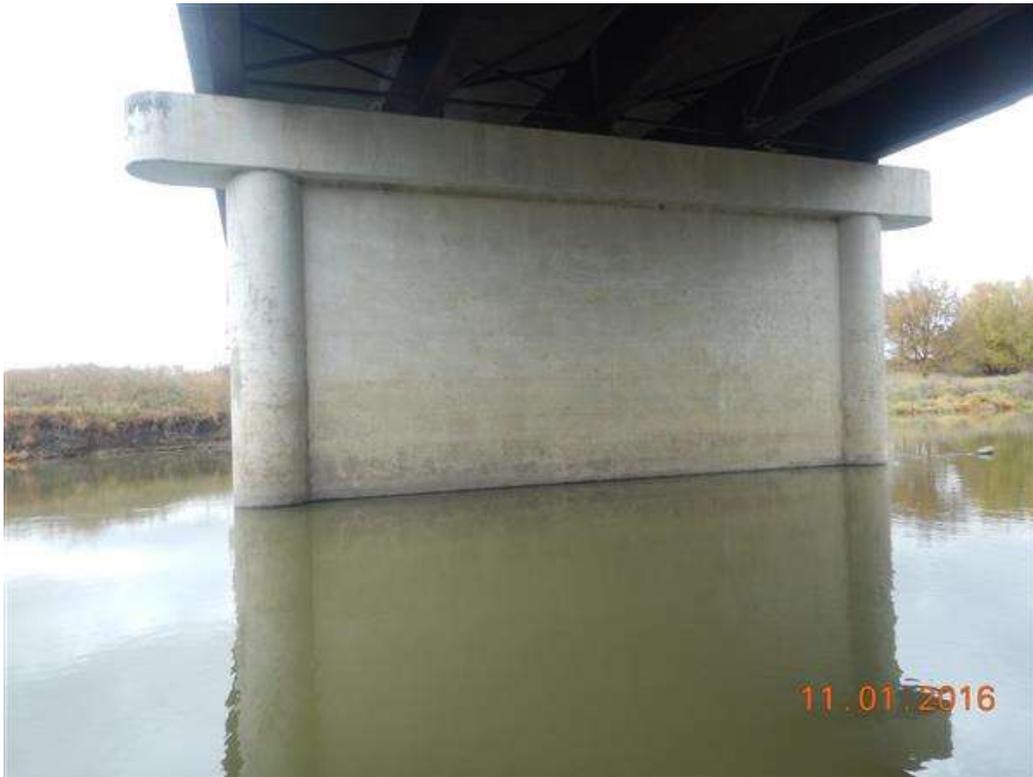
Photo 3 - West Face of Pier

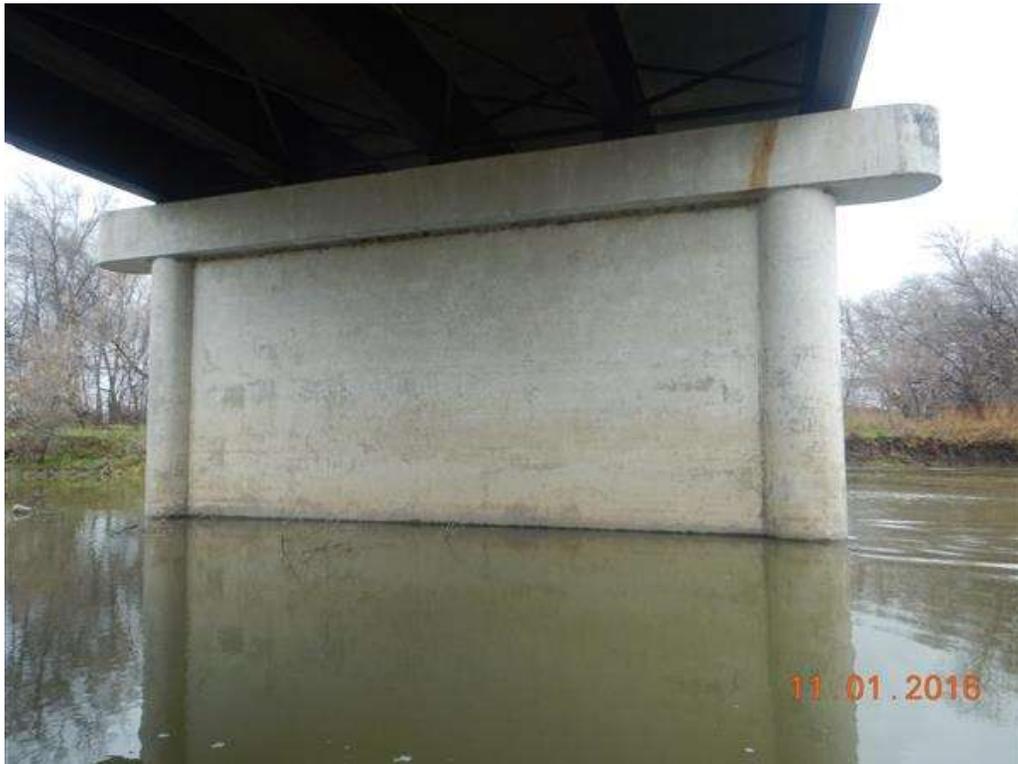
Photo 4 - East Face of Pier

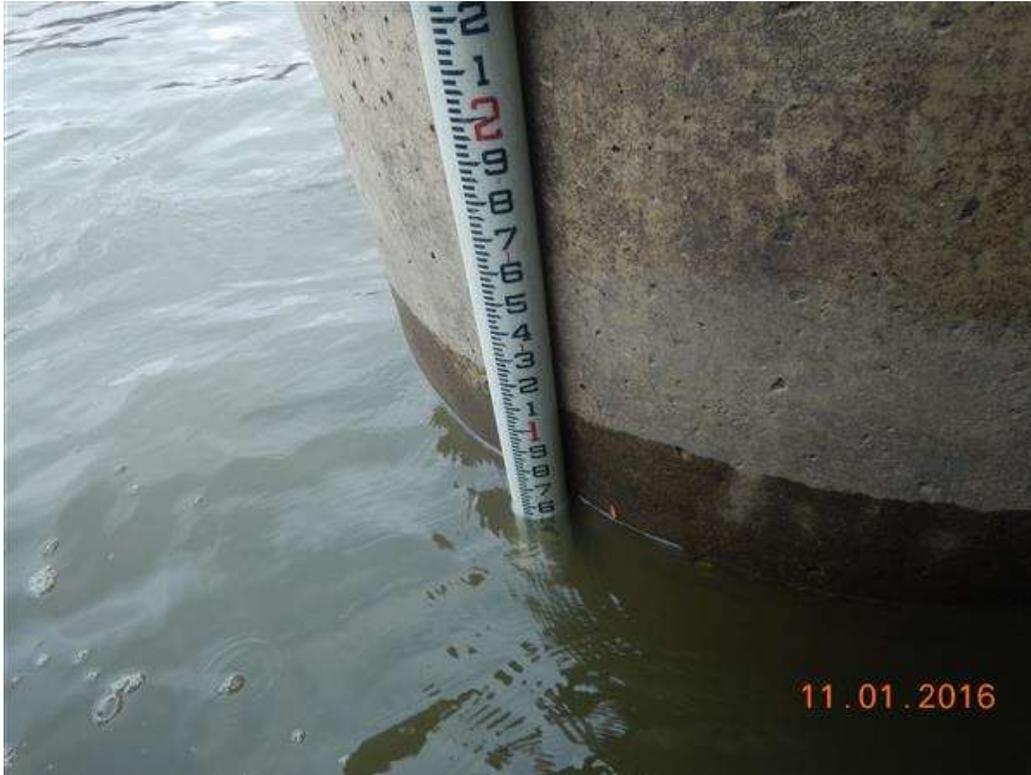
Photo 5 - Typical at Waterline

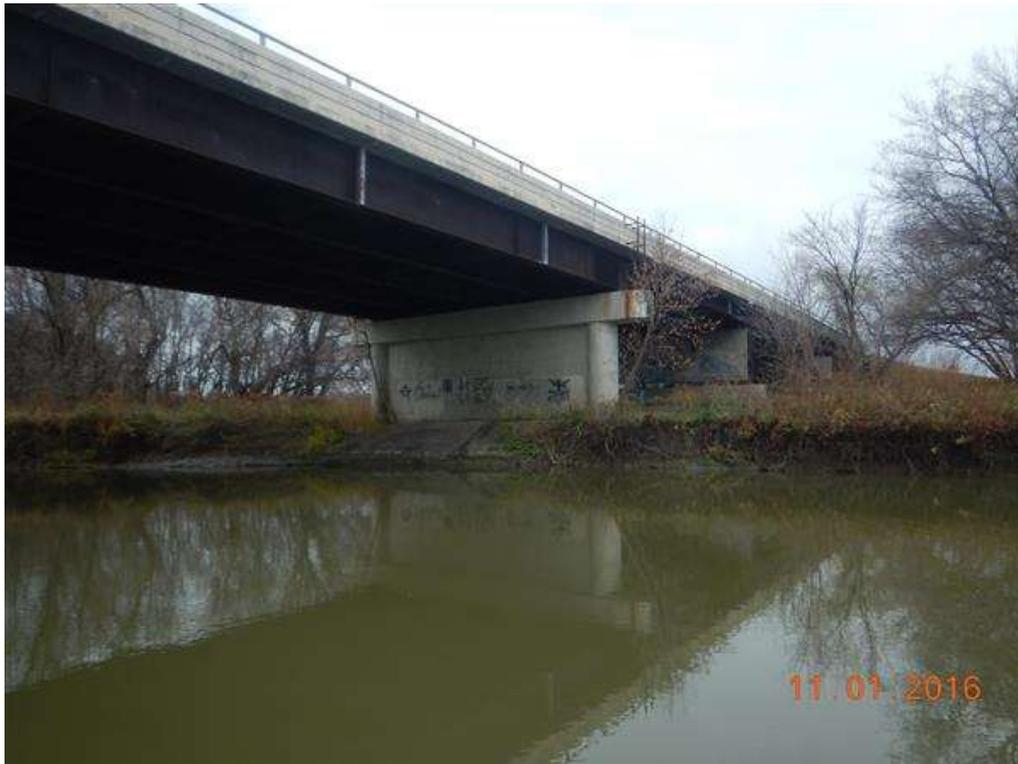
Photo 6 - West Bank

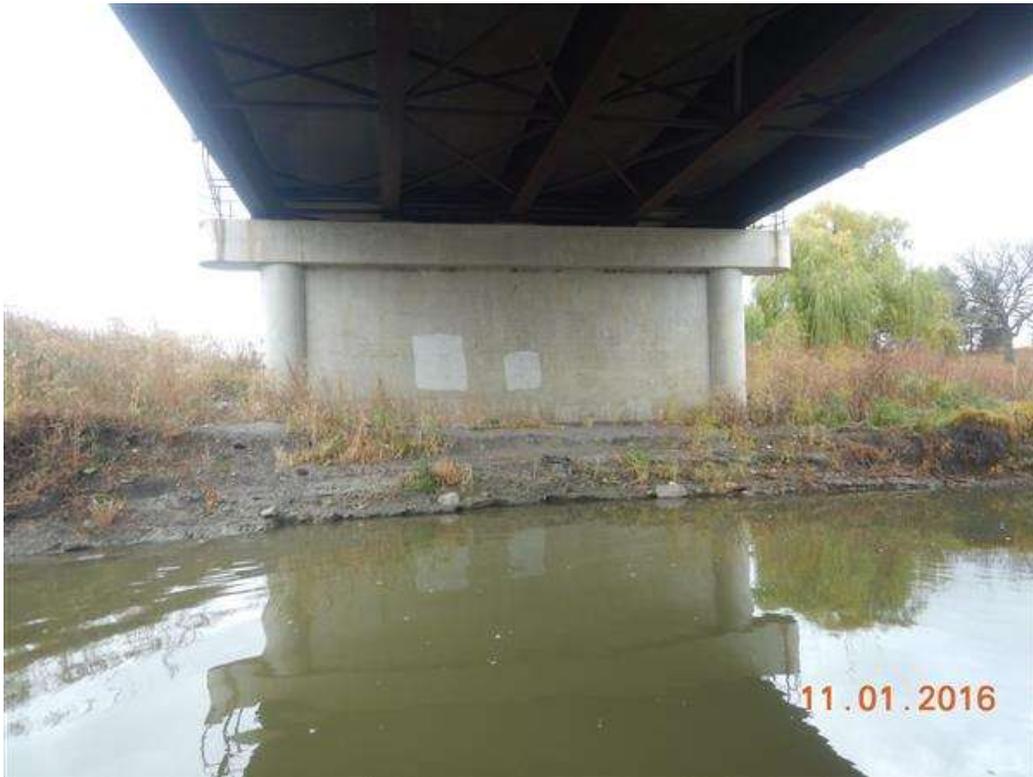
Photo 7 - East Bank

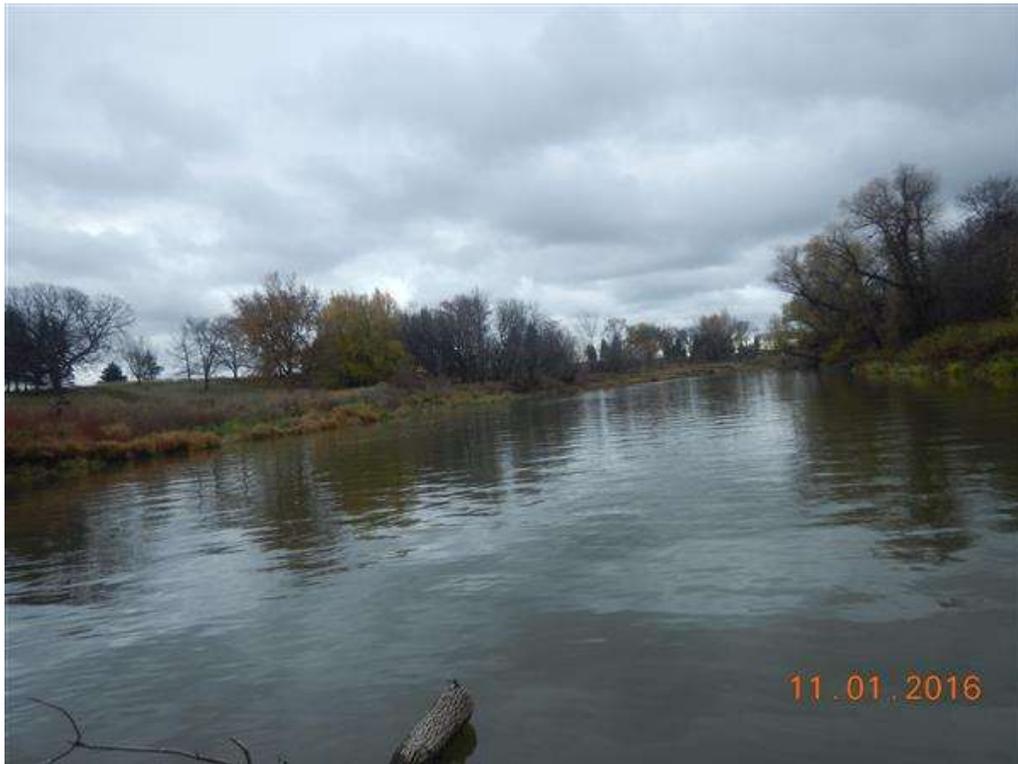
Photo 8 - Upstream Channel

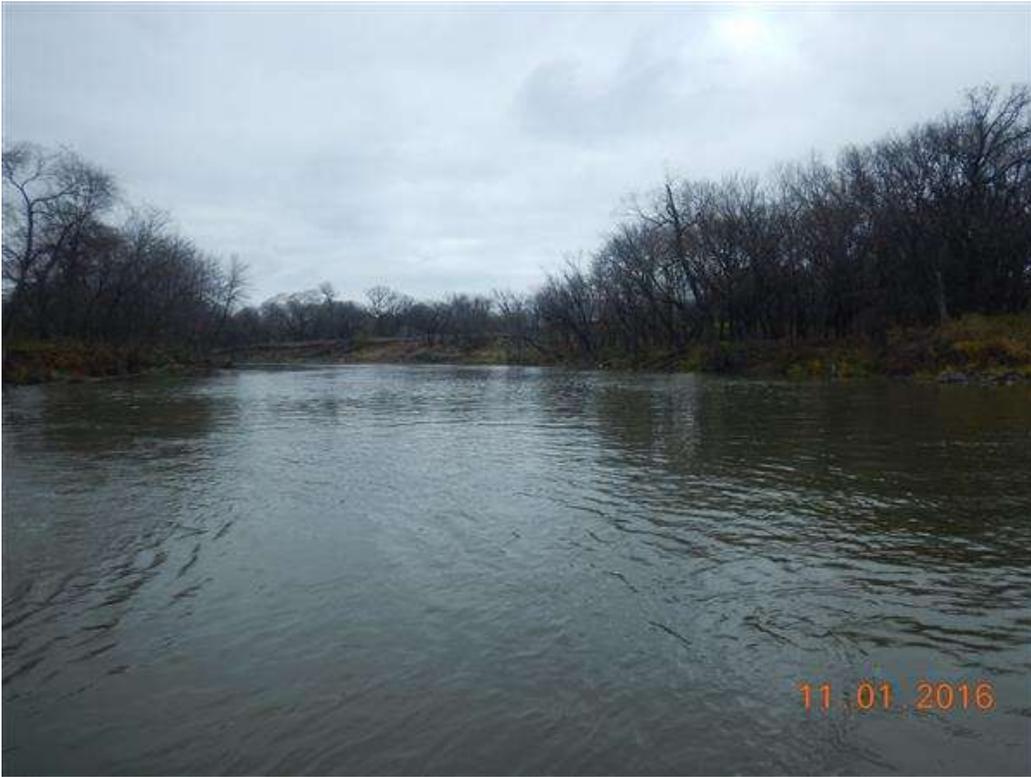
Photo 9 - Downstream Channel

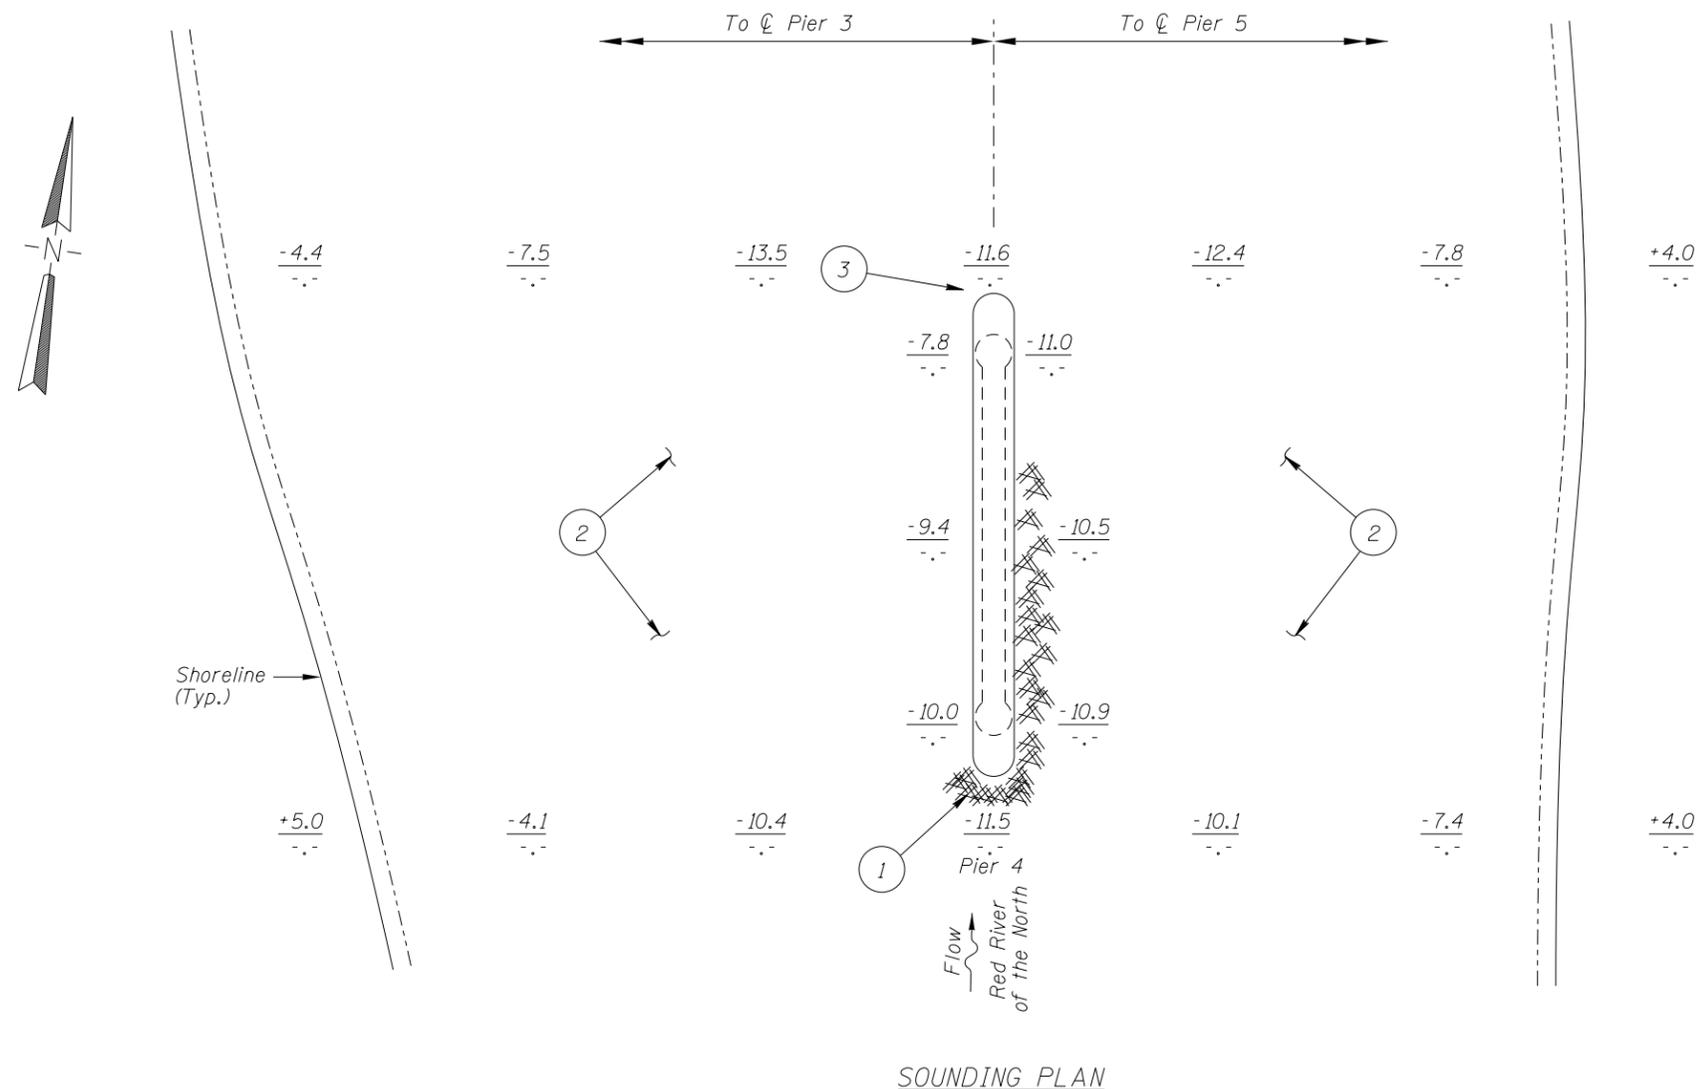
INSPECTION AND SOUNDING PLAN

- ① A moderate accumulation of timber debris was observed at the upstream end and along the east face of Pier 4. The debris extended from the channel bottom to the water surface extending 8 feet from the pier.
- ② The channel bottom material consisted of silt with 1 foot of probe rod penetration.
- ③ The top of the Pier 4 footing is exposed at the downstream nose.
