2016 UNDERWATER BRIDGE INSPECTION REPORT

BRIDGE # 5853 CSAH 52 over S BR BUFFALO RIVER

Date of Inspection: 10/18/2016

Contractor: Ayres Associates & Collins Engineers, Inc.

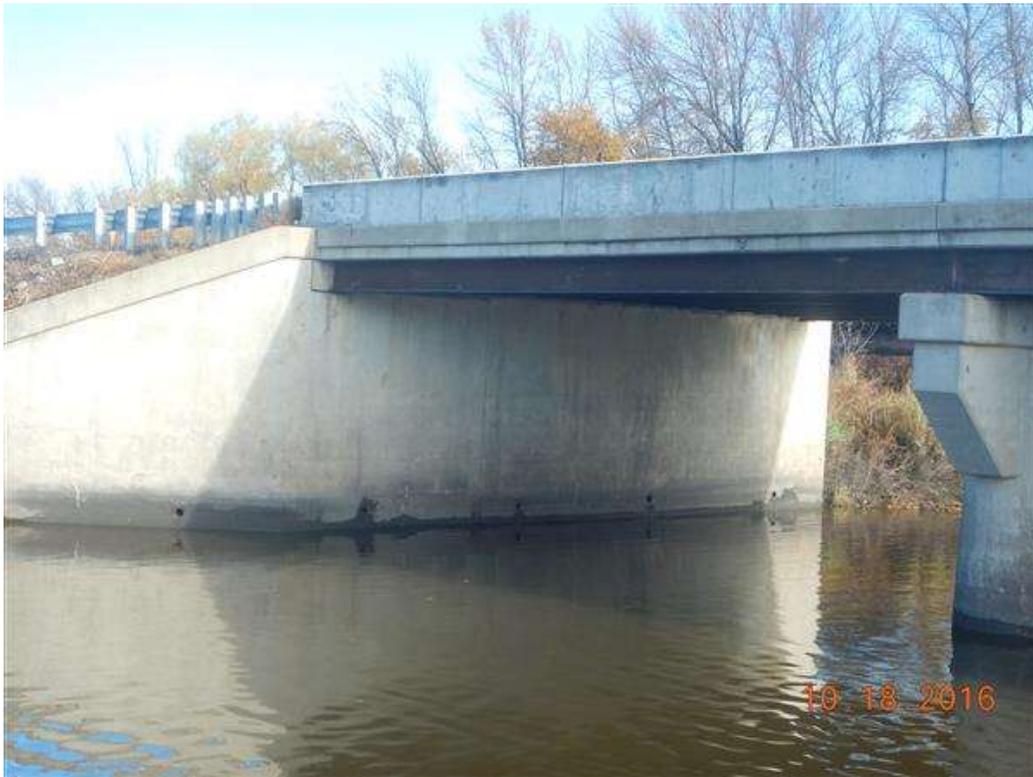
Photo 3 - North Abutment

A) The concrete piers and abutments were in good condition. Both abutments displayed minor vertical and diagonal cracks at random locations, ranging in width from hairline to 1/8 inch.

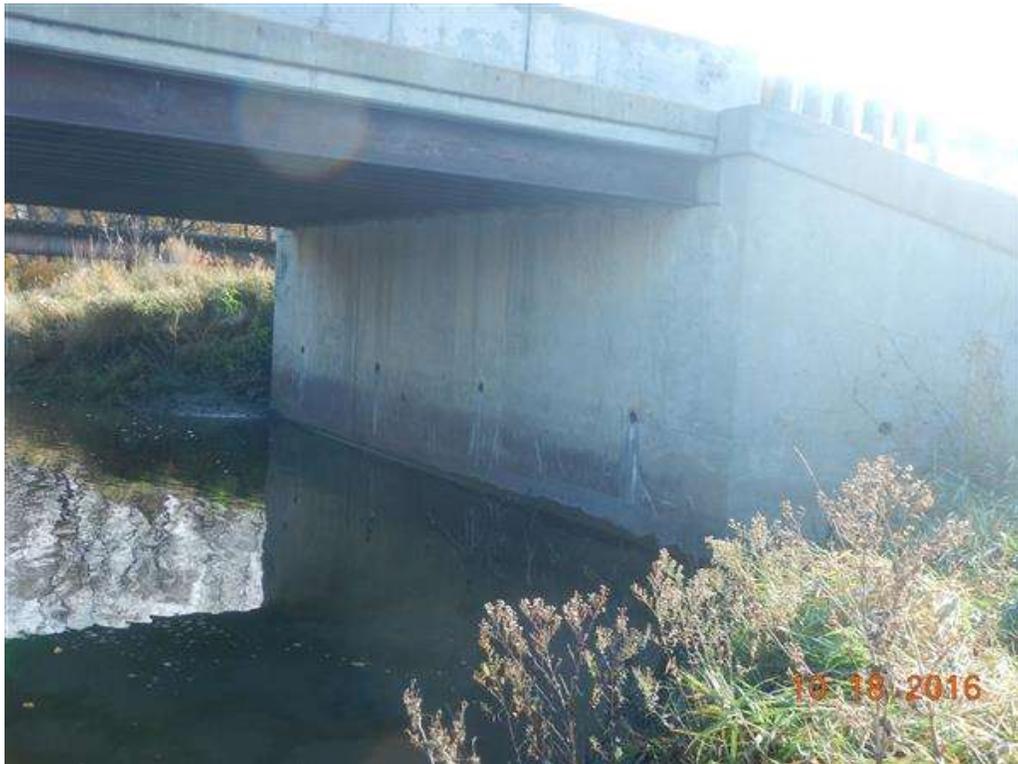
Photo 4 - South Abutment

(B) Abandoned concrete columns (two total) were observed in the channel 8 feet north of the South Abutment. The columns were removed below the channel bottom; however, the rebar from the columns extended from the bottom up to 1 foot above the waterline.

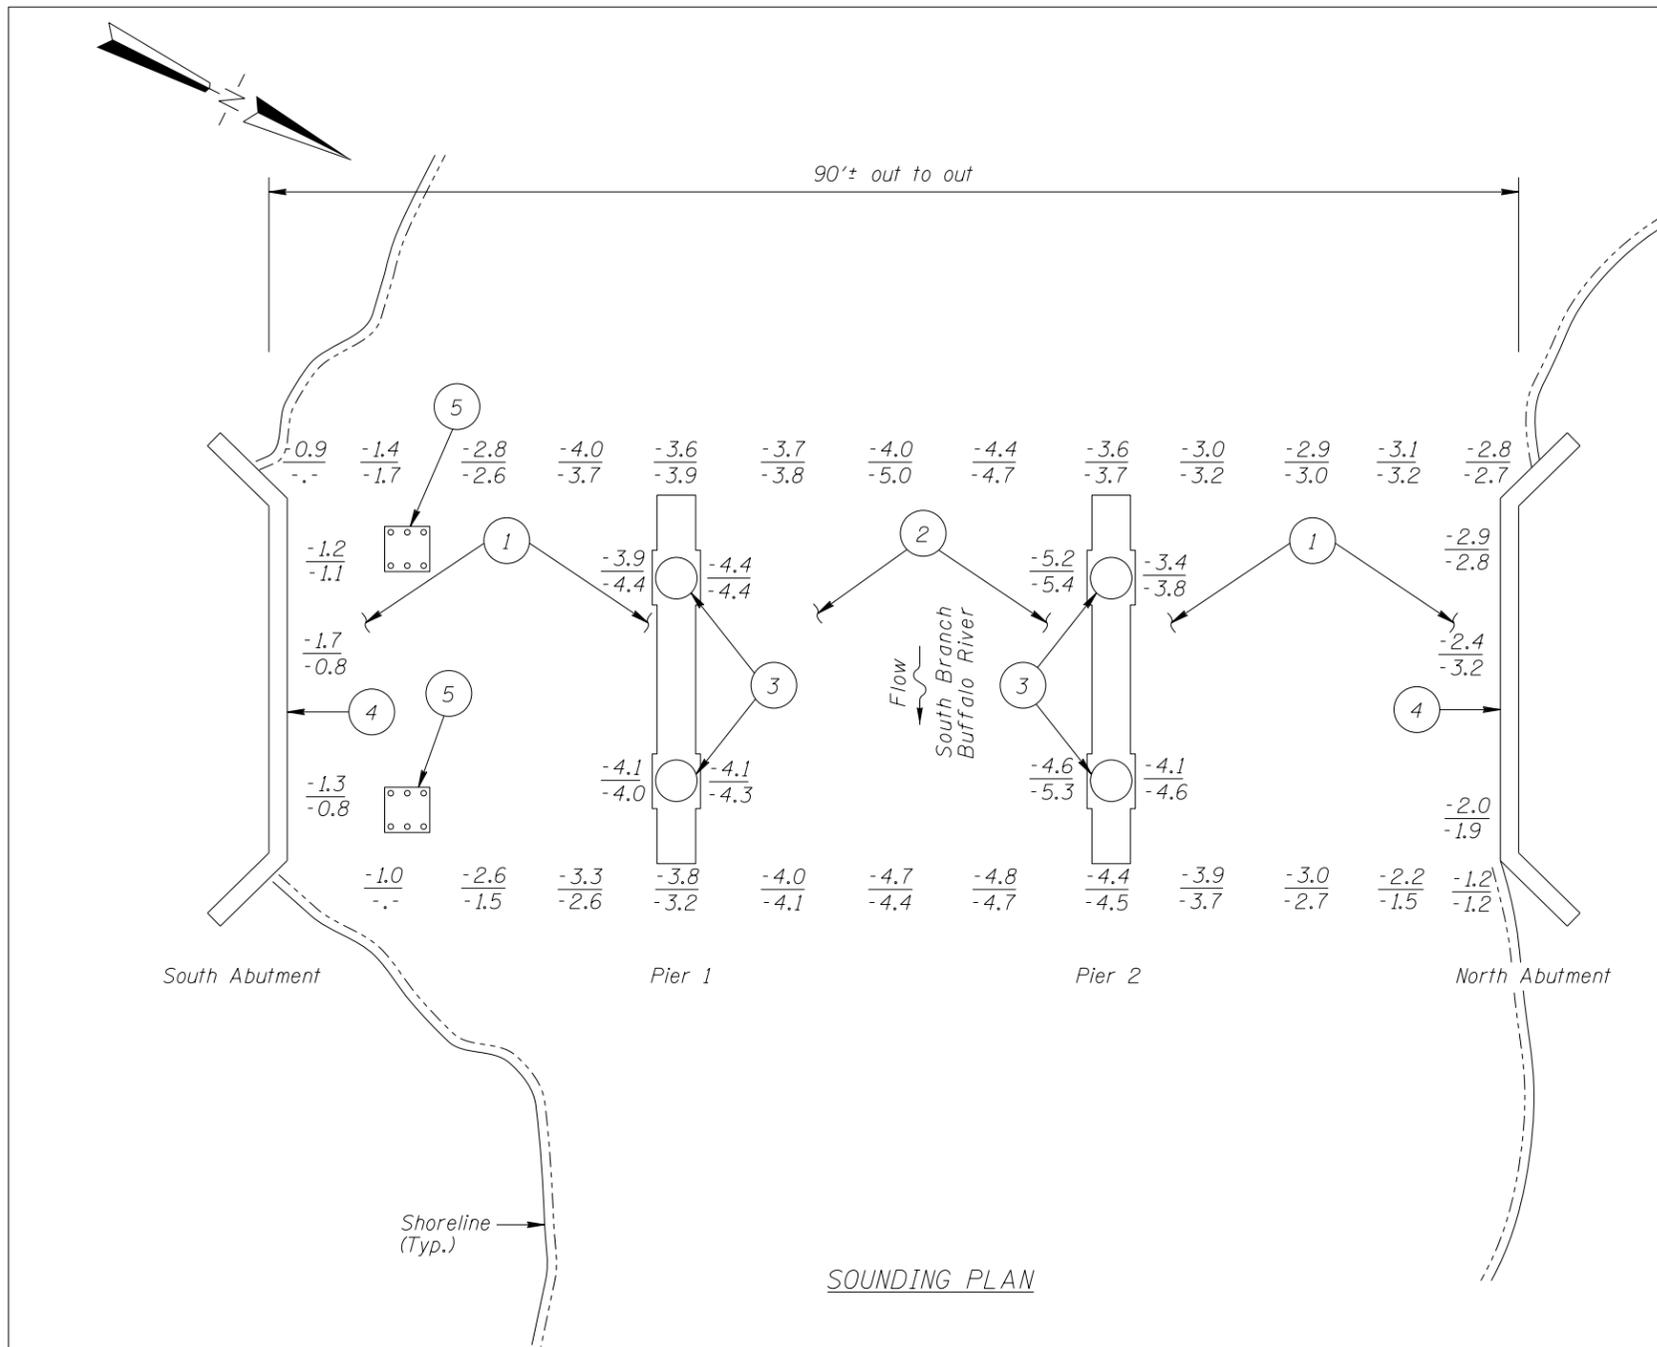
- ① The channel bottom between abutments and piers consisted of silt and random riprap up to 12 inches in diameter, with a maximum probe rod penetration of up to 2 feet.
- ② The channel bottom in between the piers consisted of silty clay and riprap, up to 12 inches in diameter, with a maximum probe rod penetration of 2 inches.
- ③ The concrete columns of Piers 1 and 2 were smooth and sound with random minor areas of poor consolidation with 1/4 inch maximum penetration.
- ④ The concrete of the abutments was typically smooth and sound with minor vertical and diagonal cracks at random locations, ranging in width from hairline to 1/8 inch.
- ⑤ Abandoned concrete columns (two total) were observed in the channel at 8 feet North of South Abutment. The columns were removed below the channel bottom; however, the rebar from the columns extended from the bottom up to 1 foot above the waterline.
