# 2016 UNDERWATER BRIDGE INSPECTION REPORT

## BRIDGE # 76518 CSAH 22 over POMME DE TERRE RIVER

Date of Inspection: 06/18/2016

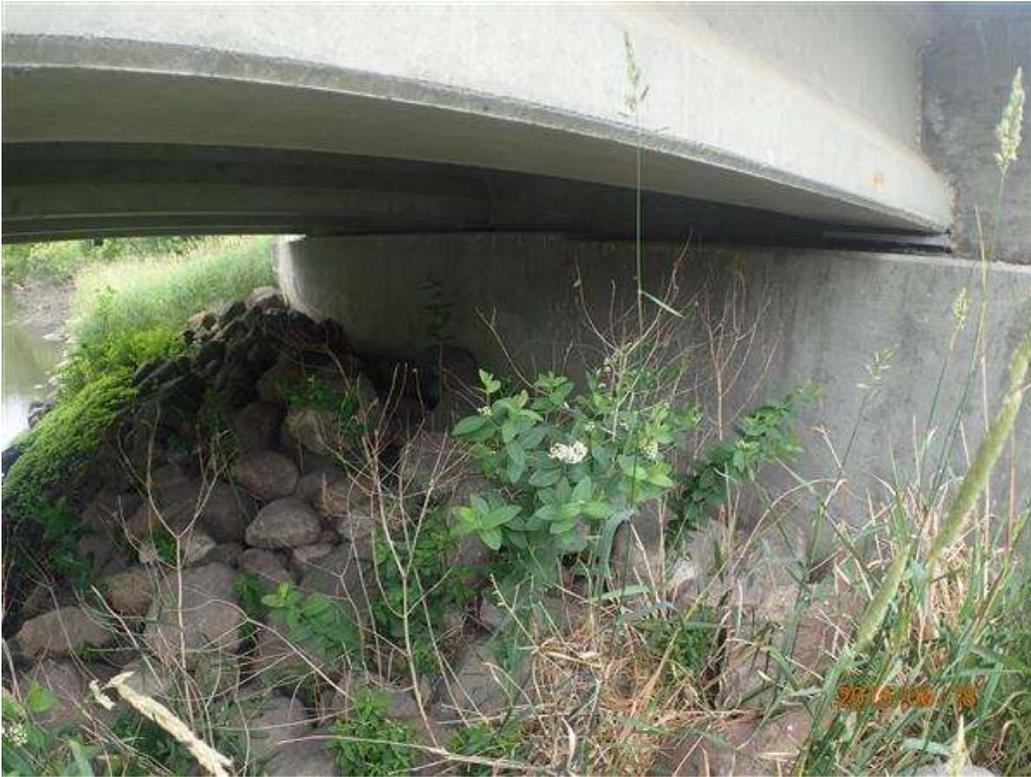
Photo 2 - View of East Abutment, looking east.

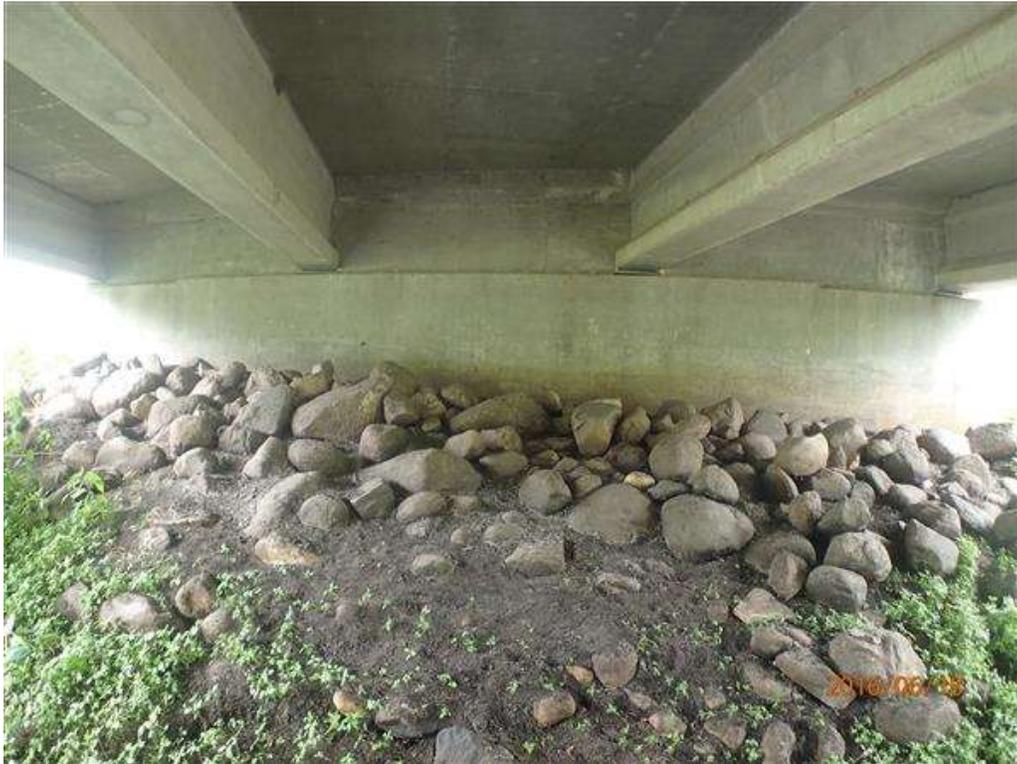
Photo 3 - View of West Abutment, looking west.

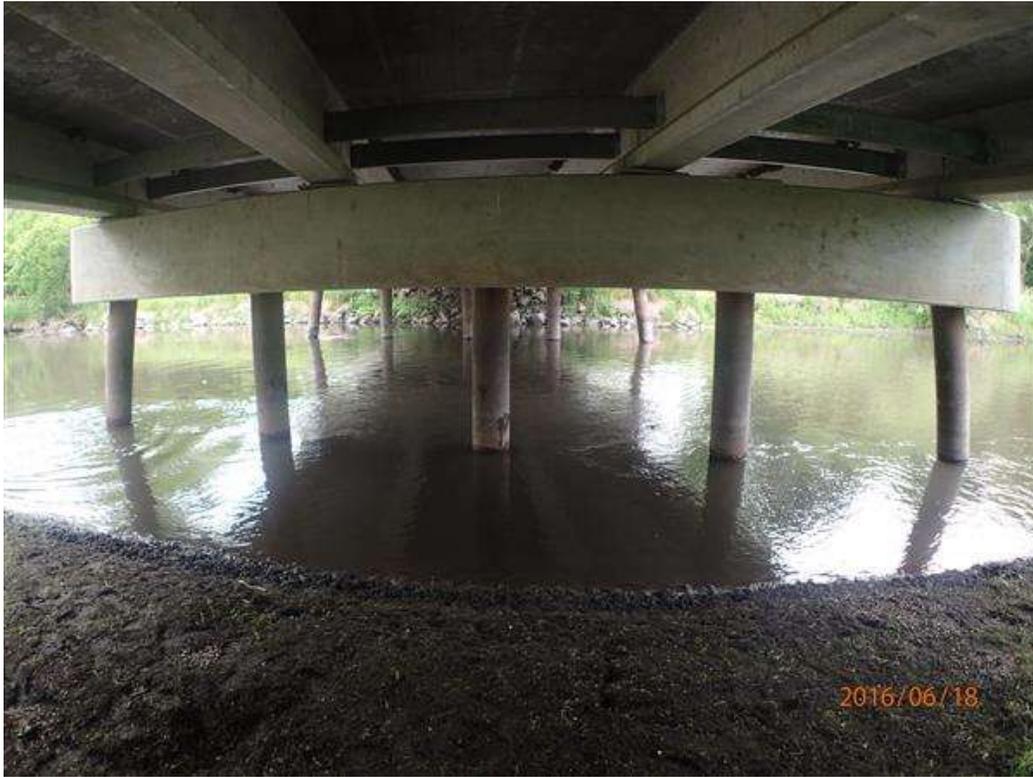
Photo 4 - View of West Bent, looking east.

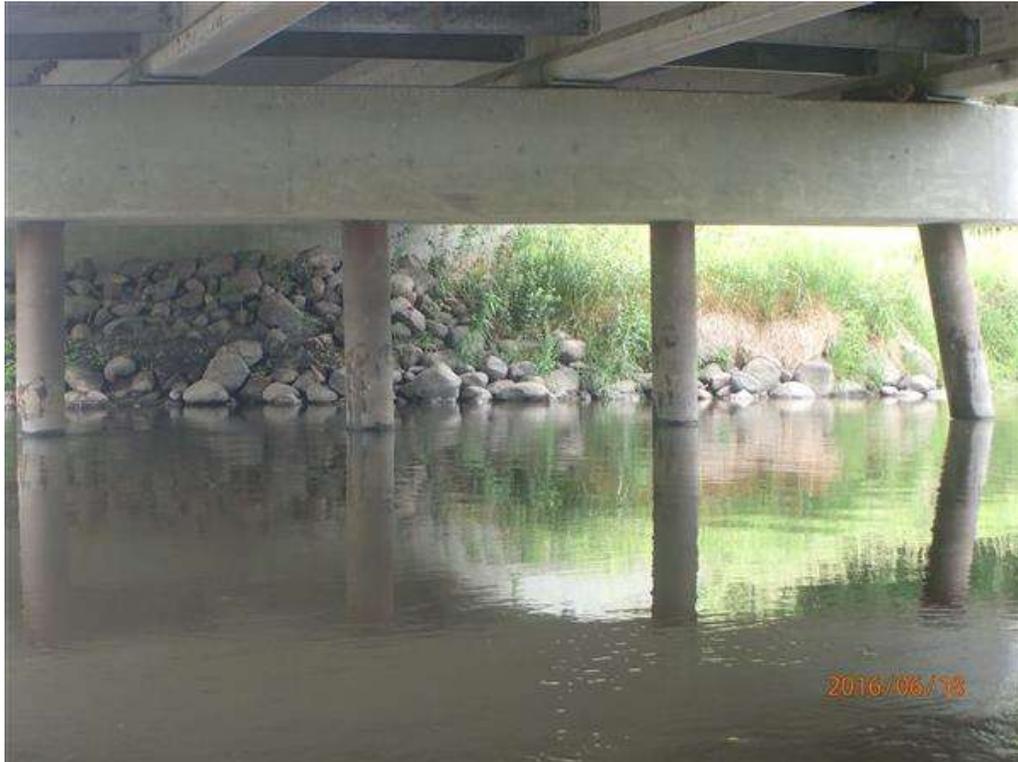
Photo 5 - View of East Bent, looking east.

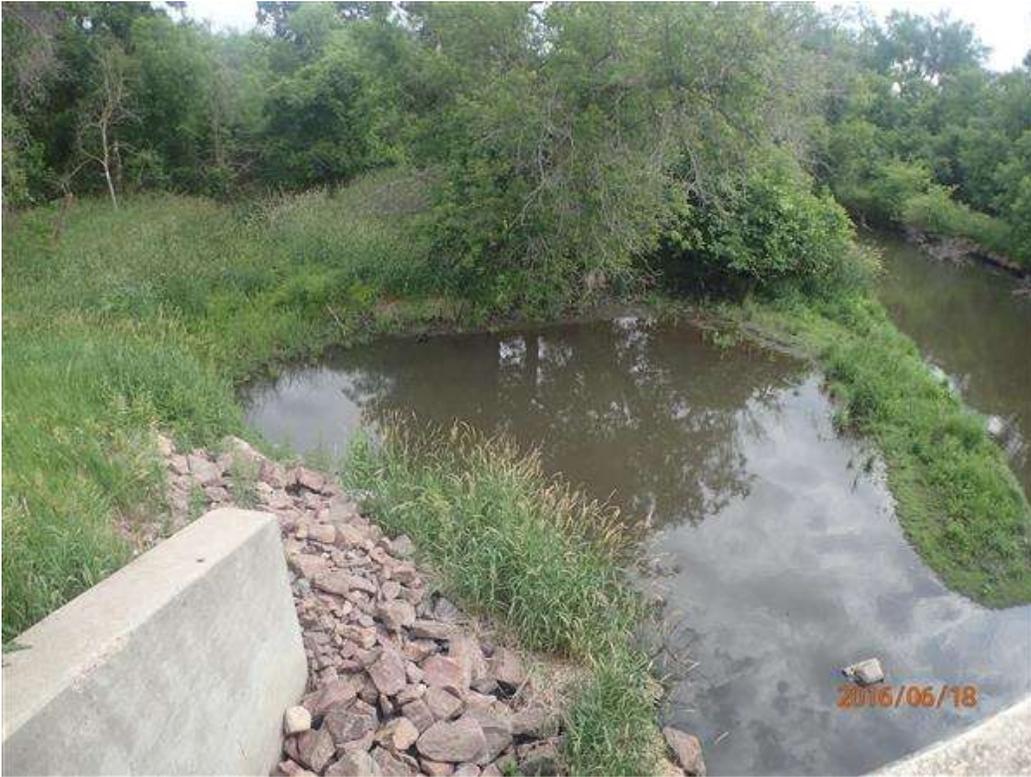
(B) There was a scour hole encroaching on the northwest wing wall.

Photo 6 - View of scour hole at the northwest wing wall, looking north.

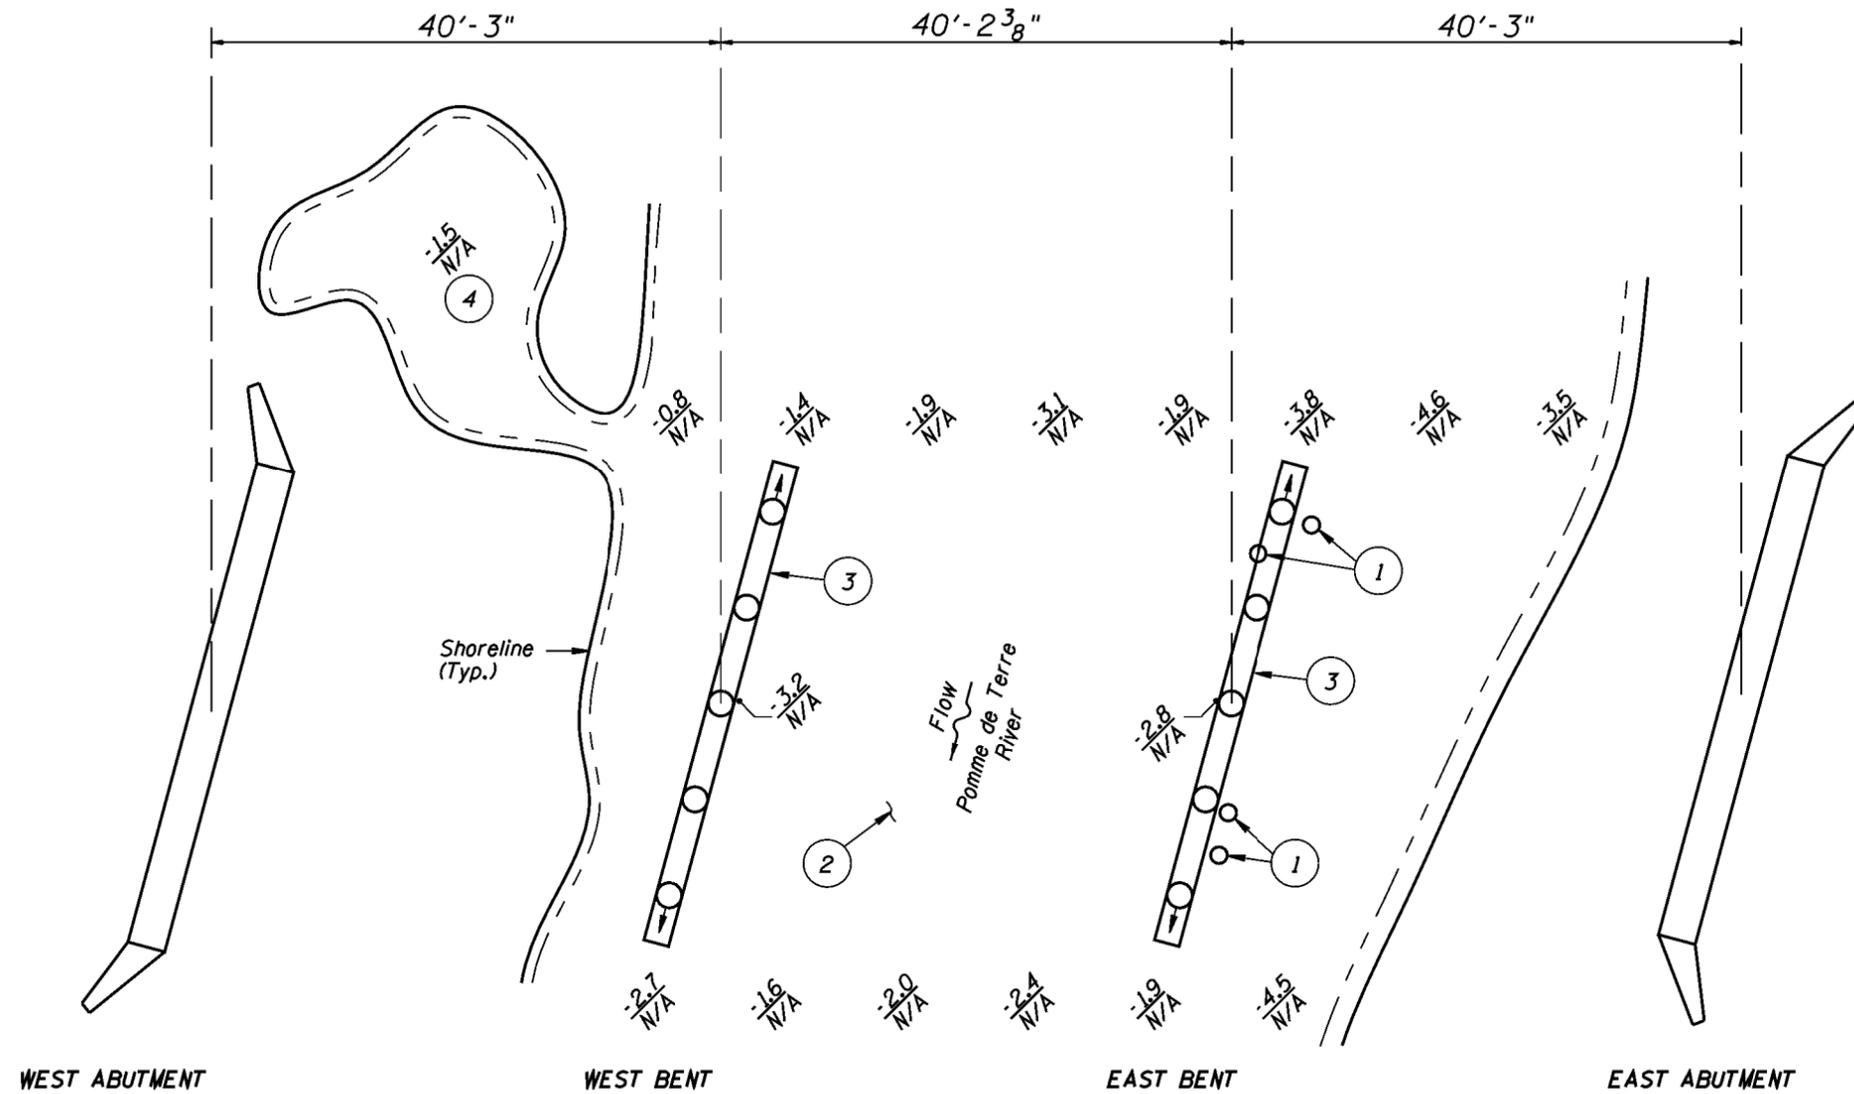
**INSPECTION AND SOUNDING PLAN**

- 1 There were abandoned timber piles cutoff 1 foot below the waterline.
- 2 The channel bottom material consisted of sand with 6 inches of maximum probe rod penetration.
- 3 All piles exhibited 100 percent loss of painted coating with light surface corrosion and 1/8 inch maximum pitting from 1 foot above the waterline to the channel bottom.
- 4 There was a scour hole encroaching on the Northwest wingwall of the West Abutment.
