2016 UNDERWATER BRIDGE INSPECTION REPORT

BRIDGE # 91949 MUN 28 over RIVER DR/OTTER TAIL RIVE

Date of Inspection: 10/17/2016

Contractor: Ayres Associates & Collins Engineers, Inc.

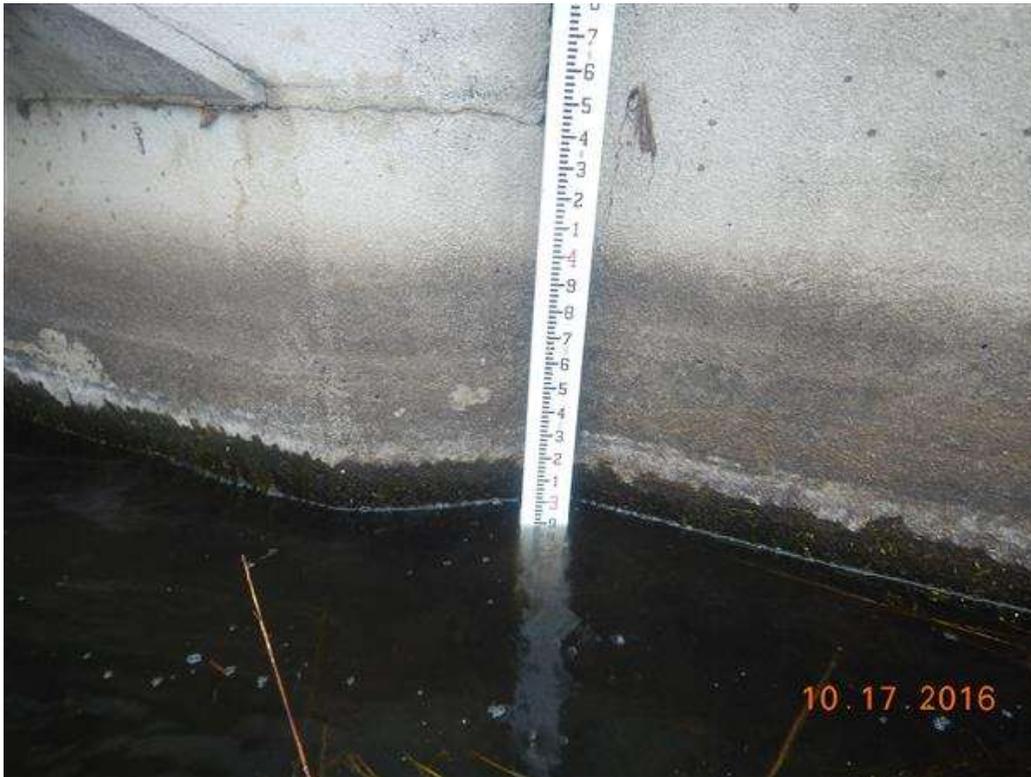
Photo 3 - Condition at Waterline

The substructure units inspected at Bridge No. 91949, Culvert Barrels 1 through 3 and the wingwalls, were found to be generally in good condition with no defects of structural significance observed. The concrete was smooth and south. The south barrel floor was silted over, while the middle and north barrel floors were bare.

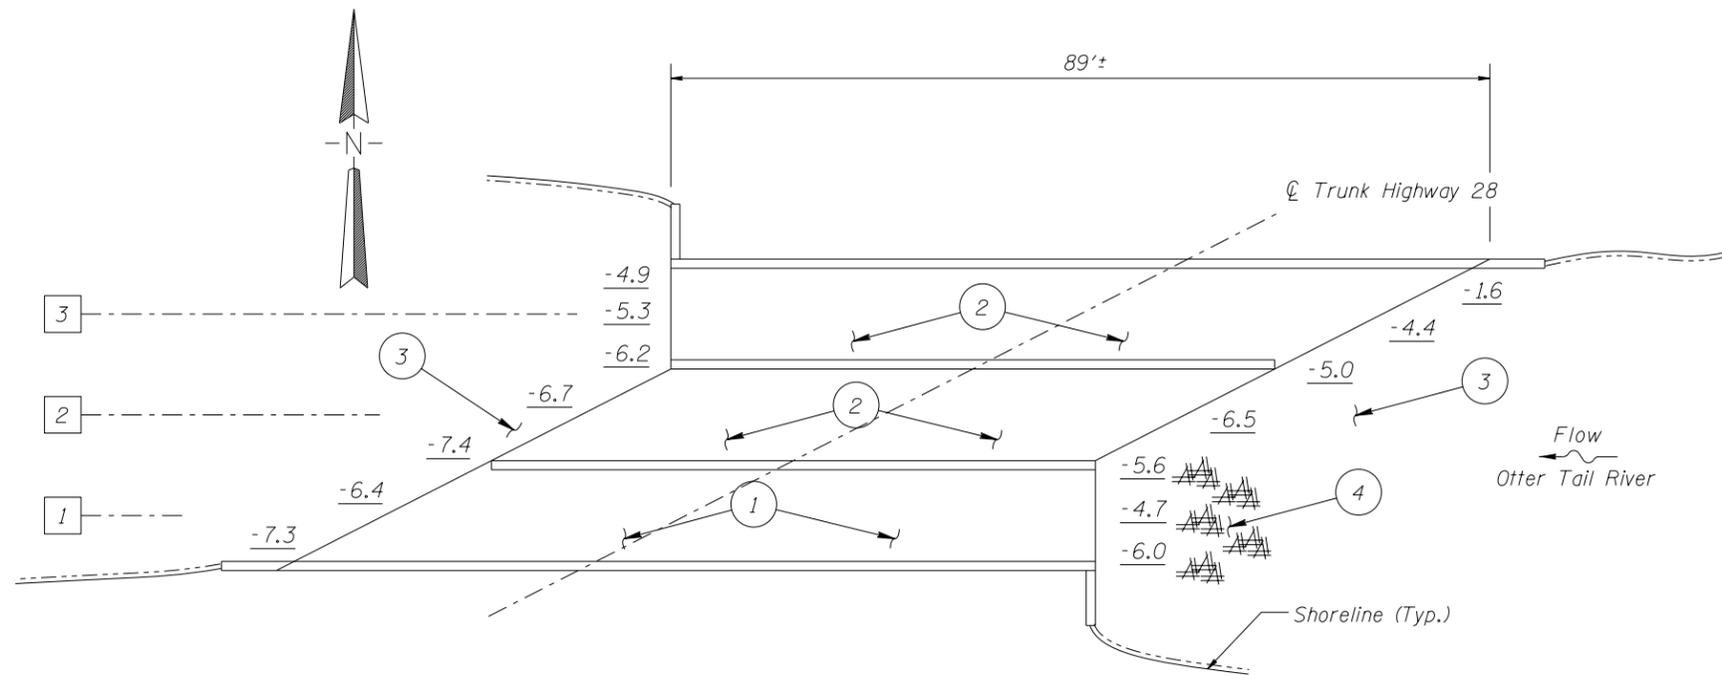
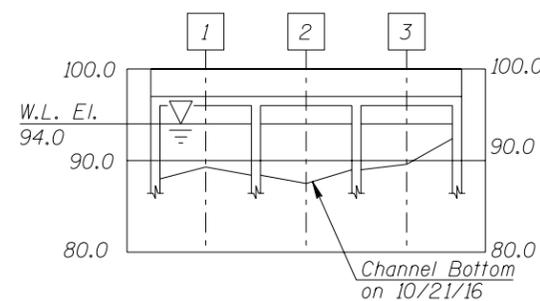
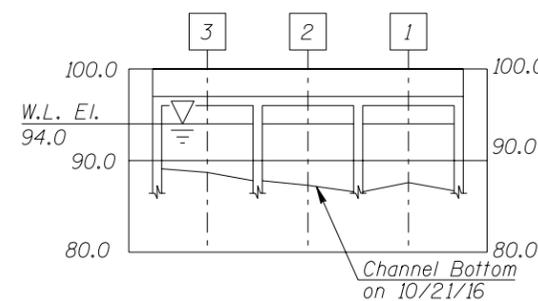
INSPECTION AND SOUNDING PLAN UPSTREAM AND DOWNSTREAM OPENING PROFILES

- 1 The floor of Culvert Barrel 1 was silted over at the time of inspection.
- 2 The floors of Culvert Barrel 2 and Culvert Barrel 3 were bare at the time of inspection.
- 3 The apron or toe was not exposed at either end of the culvert and the floor was covered with silt at the edges of the inlet and outlet.
- 4 Light debris was found at the culvert inlet.

- (A) Remove debris at inlet.
- (B) Reinspect the submerged substructure units at the normal maximum recommended (NBIS) interval of sixty (60) months.
