2016 UNDERWATER BRIDGE INSPECTION REPORT

BRIDGE # L8228 TWP 31 over S BR BUFFALO RIVER

Date of Inspection: 10/17/2016

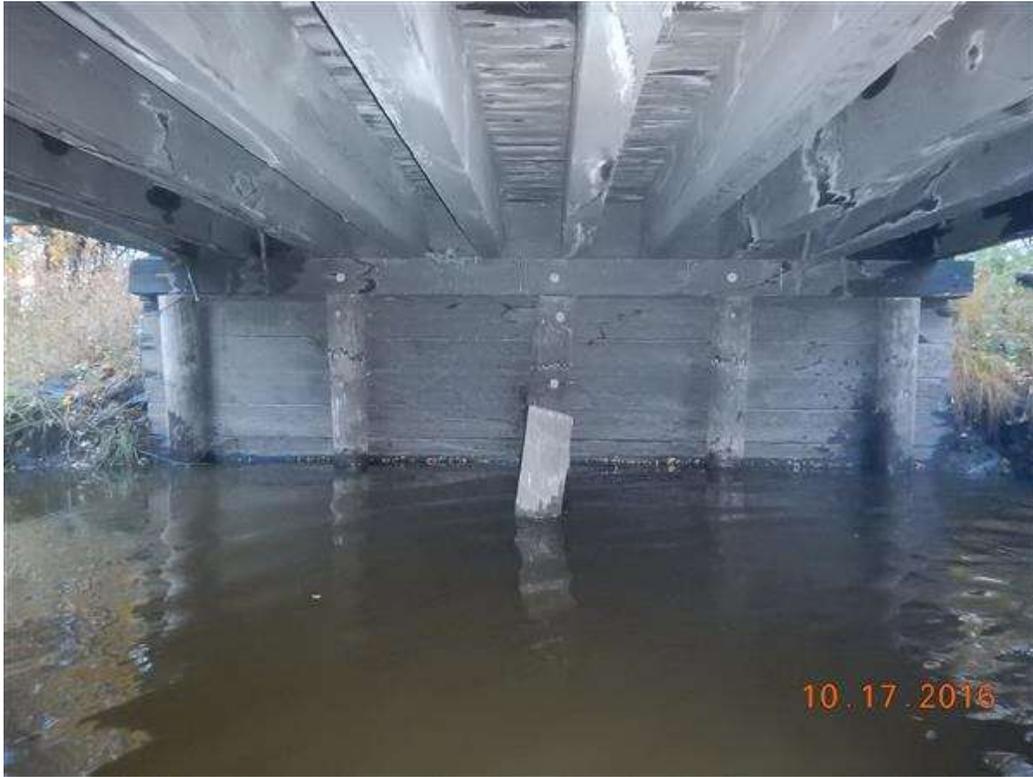
Photo 3 - West Abutment

- (E) The West Abutment timber backwall and piles had minor lateral movement up to 1 inch indicating possible excessive lateral earth pressure on the abutment.

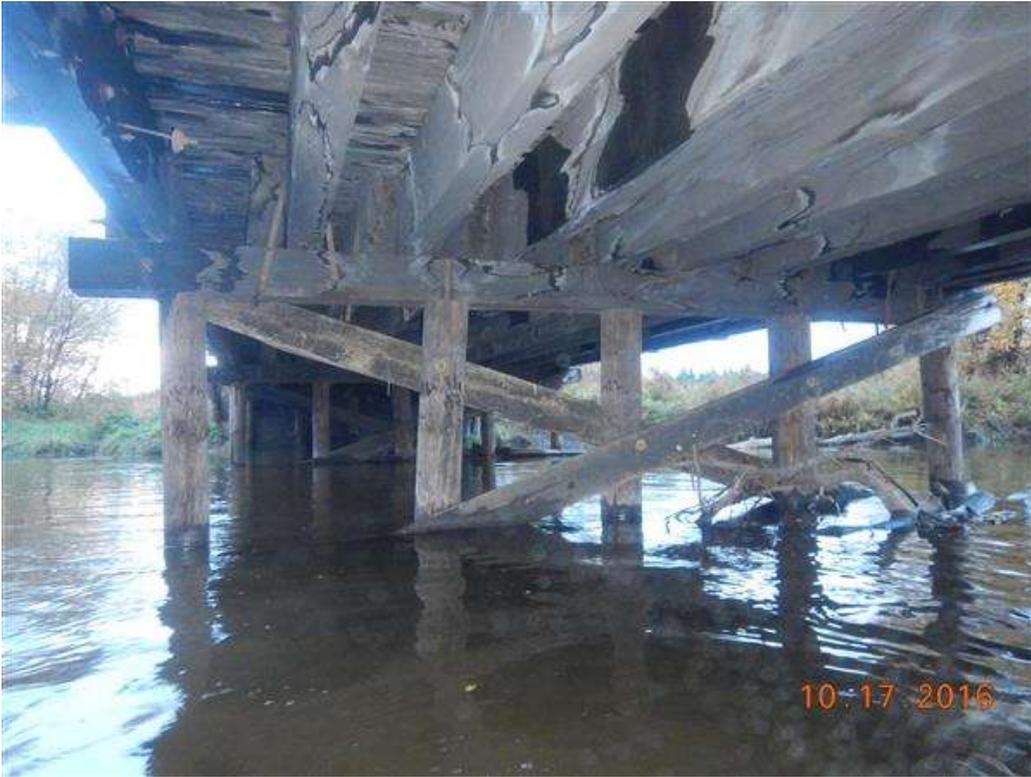
Photo 5 - Pier 1 West Side

- (A) The diagonal timber braces were split through their connections at several locations at both piers. The splitting in the connections measured up to 2 inches wide by 12 feet in length.

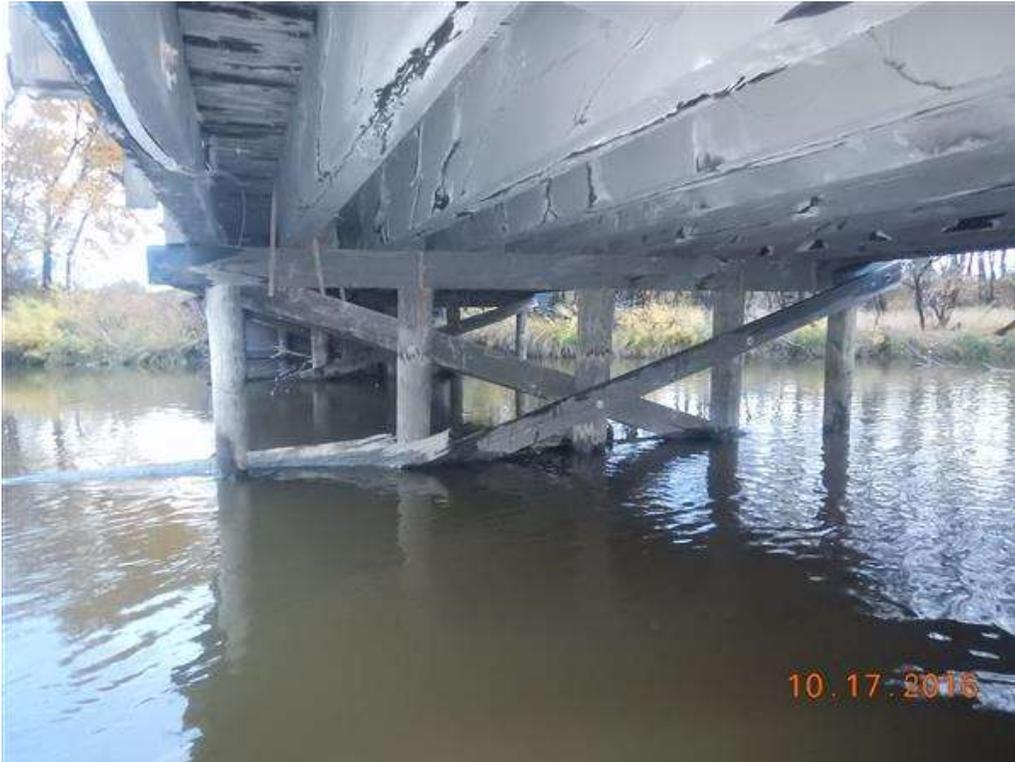
Photo 8 - Pier 2 East Side

- (B) The diagonal on the east face of Pier 2 has broken off at the fourth upstream pile and is not engaging the fifth upstream pile.
- (C) A heavy timber debris accumulation was observed around both piers and throughout the channel. The debris consisted primarily of branches and trees.

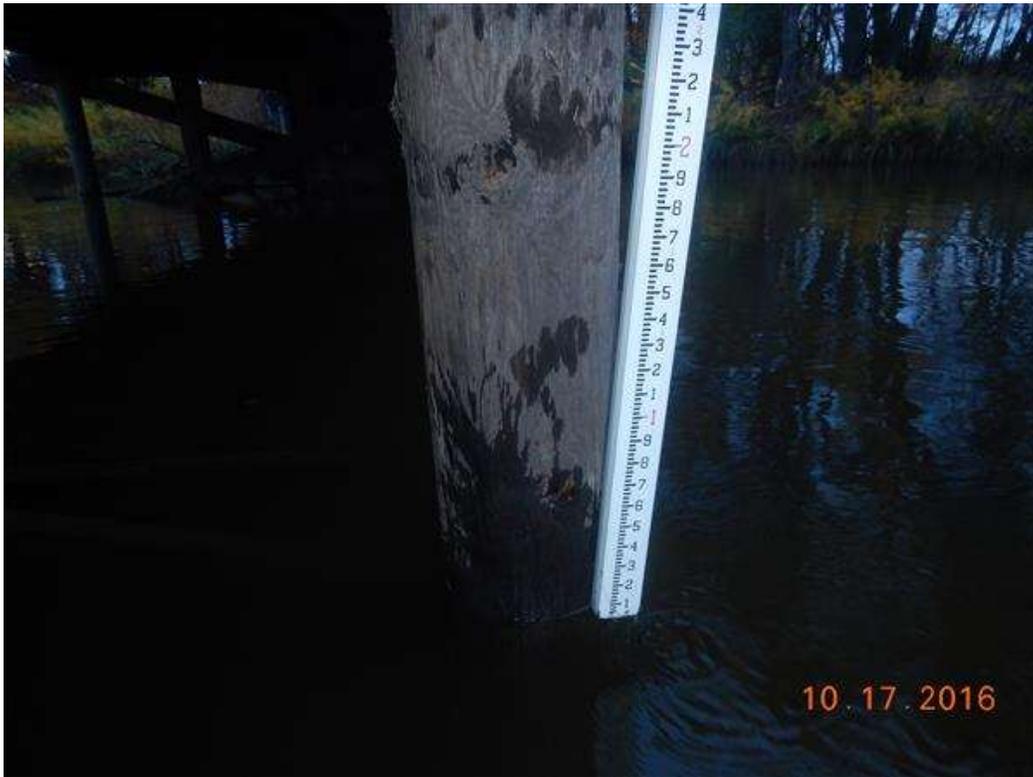
Photo 9 - Condition at Waterline

- (D) All of the timber elements had minor to moderate weathering with checks up to 1/2 inch wide and penetrations 1/4 to 3/4 inch deep. The fourth upstream pile at Pier 1 had the most extensive cracking and splitting. The galvanized connection hardware had minor surface corrosion.

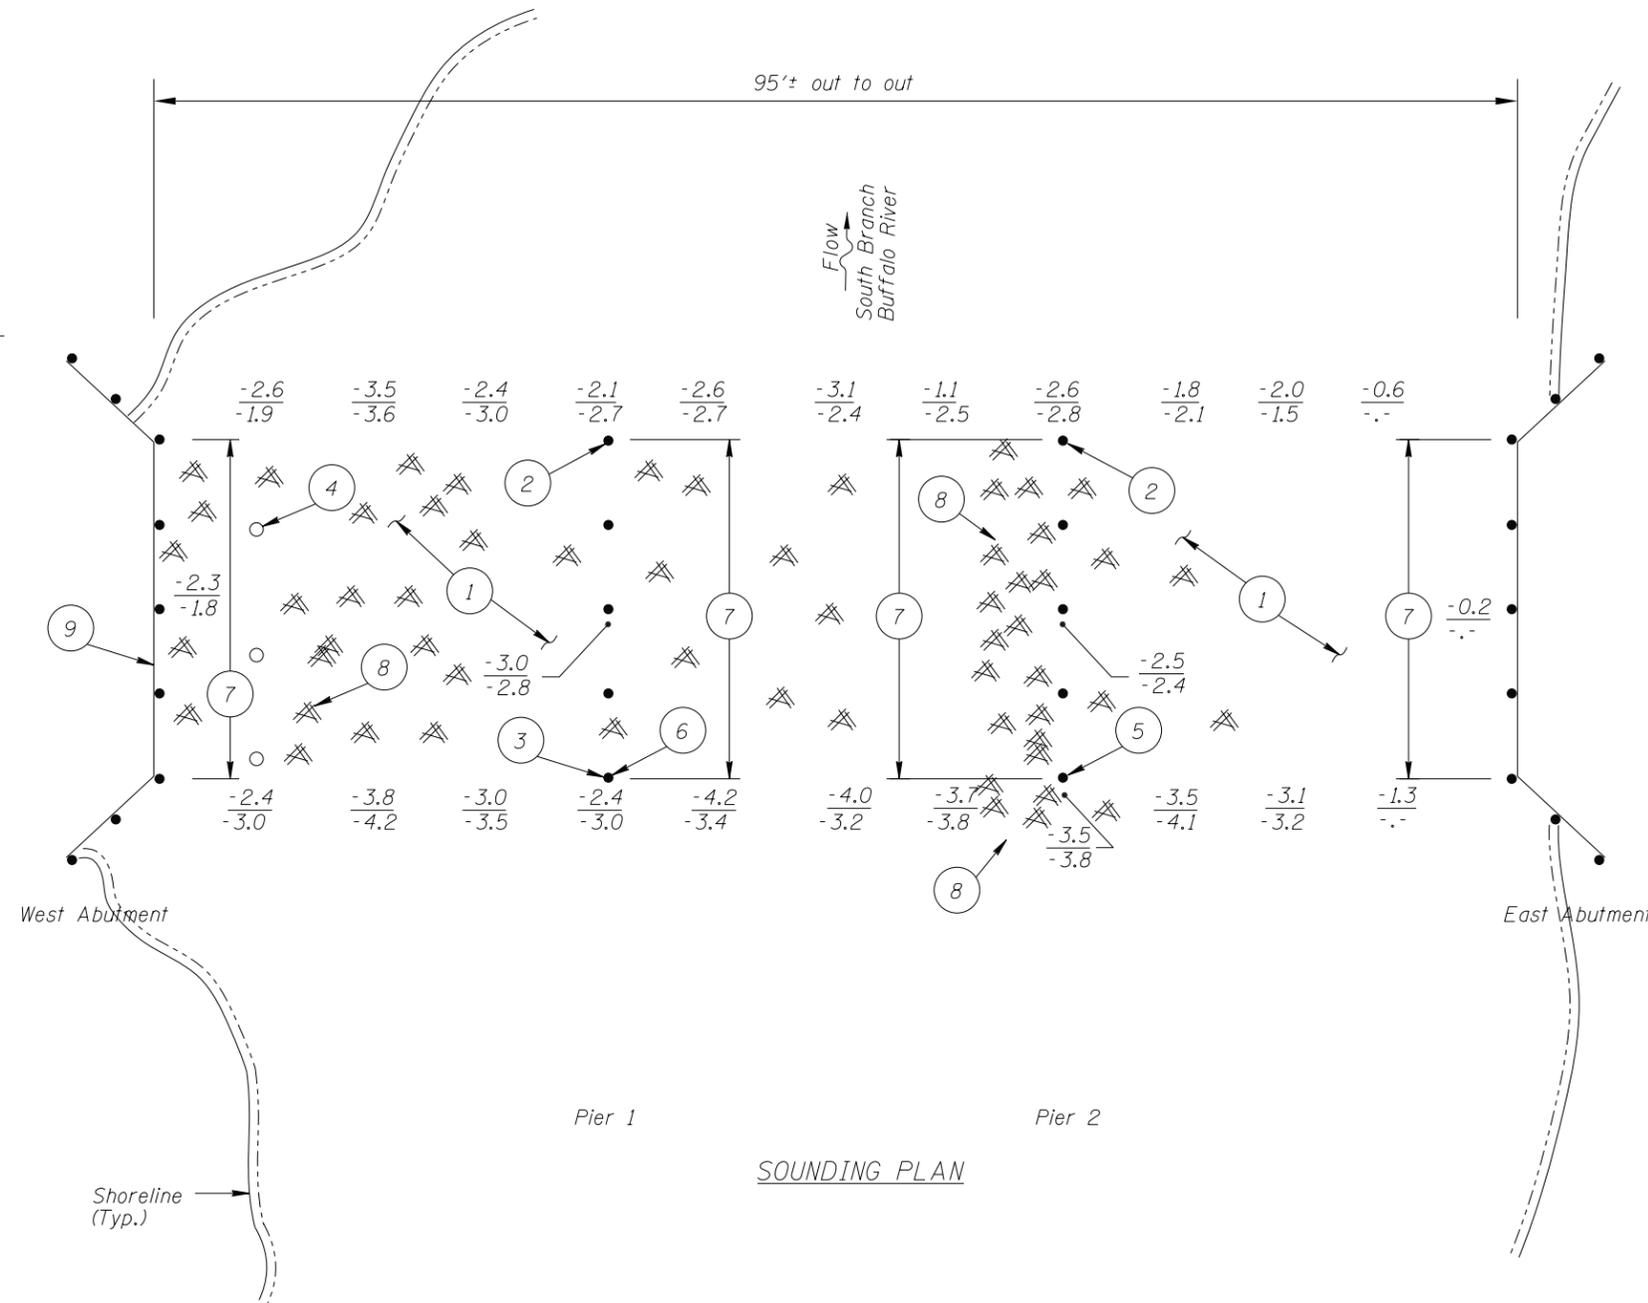
SOUNDING PLAN

- 1 The channel bottom consisted of silt with up to 1 foot of probe rod penetration.
- 2 The diagonal bracing was split at the connection below the waterline, measuring 2 inches wide at the northernmost 8 feet of the diagonal bracing attached to the west face of Piers 1 and 2.

- 3 The diagonal bracing was split at the pile cap connection, measuring 1 inch wide at the southernmost 4 feet of the diagonal bracing attached to the west face of Pier 1.

- 4 Old cut off piles were observed protruding from the channel bottom up to 1.5 feet above the waterline (typical).
- 5 The diagonal bracing was split/broken for the southernmost 12 feet of the diagonal bracing attached to the east face of Pier 2.

- 6 The diagonal bracing was split for the southernmost 8 feet of the diagonal bracing attached to the east face of Pier 1.
- 7 All timber elements (piles, cross bracing, caps, and abutment sheeting) had minor to moderate weathering with checks up to 1/2 inch wide and awl penetrations 1/4 to 3/4 inch deep. These defects were particularly heavy at the fourth upstream pile of Pier 1. The galvanized connection hardware had only minor surface corrosion.

- 8 A heavy accumulation of timber debris consisting of logs and branches was observed along both sides of Pier 1 and Pier 2 and throughout the entire channel under the structure.

- 9 Lateral deflection/movement of up to 1 inch (eastward) was present along the West Abutment.
