UNDERWATER BRIDGE INSPECTION REPORT

STRUCTURE NO. 55517  
EAST CENTER STREET  
OVER THE  
ZUMBRO RIVER  
DISTRICT 6 - RICE COUNTY

PREPARED FOR THE  
MINNESOTA DEPARTMENT OF TRANSPORTATION  
BY  
COLLINS ENGINEERS, INC.  
JOB NO.5221

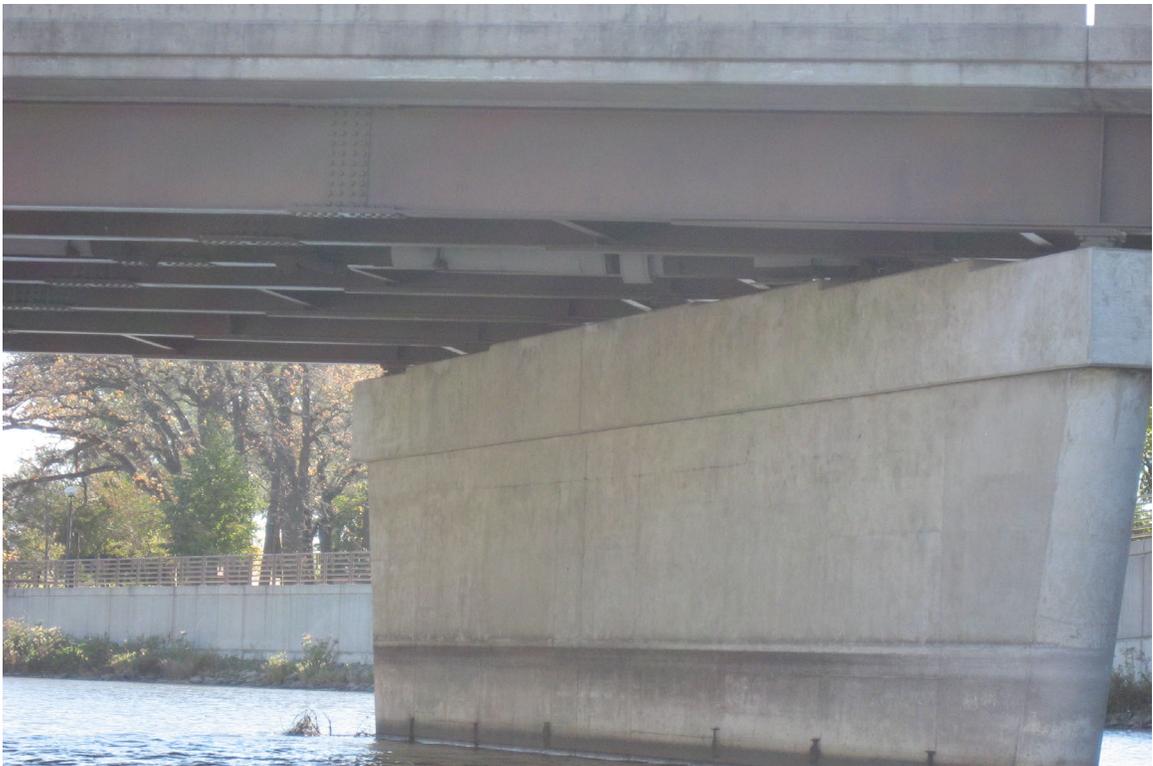
Photograph 2. View of Pier 1, Looking South.

- 4 The channel bottom consisted of sandy silt with up to 6 inches of probe rod penetration.
- 5 A light accumulation of 6-inch-diameter and smaller timber debris was observed at the upstream end of Pier 1.

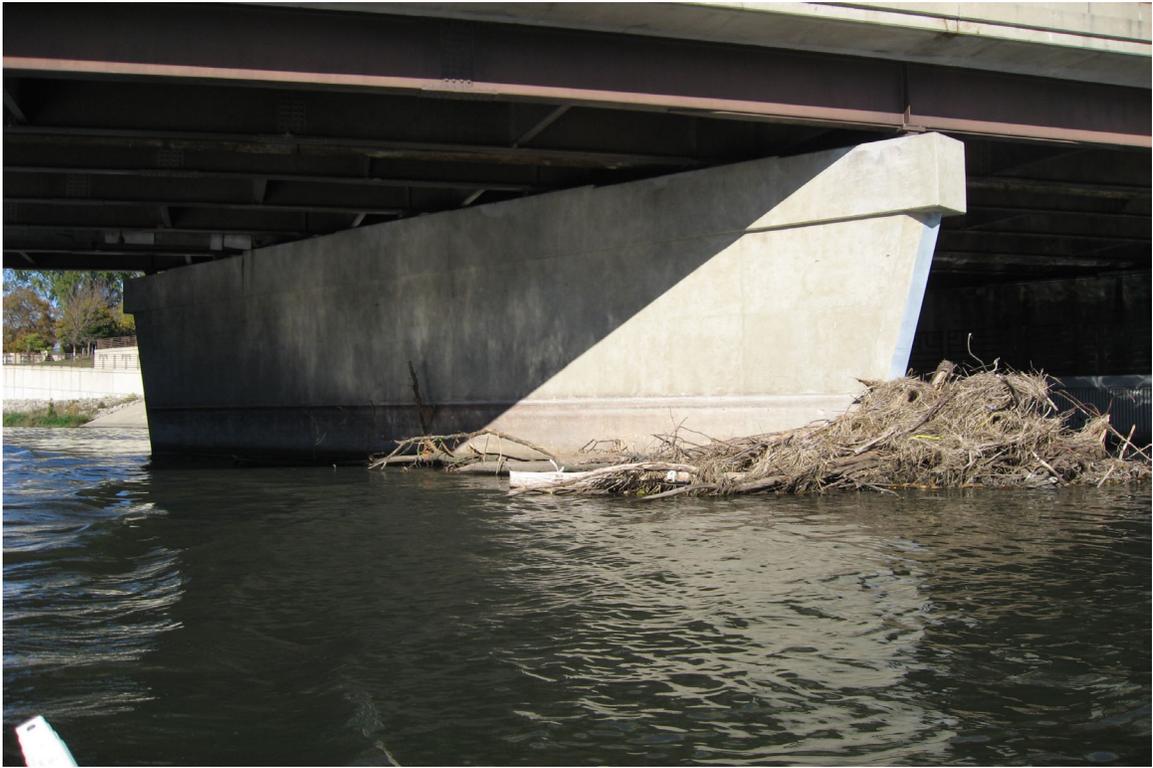
Photograph 3. View of Pier 2, Looking Northeast. Note the heavy accumulation of timber debris at the upstream end of the pier.

- 6 A vertical hairline crack extended from the bottom of the pier cap to the channel bottom.
- 7 A heavy accumulation of 1.5-foot-diameter and smaller timber debris was observed at the upstream end of Pier 2 that extended along both sides of the pier and from the channel bottom up to 5 feet above the waterline.

- (A) The heavy accumulation of timber debris at Pier 2 should be removed during routine maintenance.
- (B) Reinspect the submerged substructure units at the normal maximum recommended (NBIS) interval of five (5) years.

The heavy accumulation of timber debris at Pier 2 should be removed during routine maintenance.

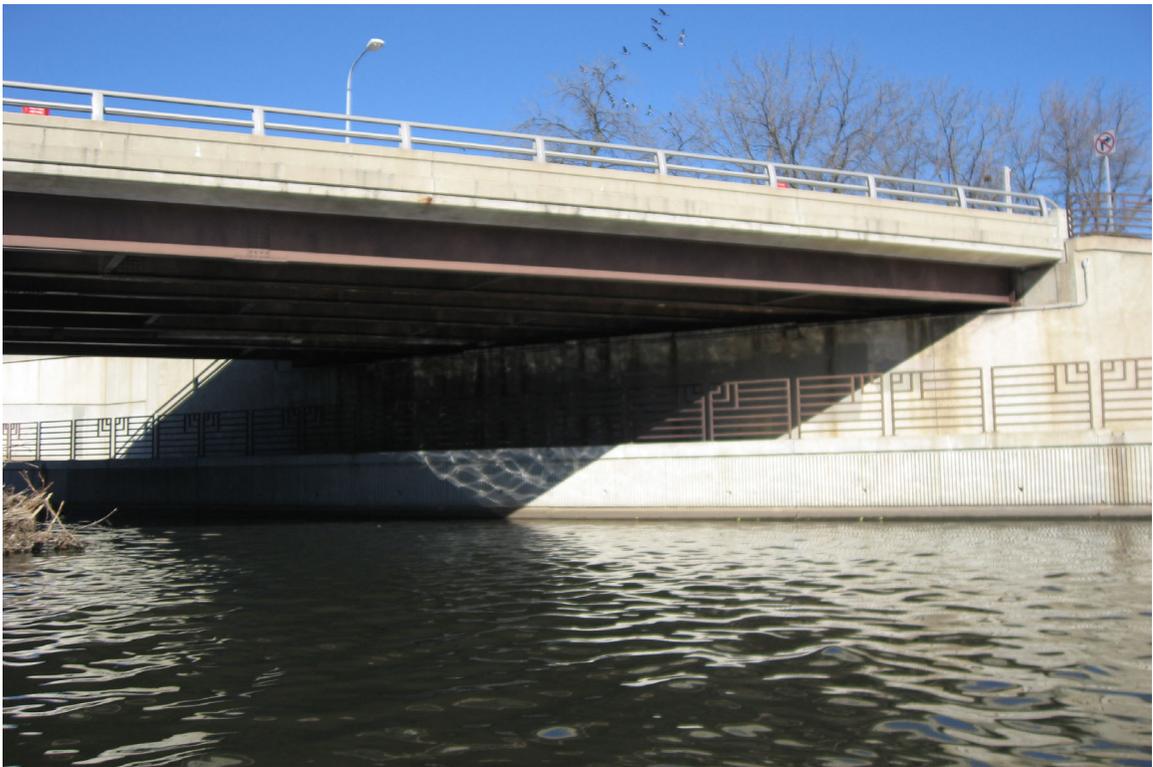
Photograph 4. View of the East Abutment, Looking Northeast.

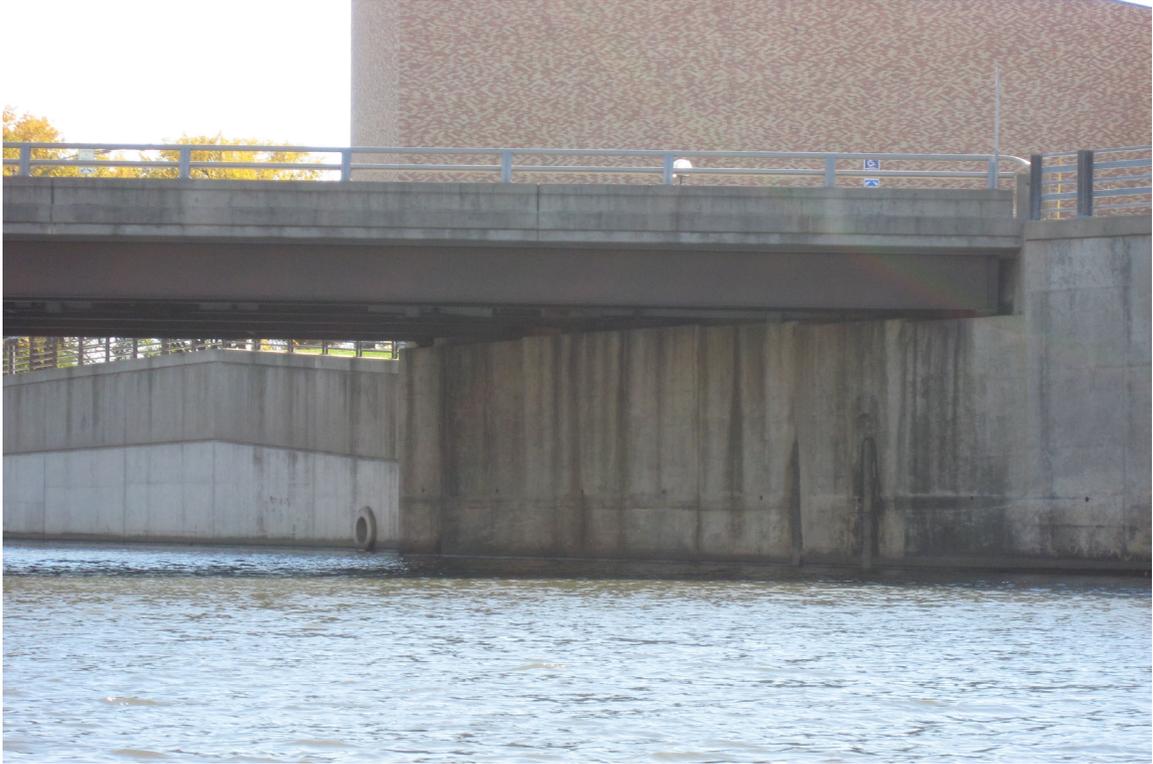
Photograph 5. View of the West Abutment, Looking Southwest.

- 1 An area of poor consolidation was located 1 foot above the waterline along a joint at the upstream end of the West Abutment that measured 1 foot in diameter with up to 6 inches of penetration.

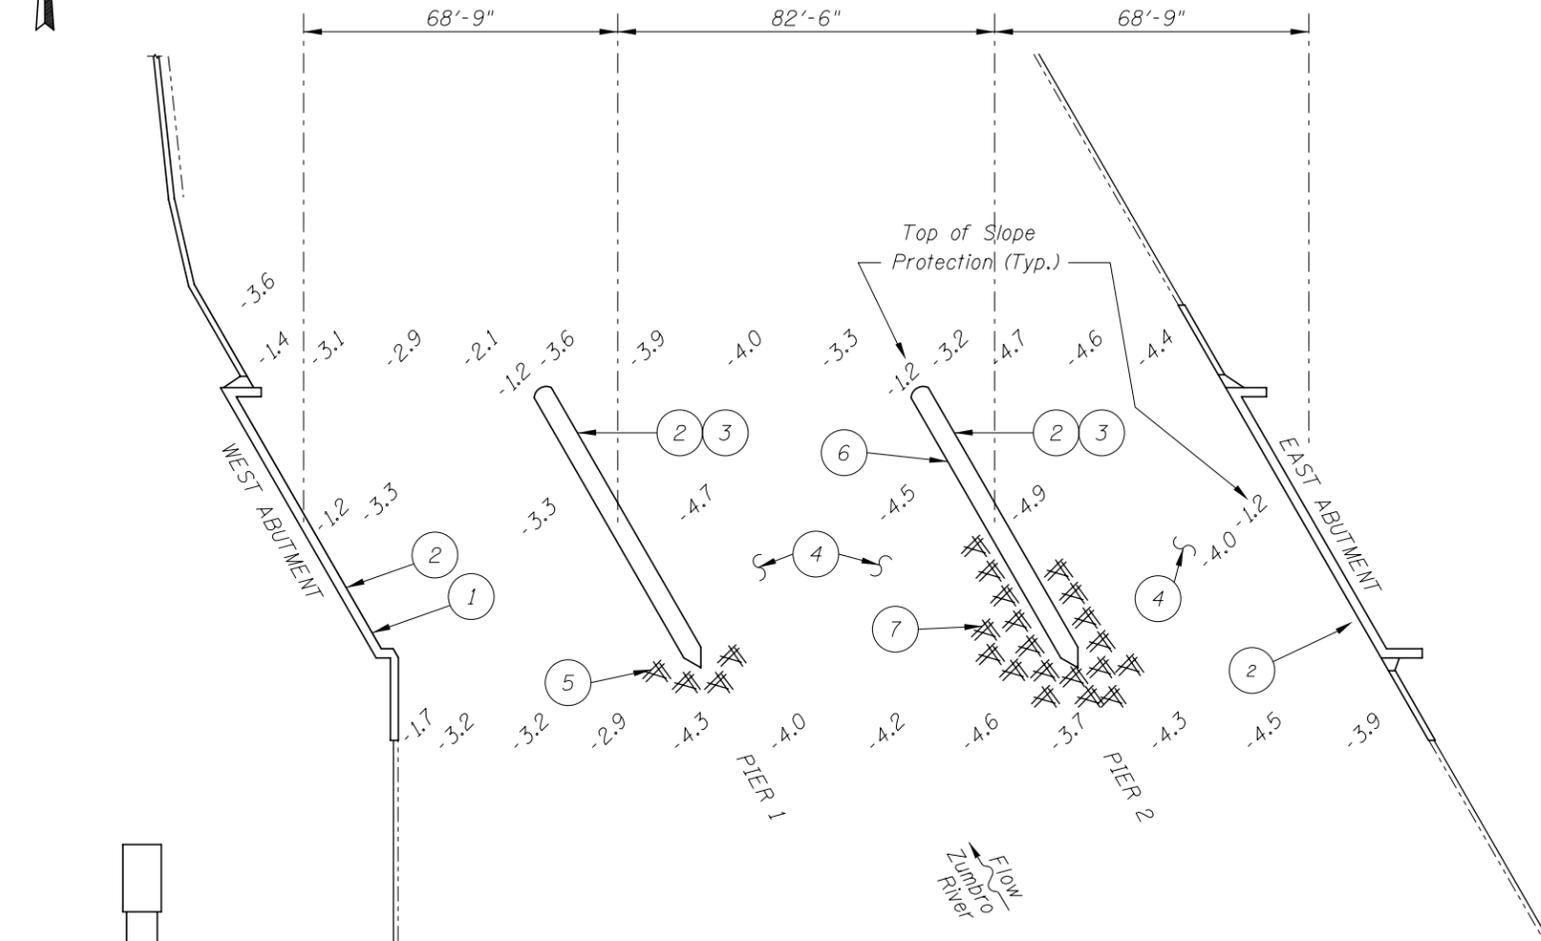
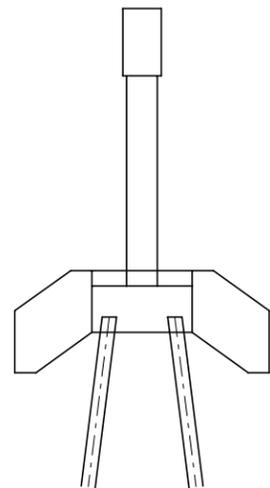
SOUNDING PLAN

- 2 The concrete was typically smooth and sound with random minor areas of poor consolidation with up to 1 inch of penetration. A sloped concrete slope protection was around both abutments, and was typically in good condition.

- 3 Three steel beams on 6-foot centers were embedded in the concrete pier shafts near the waterline at both the upstream and downstream ends of Piers 1 and 2.
