UNDERWATER BRIDGE INSPECTION REPORT

STRUCTURE NO. 66512  
PEDESTRIAN WALKWAY  
OVER THE  
CANNON RIVER  
DISTRICT 6 - RICE COUNTY

PREPARED FOR THE  
MINNESOTA DEPARTMENT OF TRANSPORTATION  
BY  
COLLINS ENGINEERS, INC.  
JOB NO. 5221

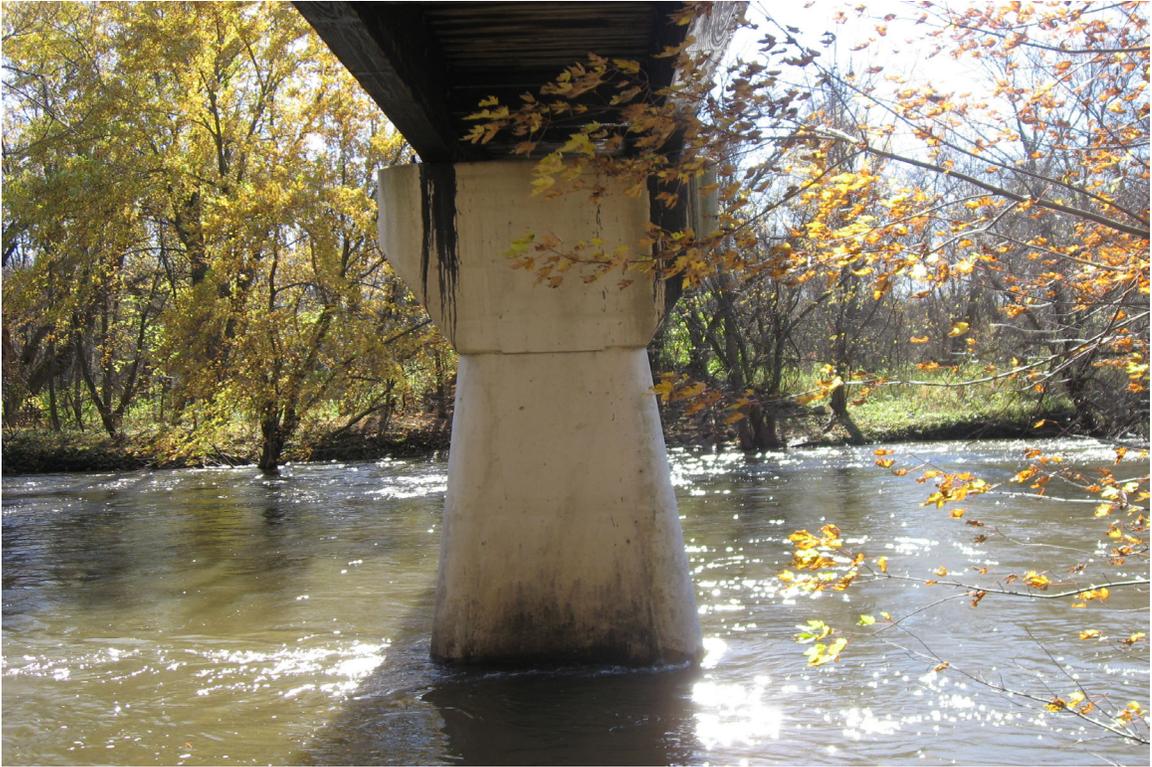
- (A) The concrete of the piers was smooth and sound with no notable defects.
- (B) A 3 foot diameter tree trunk was found at the upstream nose and along the south side of the South Pier.

Photograph 2. View of the North Pier, Looking South.

- (A) Reinspect the submerged substructure units at the normal maximum recommended (NBIS) interval of five (5) years.

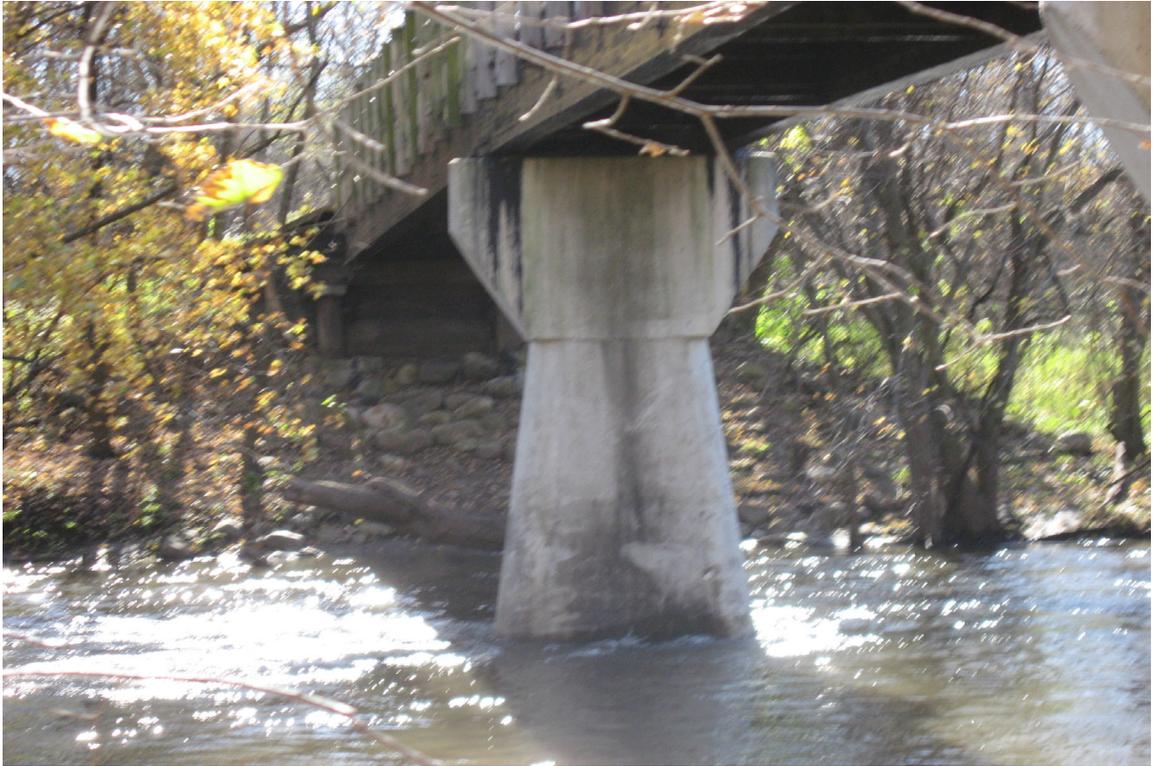
Photograph 3. View of the South Pier, Looking South.

REMARKS: Overall, the concrete of the piers was in good condition with no defects of structural significance observed. A 3 foot diameter tree trunk was found at the upstream nose and along the south side of the South Pier.

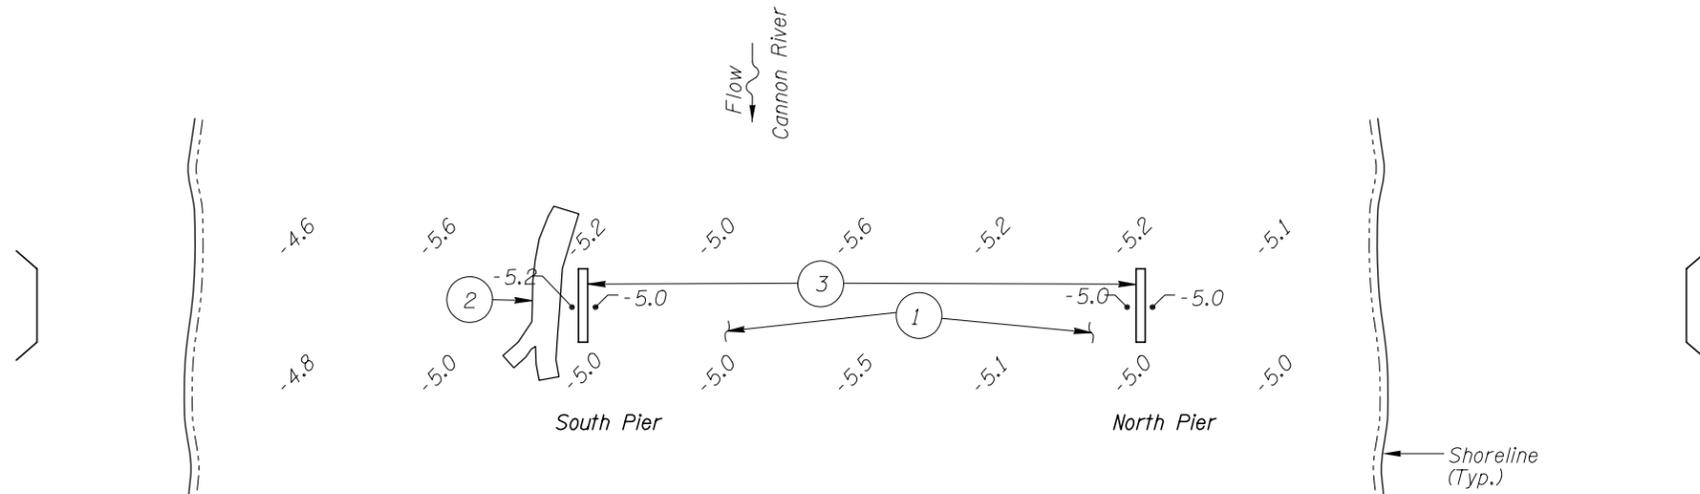
SOUNDING PLAN

- ① The channel bottom at North and South Piers consisted of rock and gravel with no appreciable probe rod penetration.
- ② A 3 foot diameter tree trunk was found at the upstream nose and along the south side of South Pier.
- ③ Overall concrete was smooth and sound with no notable defects.
