UNDERWATER BRIDGE INSPECTION REPORT

STRUCTURE NO. L4665
UN-NAMED TWP RD
OVER THE
SOUTH FORK RIVER
DISTRICT 6 - FILLMORE COUNTY

PREPARED FOR THE
MINNESOTA DEPARTMENT OF TRANSPORTATION
BY
COLLINS ENGINEERS, INC.
JOB NO. 5221

MINNESOTA DEPARTMENT OF TRANSPORTATION
UNDERWATER BRIDGE INSPECTION

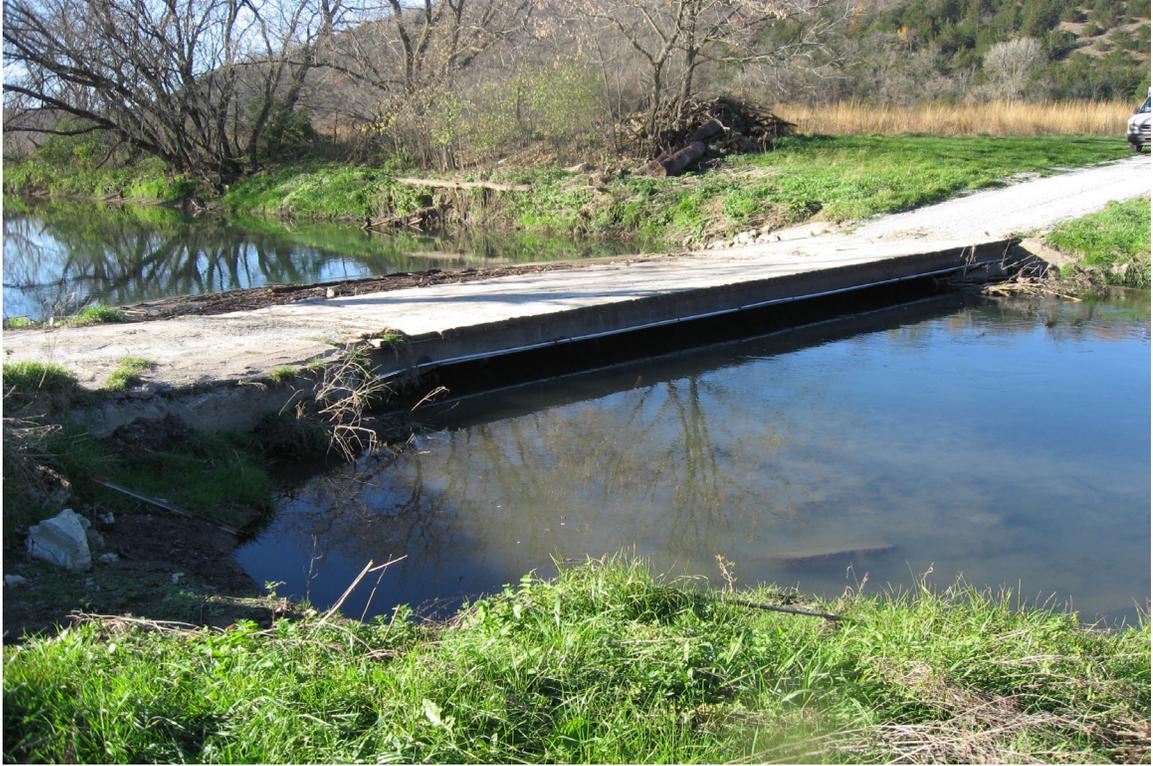
Photograph 1. Overall View of the Structure, Looking Northwest.

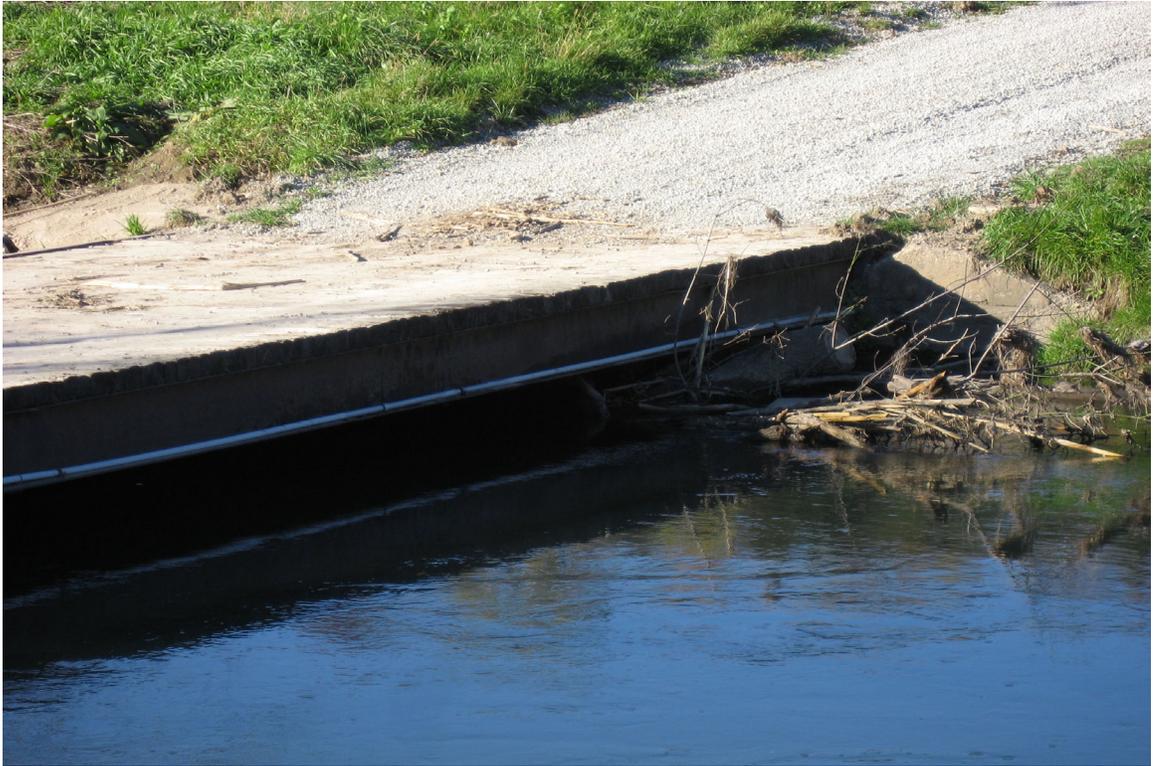
Photograph 2. View of the North End of the Structure, Looking Southeast.

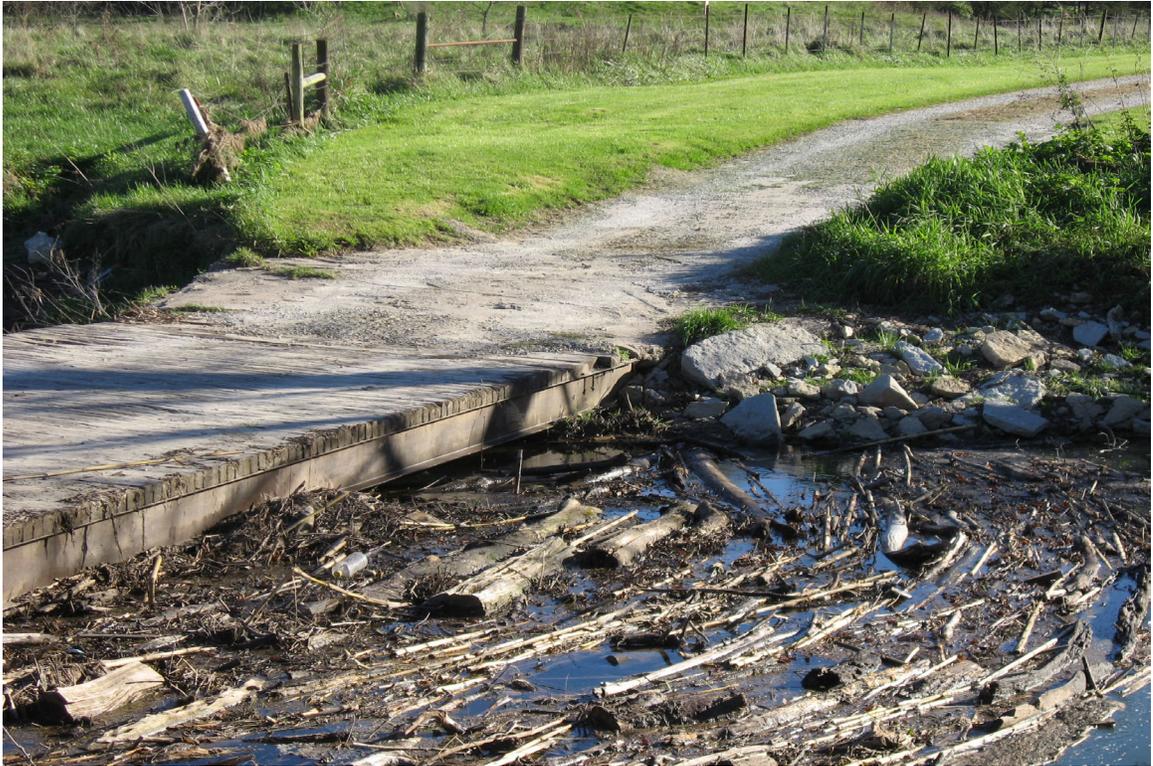
Photograph 3. View of South End of the Structure, Looking Southeast. Note heavy timber debris.

- (A) Remove the heavy accumulation of timber debris which is significantly restricting the channel at the bridge and has the potential to exert considerable lateral load on the bridge superstructure.

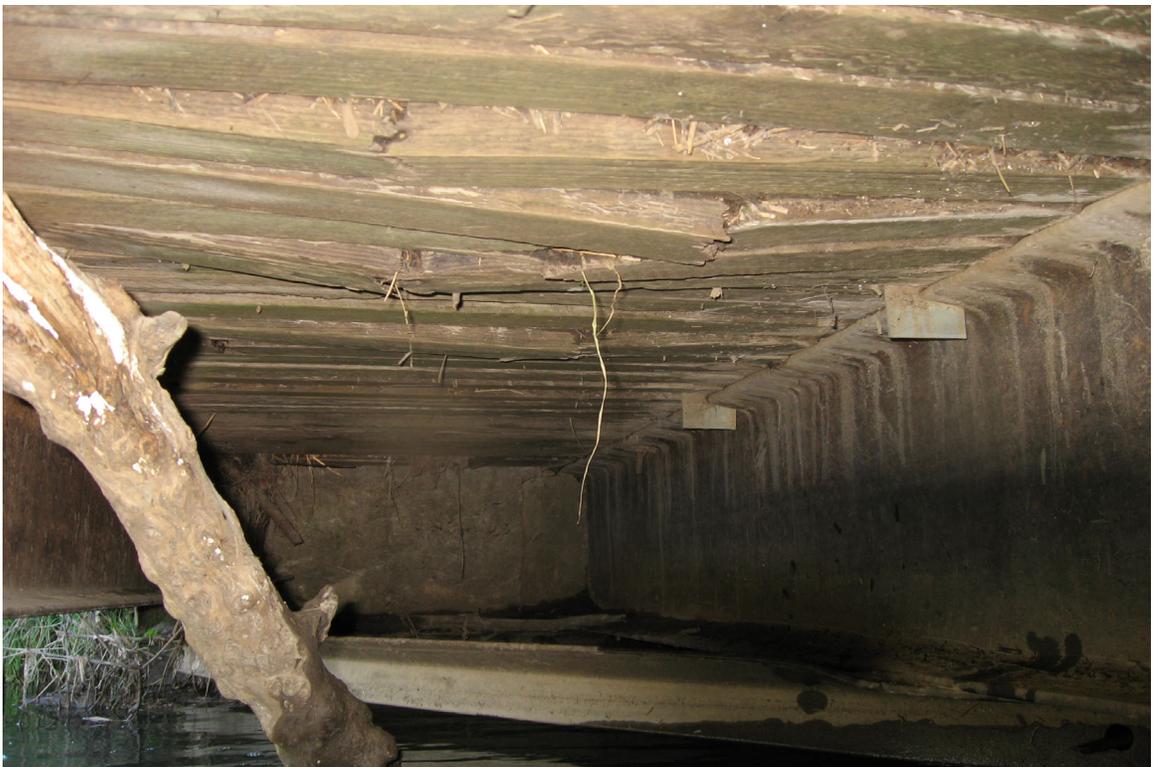
Photograph 4. View of the South Abutment and Underside of Deck between Beams 5 and 4, Looking South. Note crack deck plank members.

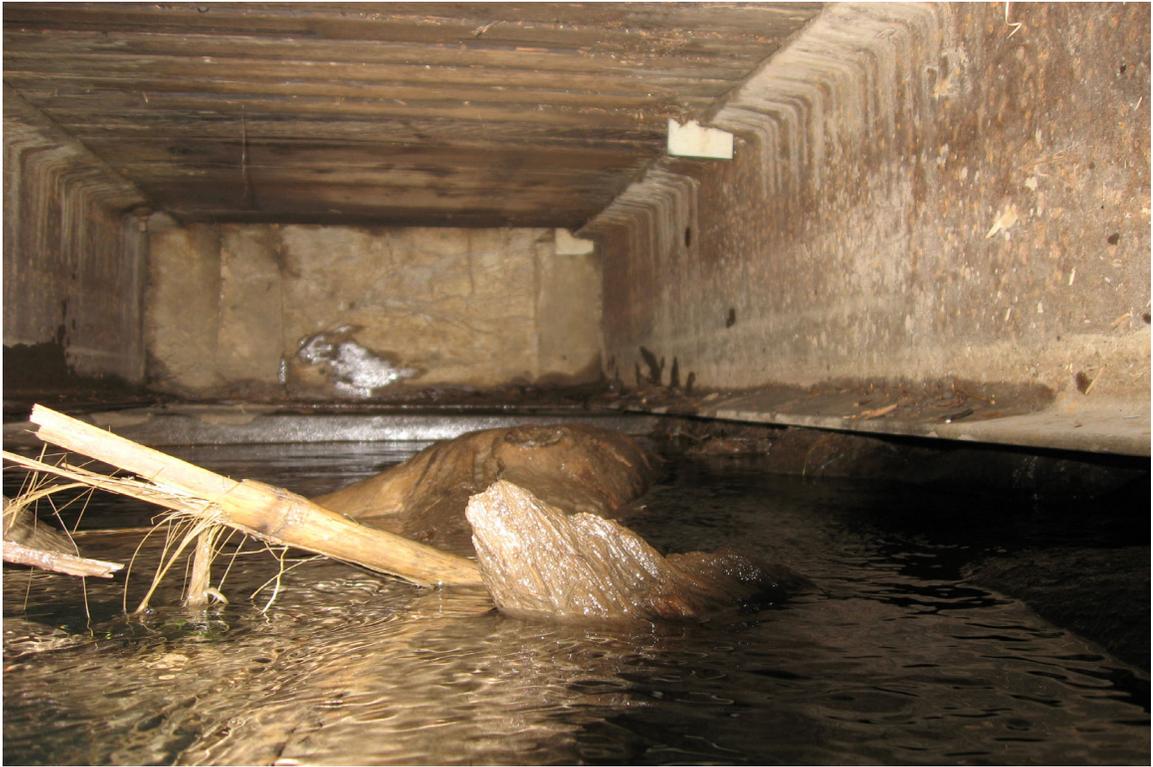
Photograph 5. View of the South Abutment and Underside of Deck between Beams 4 and 3, Looking South. Note timber debris up to superstructure.

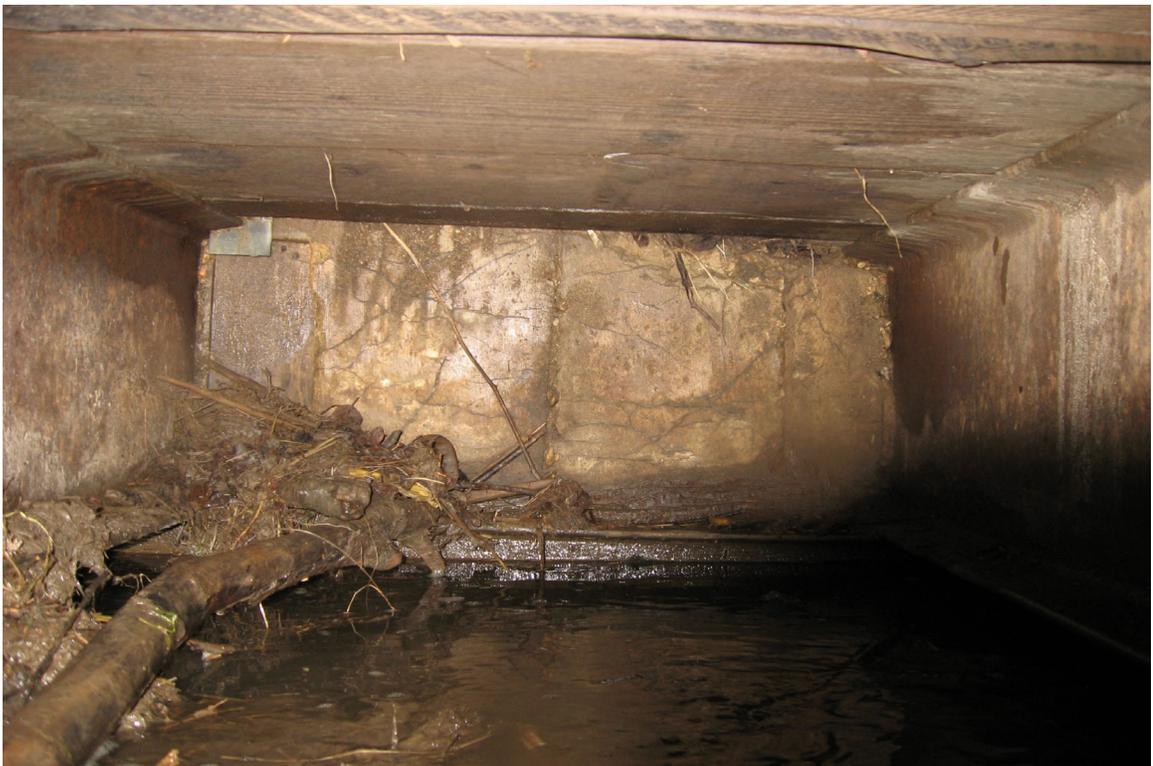
Photograph 6. View of the South Abutment and Underside of Deck between Beams 3 and 2, Looking South. Note timber debris up to superstructure.

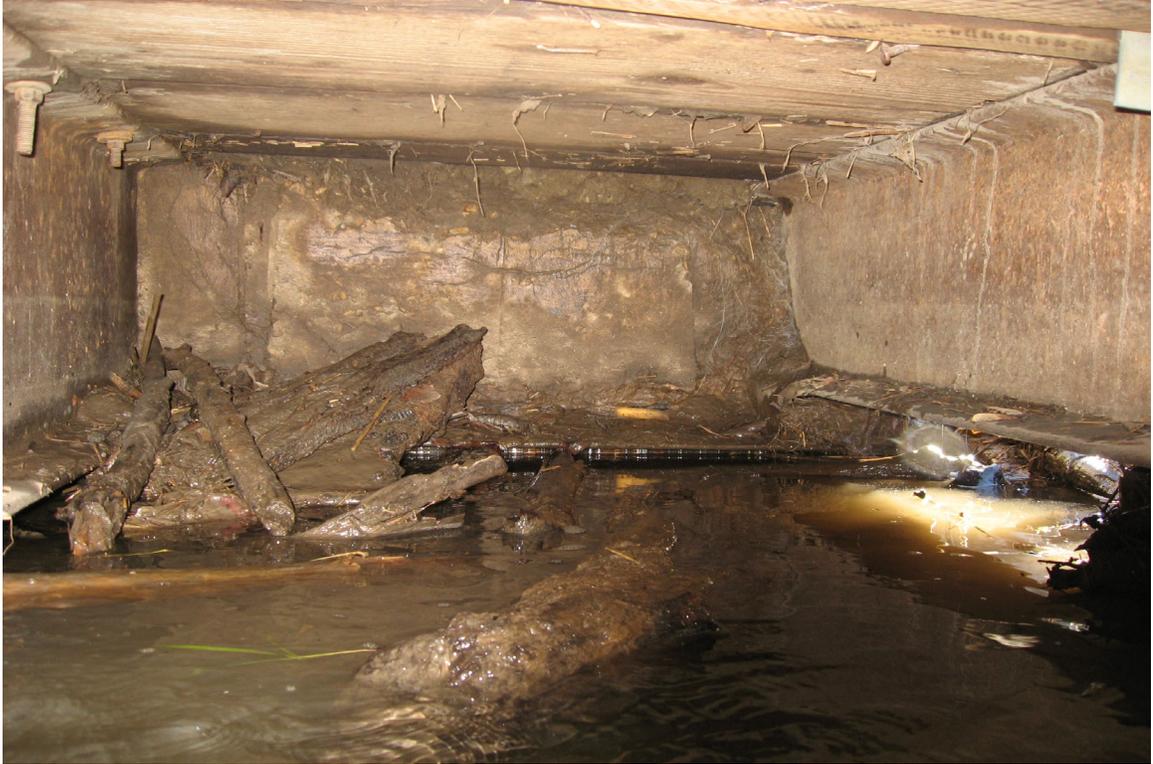
Photograph 7. View of the South Abutment and Underside of Deck between Beams 2 and 1, Looking South. Note timber debris up to superstructure.

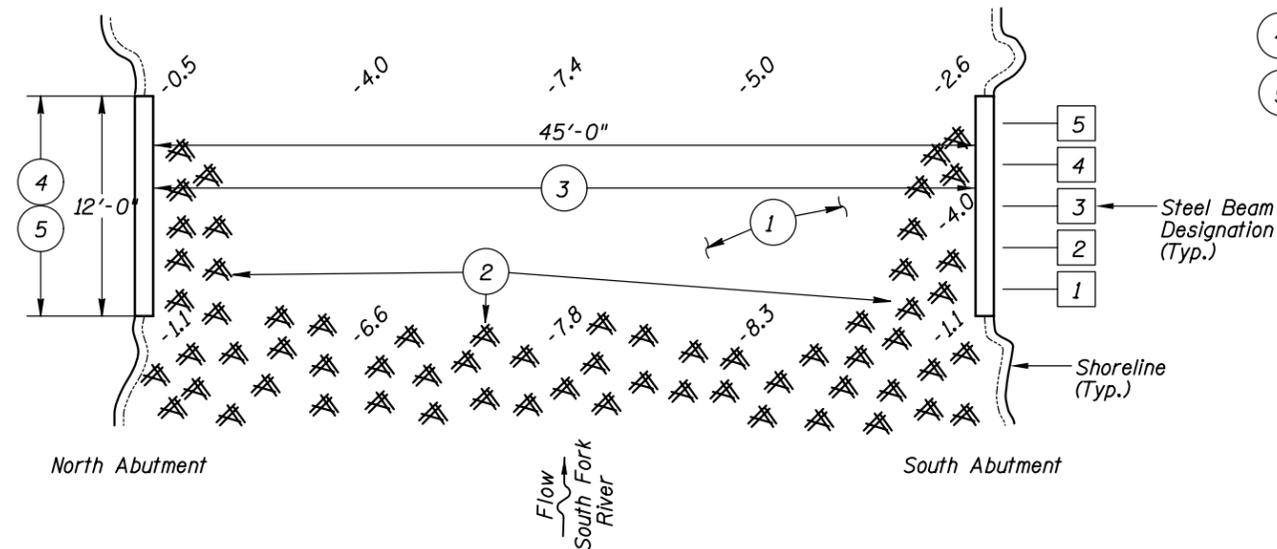
- ① Channel bottom consisted of soft organics and silt with up to 2 feet of probe rod penetration.
- ② Heavy accumulation of timber debris was observed at the upstream fascia of bridge, under most of the superstructure span, and about 10 feet upstream of the bridge and each abutment consisting of 1 foot diameter and smaller logs and branches extending from the channel bottom to 1 foot above the waterline.
- ③ Concrete was rough and scaling was present with approximately 1/4 inch of maximum penetration.
- ④ The steel beams showed light surface corrosion with no notable section loss.
- ⑤ The underside of deck exhibited random cracking in isolated deck plank members.
