UNDERWATER BRIDGE INSPECTION REPORT

STRUCTURE NO. 25552

NORTH BRANCH MIDDLE FORK ZUMBRO RIVER

JOB NO. 7423

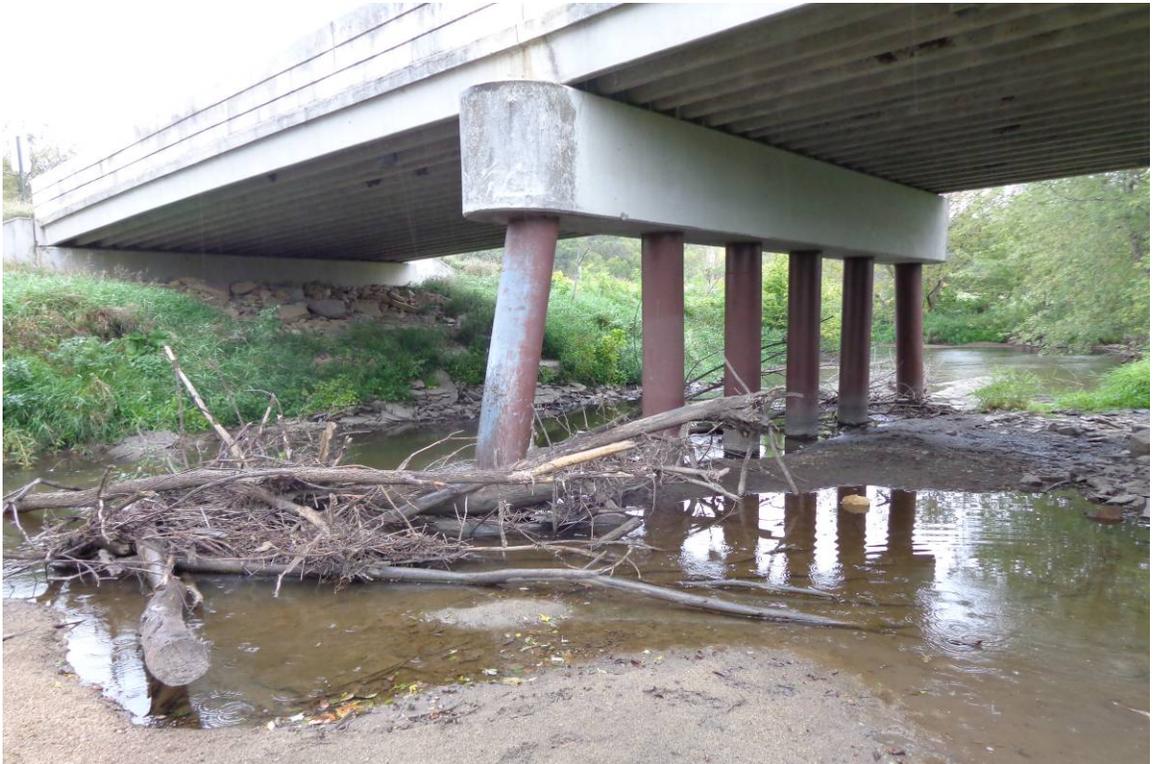
Photograph 2. View of Pier 1, Looking Northeast.

The substructure unit inspected below water at Bridge No. 25552, Pier 1, was found to be in good condition with no defects of structural significance observed. The steel pipe piles appeared to be sound with the protective coating still mostly intact. The channel bottom appeared stable with silty sand and no significant scour. Timber debris accumulation was observed at the upstream nose and along the north side of Pier 1.

- (A) All steel piles were in good condition with painted coating intact.
- (B) The channel bottom material consisted of silty sand with 6 inch of probe rod penetration.
- (C) Accumulation of timber debris was observed at the upstream nose and along the north side of the pier extending from the channel bottom to 4 feet above the waterline.

- (A) The inspection of the submerged substructure units of Structure No. 25552 can most likely be accomplished in the future without the use of a dive team. To perform the underwater inspection, a properly equipped qualified inspector will have to enter the water during a period of low flow. As channel bottom contours and depths of flow can change quickly, it is recommended that lead line soundings of water depth be taken along the upstream and downstream fascias to determine whether wading is possible prior to beginning the inspection. If conditions are unsafe for inspection by wading, then an underwater inspection with the use of a dive team will be required.
- (B) Reinspect the submerged substructure units at the normal maximum recommended (NBIS) interval of sixty (60) months.

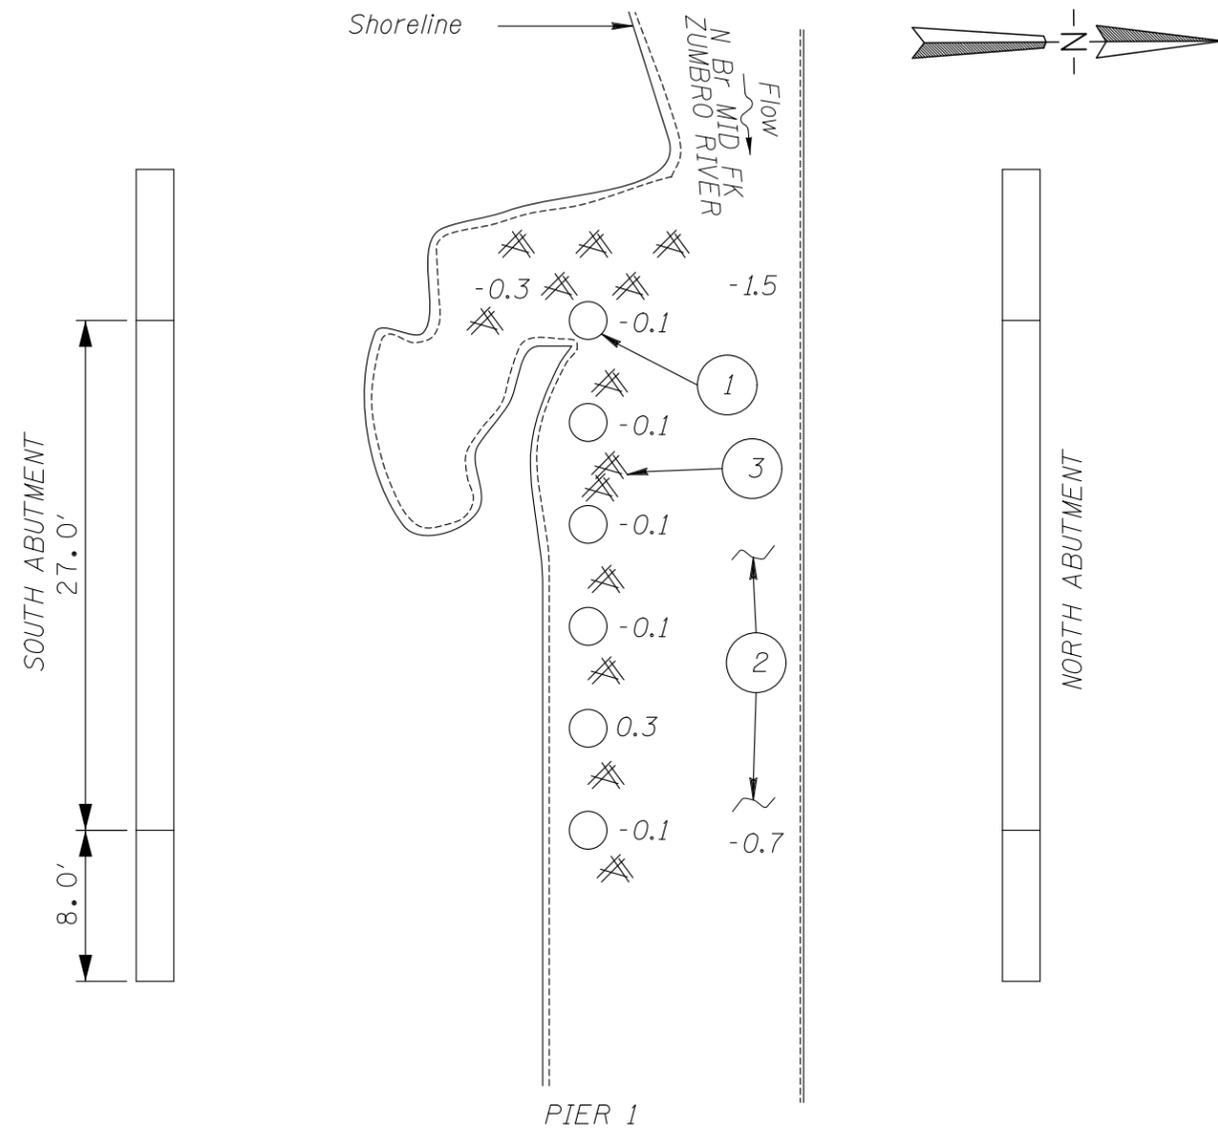
TYPICAL END VIEW OF PIERS

- ① All steel piles were in good condition with paint coating intact.
- ② The channel bottom material consisted of silty sand allowing 6 inch of penetration.
- ③ Timber debris accumulation was observed at the upstream end and along the north face of the pier extending from the channel bottom to 4 feet above the waterline.
