UNDERWATER BRIDGE INSPECTION REPORT

STRUCTURE NO. 5833  
LOST LOOP ROAD  
OVER THE  
NORTH BRANCH ROOT RIVER  
FILLMORE COUNTY

OCTOBER 5, 2012  
PREPARED FOR THE  
MINNESOTA DEPARTMENT OF TRANSPORTATION  
BY  
COLLINS ENGINEERS, INC.  
JOB NO. 7423

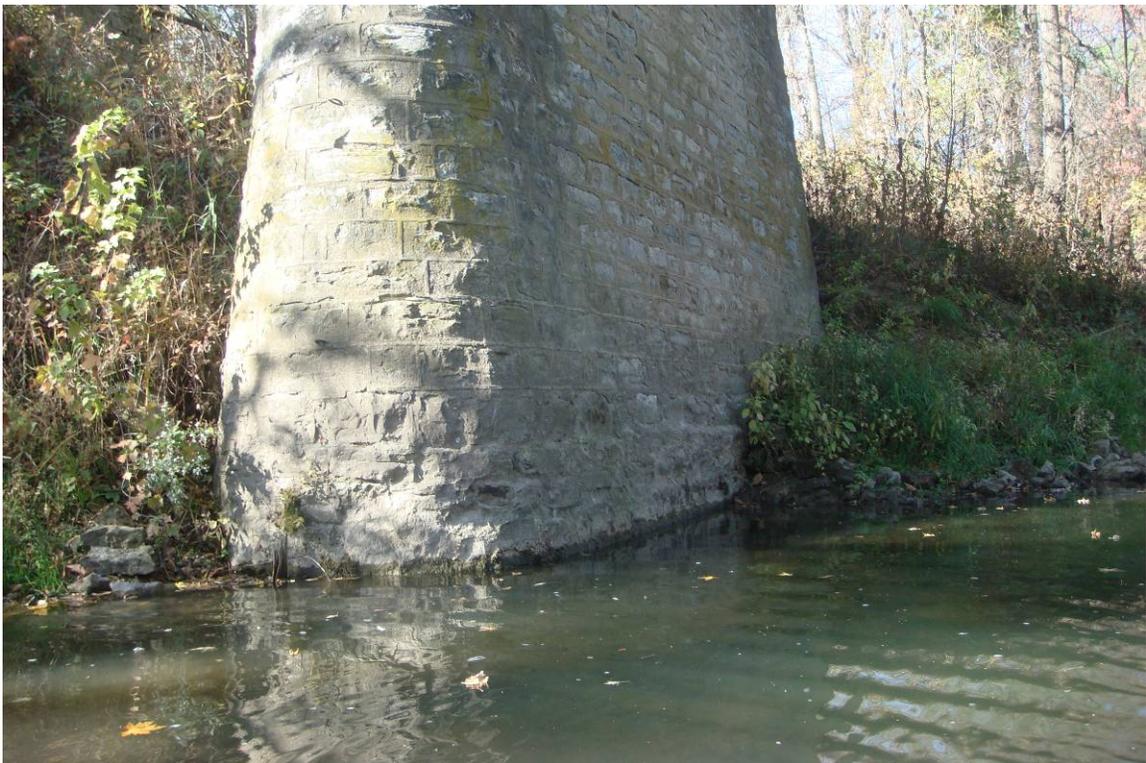
- (A) The channel bottom material on the channel side of Pier 1 consisted of 1 foot diameter and smaller rocks allowing no probe rod penetration.
- (B) The channel bottom material on the channel side of Pier 2 consisted of soft silt allowing a maximum probe rod penetration of 2.5 feet.

Photograph 2. View of the Submerged Portion of Pier 1, Looking West.

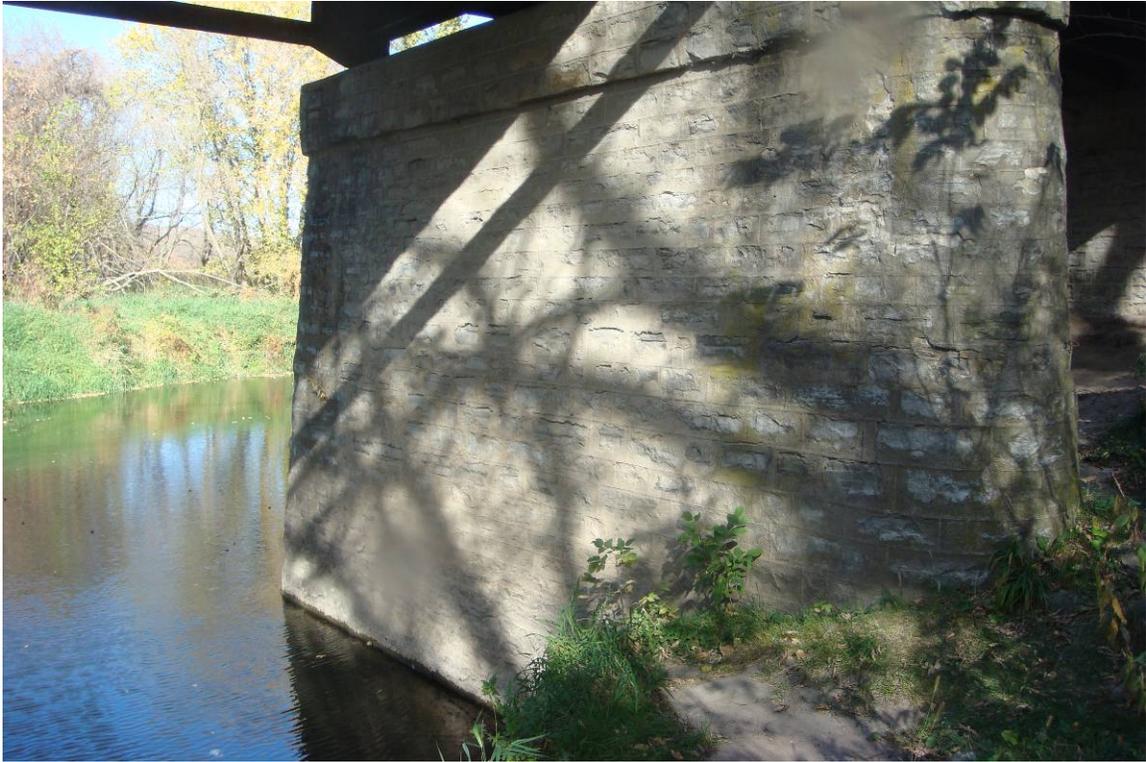
- (D) The footing of Pier 2 was exposed along the south face of the pier from the upstream nose to the downstream quarter point. The maximum vertical face exposure reached 2.5 feet (the height of the footing), and the footing was undermined at the southwest corner measuring a maximum vertical height of 3 inches and allowing up to 1.5 feet of horizontal penetration. The channel bottom material within the undermining cavity consisted of soft silt allowing up to 2 feet of penetration.

Photograph 3. View of Pier 2, Looking Northwest

- (A) Monitor the footing exposure and extend of undermining during future underwater inspection and if found to be increasing, scour countermeasures may be warranted.
- (B) Reinspect the submerged substructure units at the normal maximum recommended (NBIS) interval of sixty (60) months.

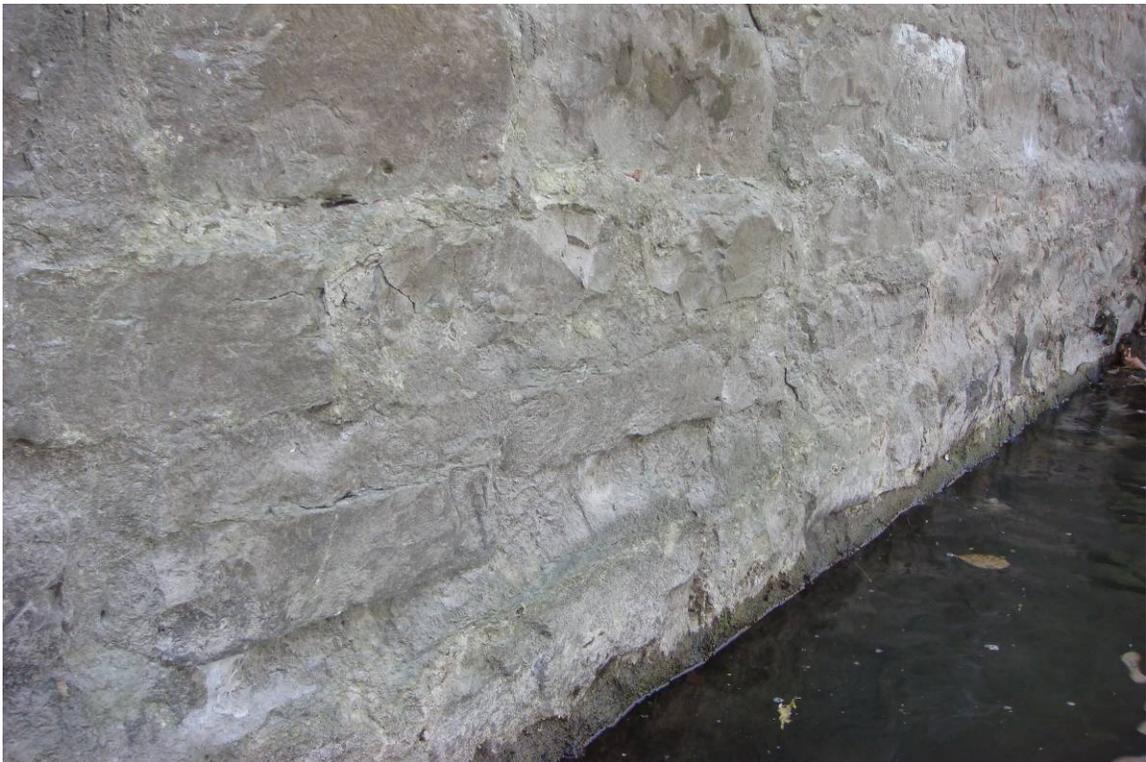
- (C) The masonry of both piers was in good and sound condition. The mortar joints were sound and tight. The face of the masonry bricks exhibited minor surface weathering.

Photograph 4. View of the Typical Masonry Condition at Pier 2, Looking North.

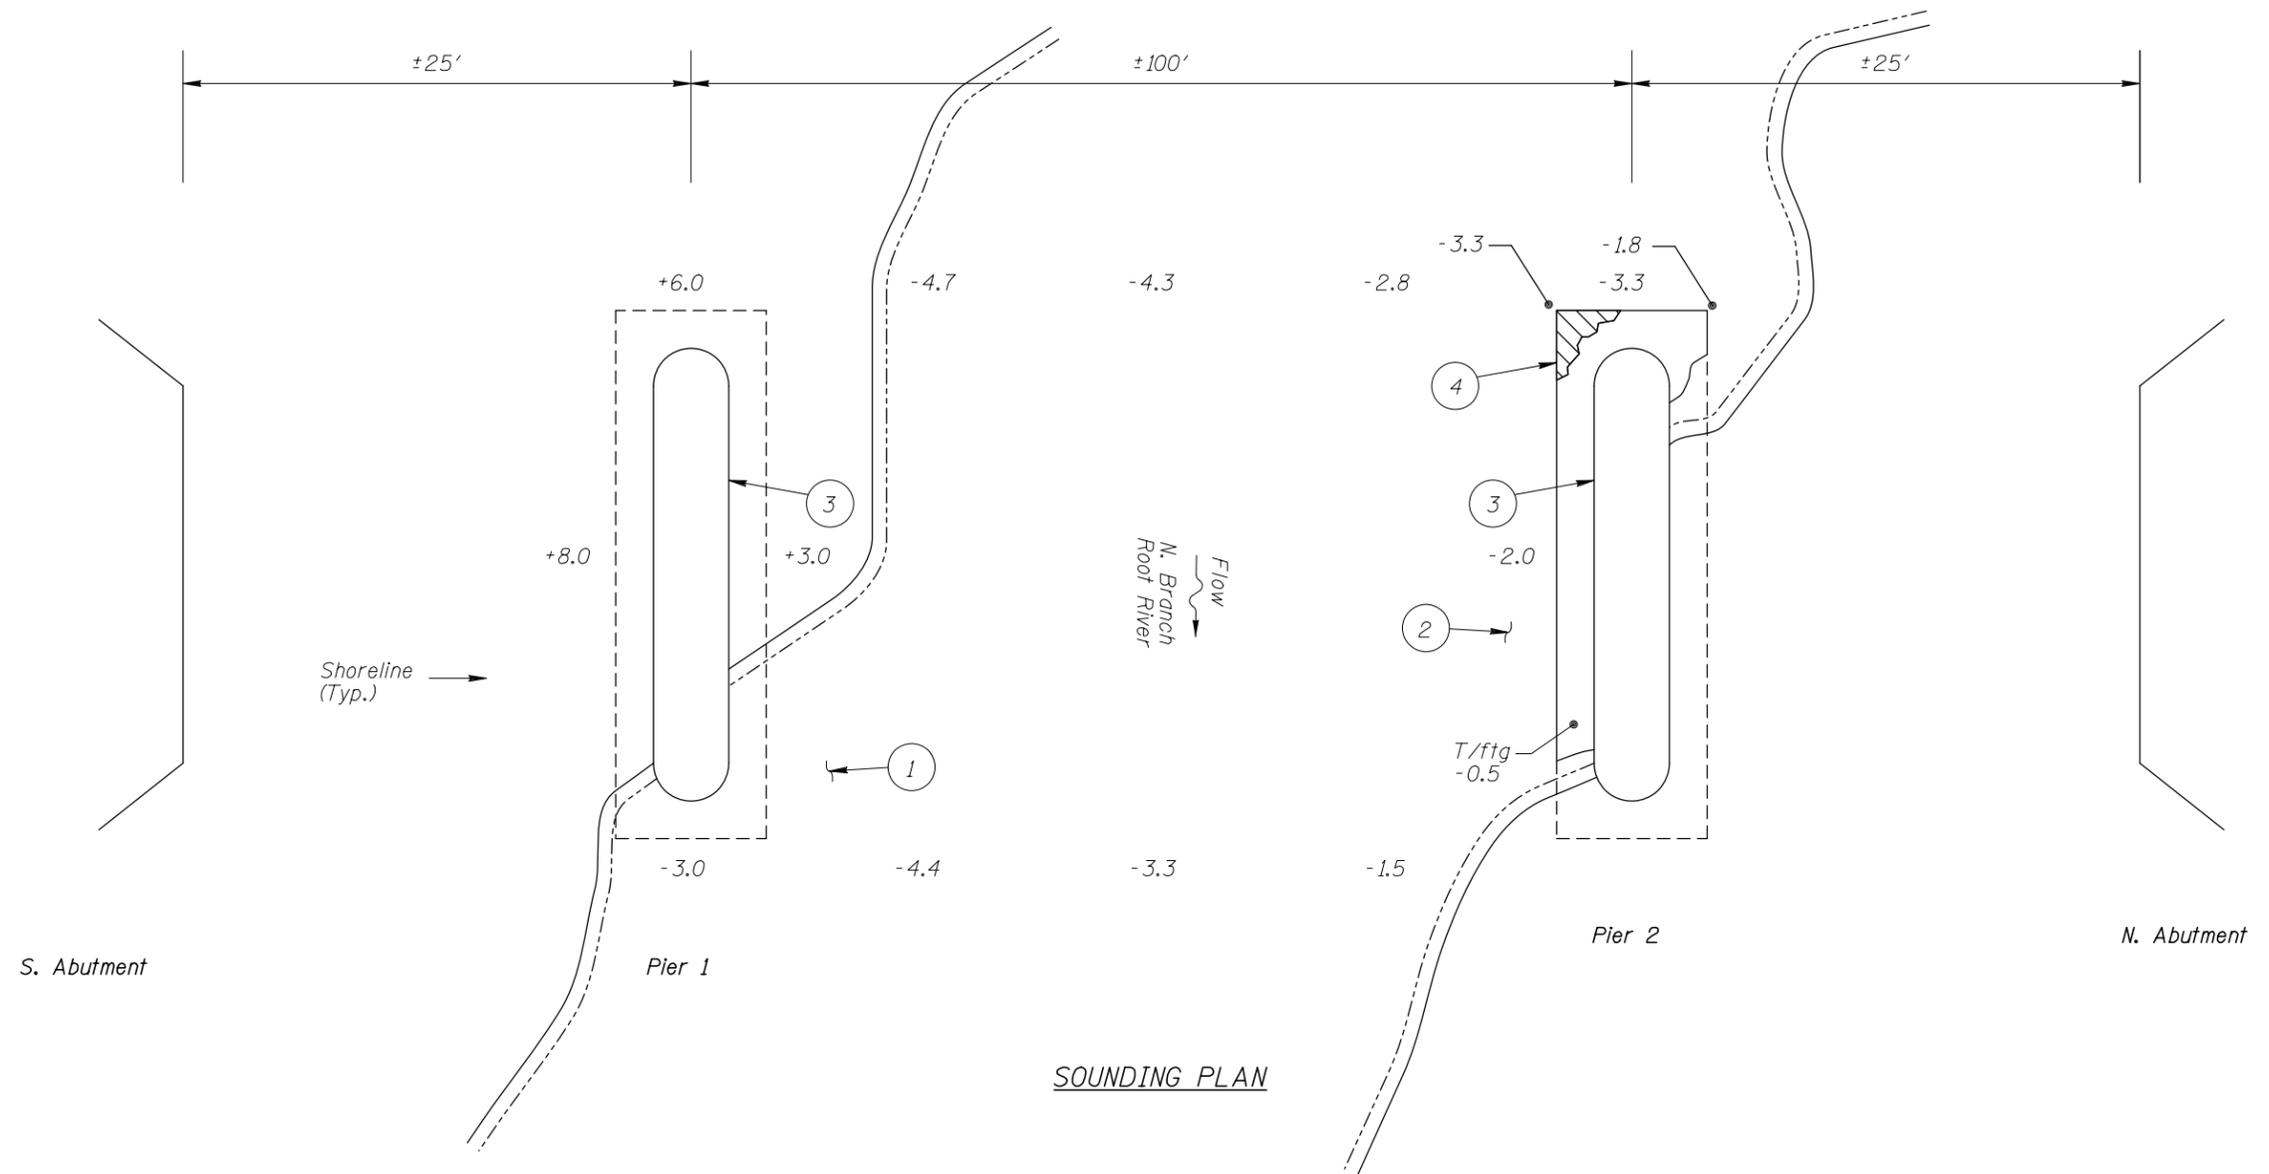
**SOUNDING PLAN**

- 1 The channel bottom material consisted of 1 foot diameter and smaller rocks allowing no probe rod penetration.
- 2 The channel bottom material consisted of soft silt allowing a maximum probe rod penetration of 2.5 feet.
- 3 The masonry of both piers was in good and sound condition. The mortar joints were sound and tight. The face of the masonry bricks exhibited minor surface weathering.
- 4 The footing of Pier 2 was exposed along the south face and the upstream end of the pier. The footing was exposed with a maximum vertical face exposure of 2.5 feet (the height of the footing). The footing was undermined 4 feet north and east of the southwest corner measuring a maximum vertical height of 3 inches and allowing up to 1.5 feet of horizontal penetration. The channel bottom material within the undermining cavity consisted of soft silt allowing up to 2 feet of penetration.
