UNDERWATER BRIDGE INSPECTION REPORT

STRUCTURE NO. L2510
MUN 41 (GRANT ST.)
OVER THE
NORTH BRANCH OF ZUMBRO RIVER
GOODHUE COUNTY

SEPTEMBER 12, 2012
PREPARED FOR THE
MINNESOTA DEPARTMENT OF TRANSPORTATION
BY
COLLINS ENGINEERS, INC.
JOB NO. 7423

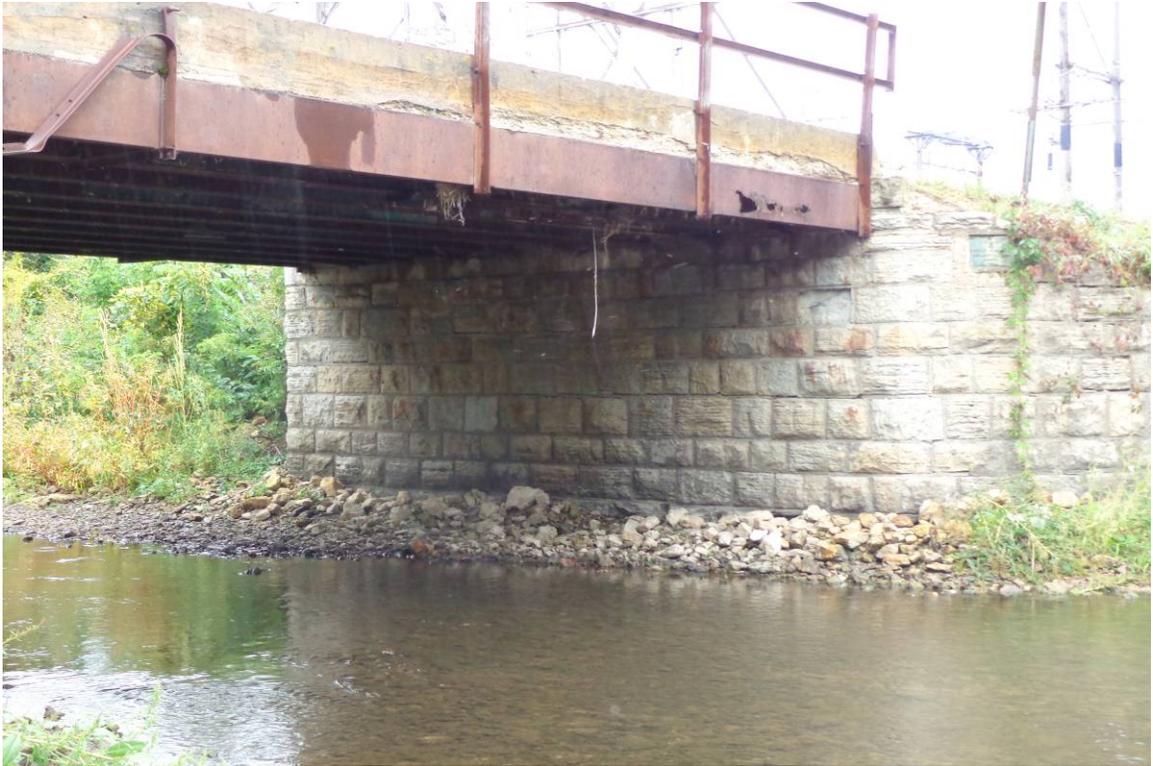
Photograph 1. View of East Abutment, Looking Northeast.

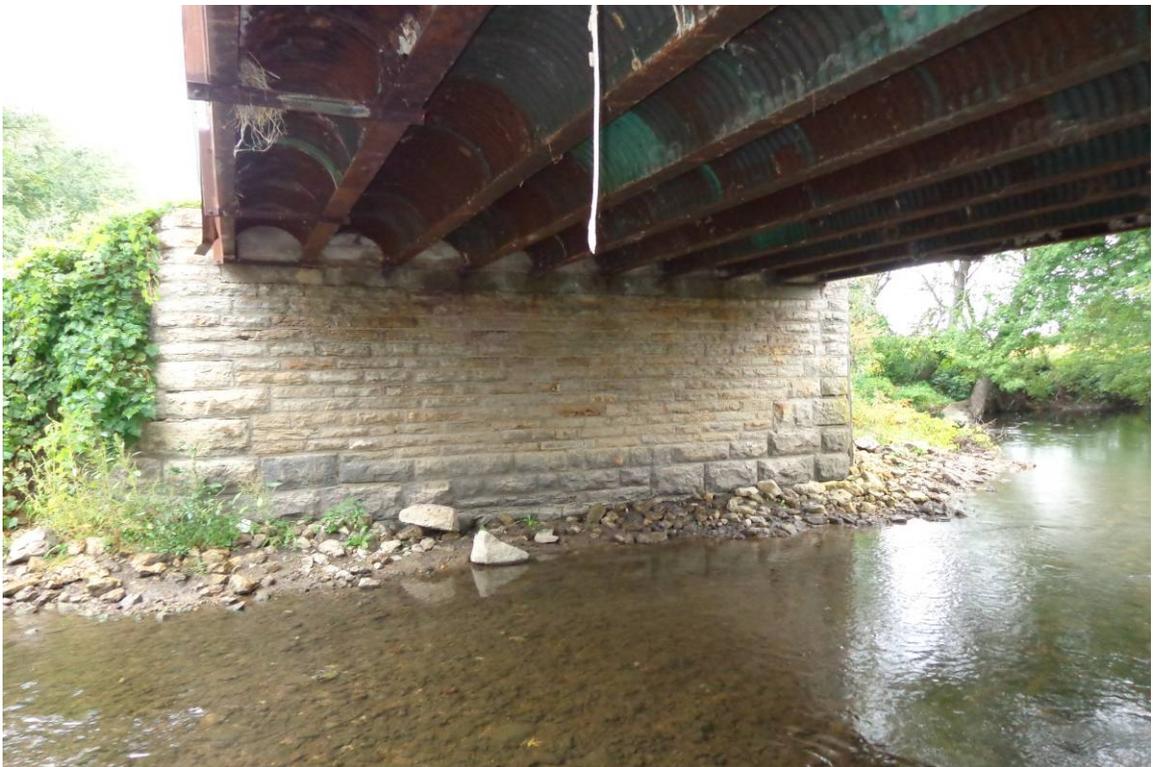
Photograph 2. View of West Abutment, Looking West.

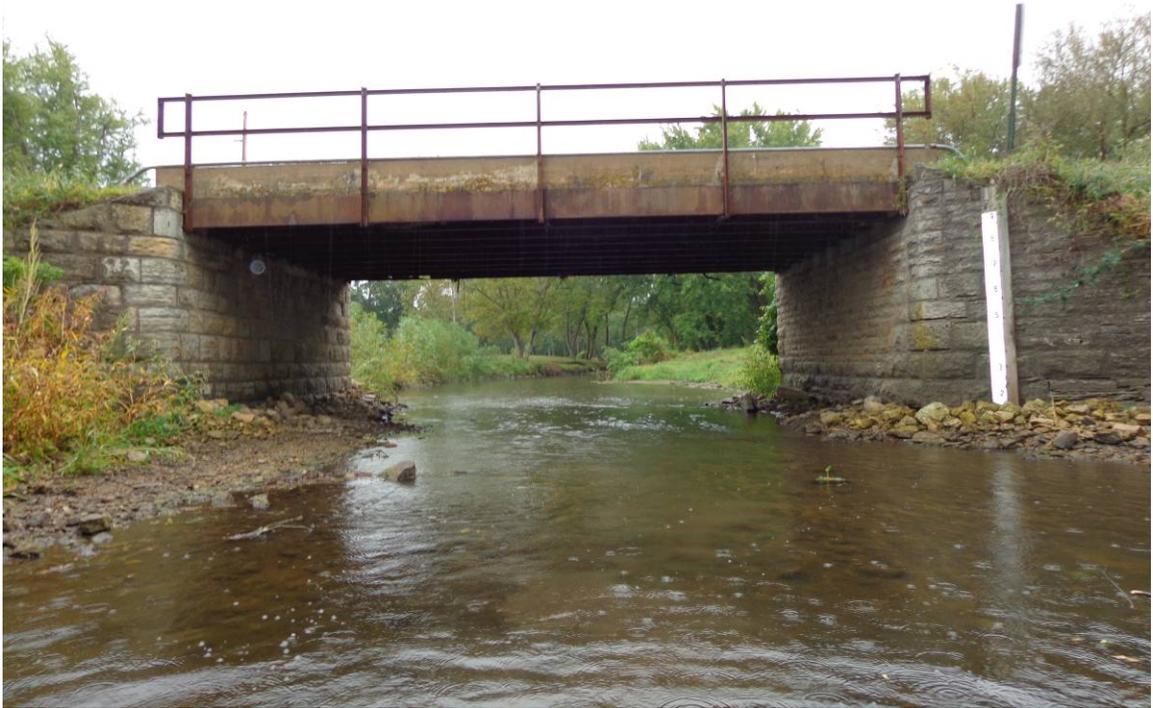
Photograph 3. Overall View of the Structure, Looking South.

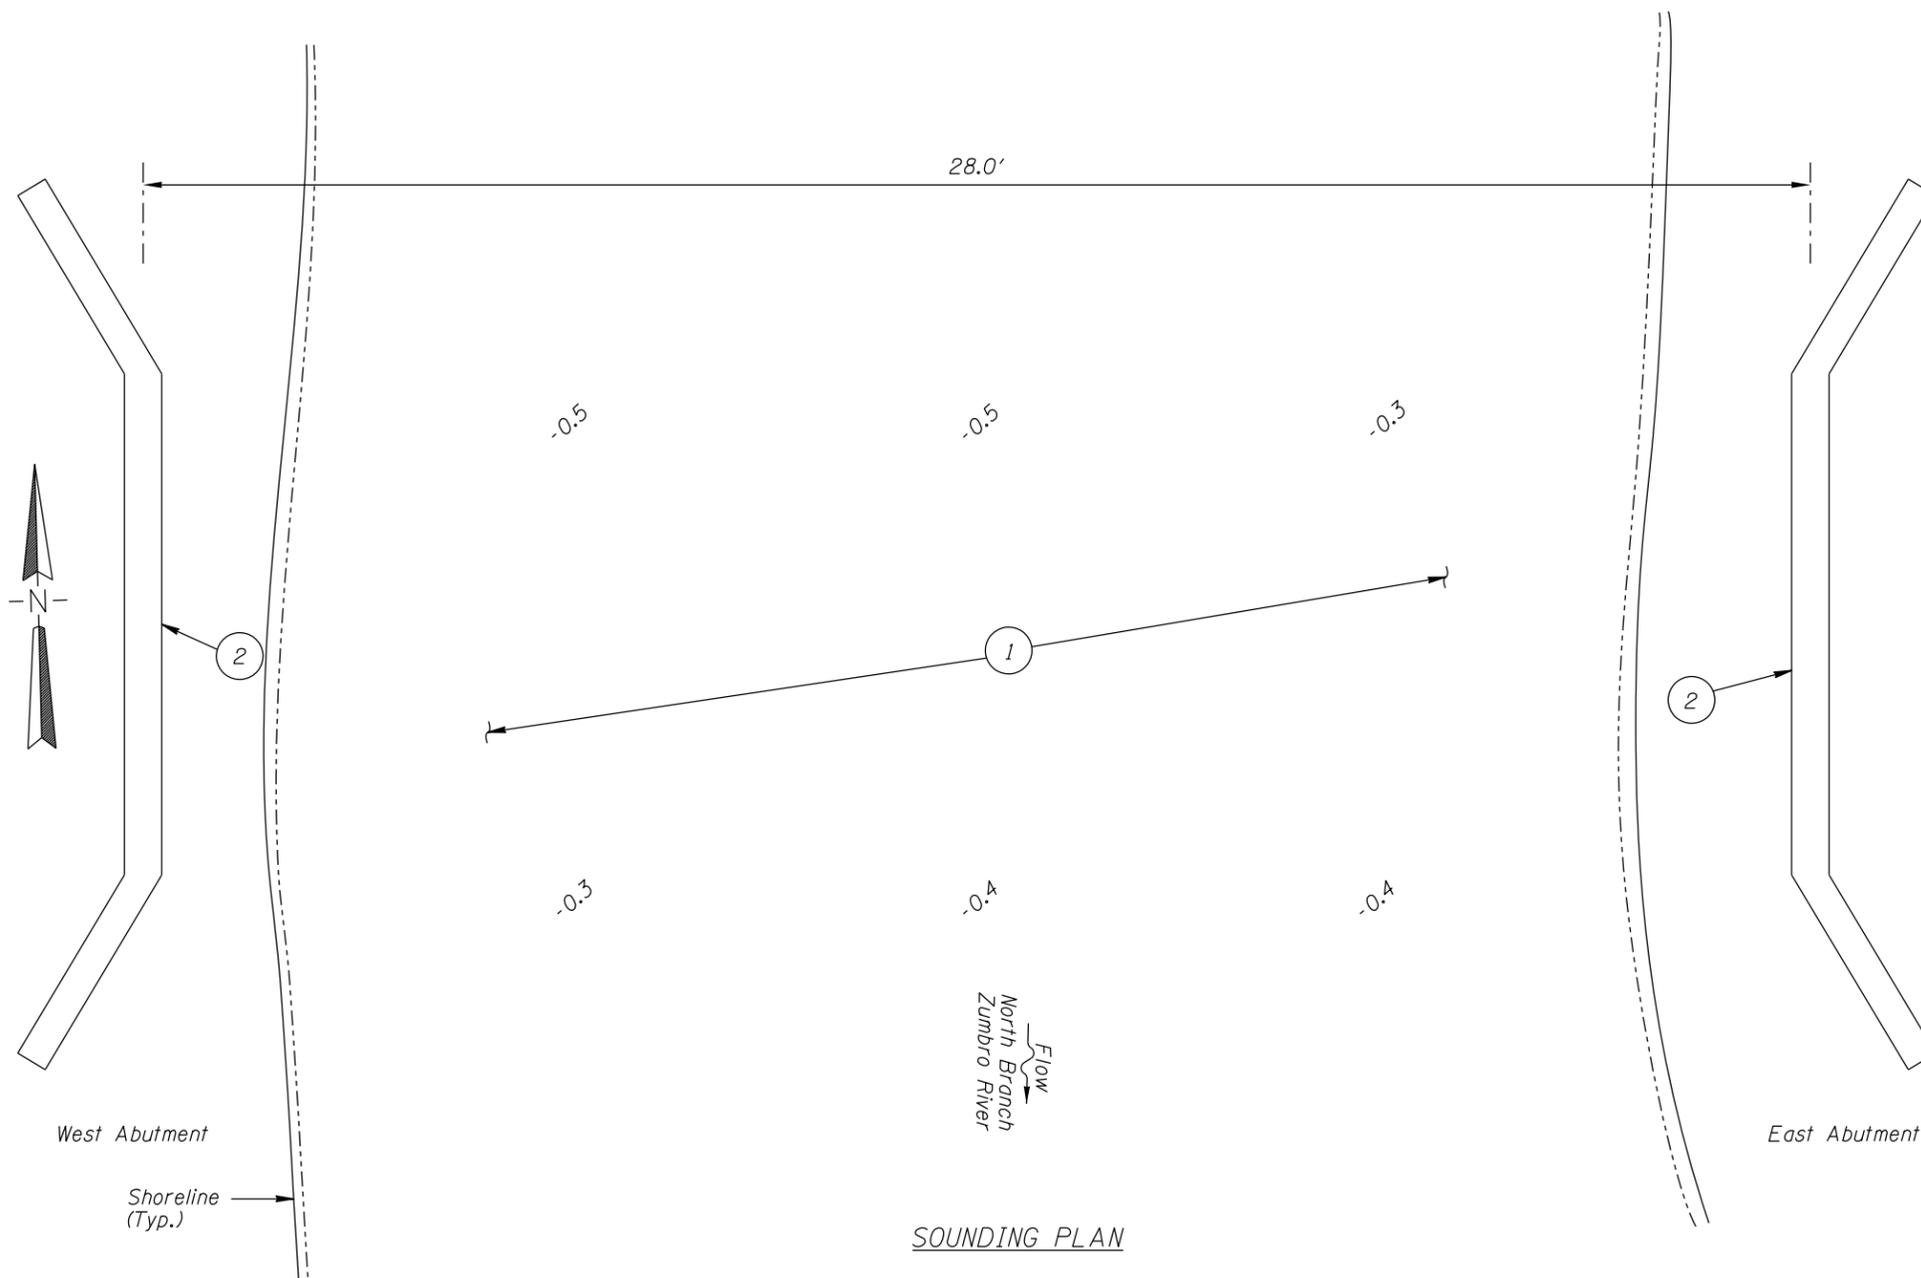
INSPECTION AND SOUNDING PLAN

- ① The channel bottom material consisted of 6 to 8 inch diameter cobbles.
- ② The masonry up to the assumed waterline was typically in good condition with some cracking of the grout and at times minor loss of joint mortar.

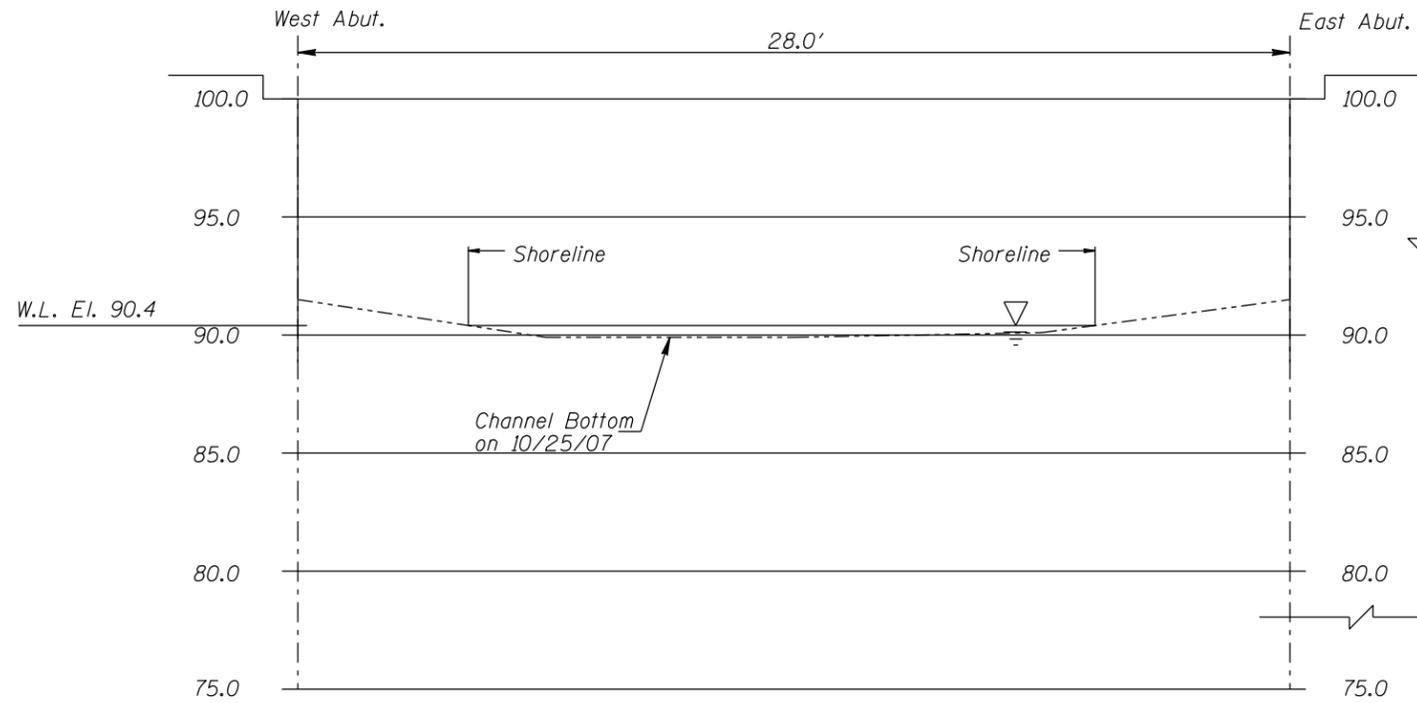
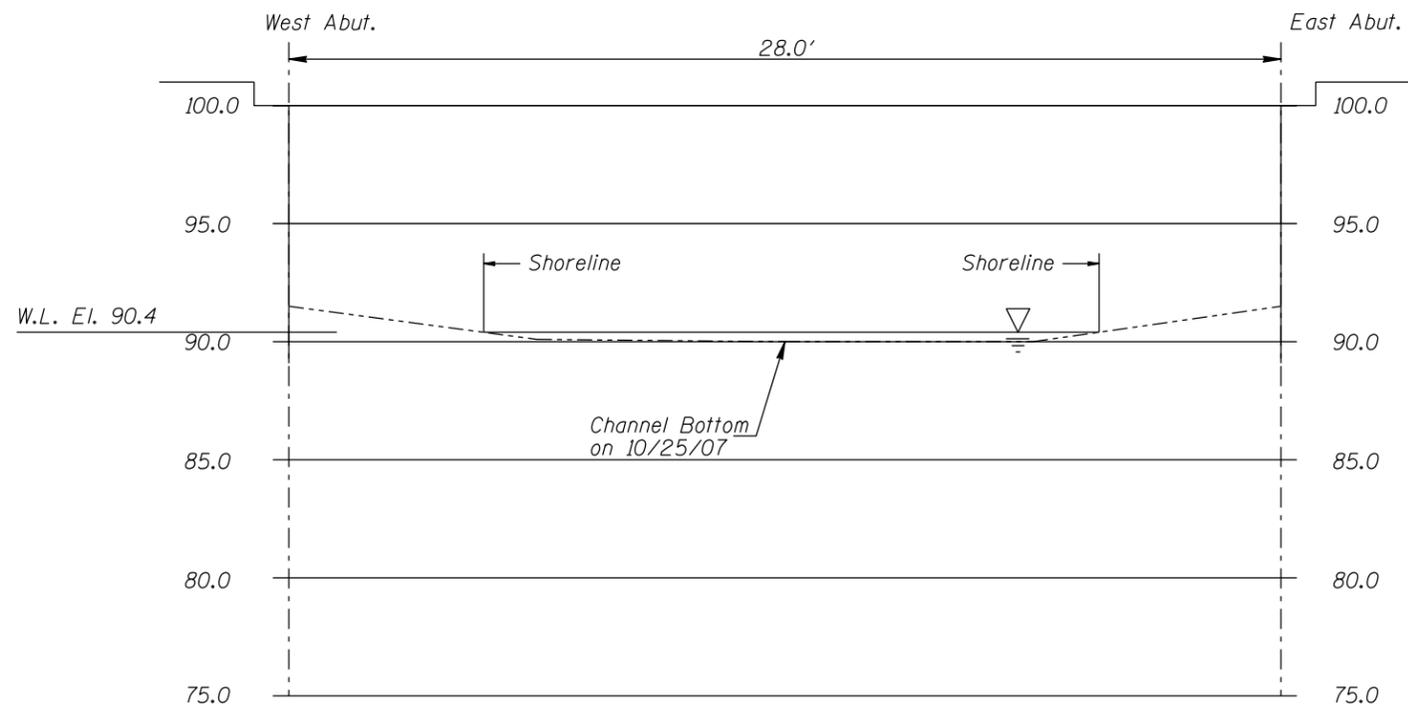
UPSTREAM FASCIA PROFILE
Vertical Scale: 1/8" = 1'-0"

DOWNSTREAM FASCIA PROFILE
Vertical Scale: 1/8" = 1'-0"
