# 2016 UNDERWATER BRIDGE INSPECTION REPORT

## BRIDGE # 55520 CSAH 12 over ZUMBRO RIVER

Date of Inspection: 11/16/2016

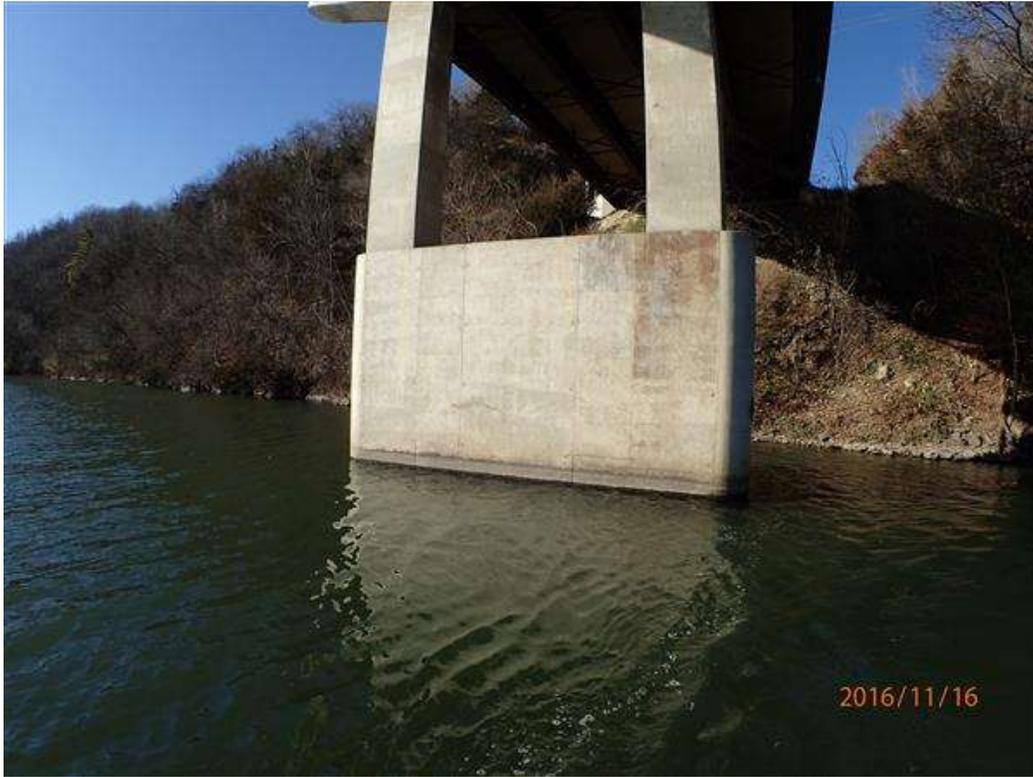
220	Reinforced Concrete Pile Cap/Footing	Underwater	12/27/2016	1 LF	0	1	0	0
Notes: [2016 Underwater] - The footing was exposed on all faces of Pier 1 with a maximum vertical face exposure of 2.5 foot. The surface of the footing was rough with 6 to 12 inch diameter irregularities.

Photo 5 - View of Pier 1, looking west.

- (A) Monitor the extent of footing exposure at Pier 1 during future underwater inspections.
- (B) Reinspect the submerged substructure units at the normal maximum recommended (NBIS) interval of sixty (60) months.

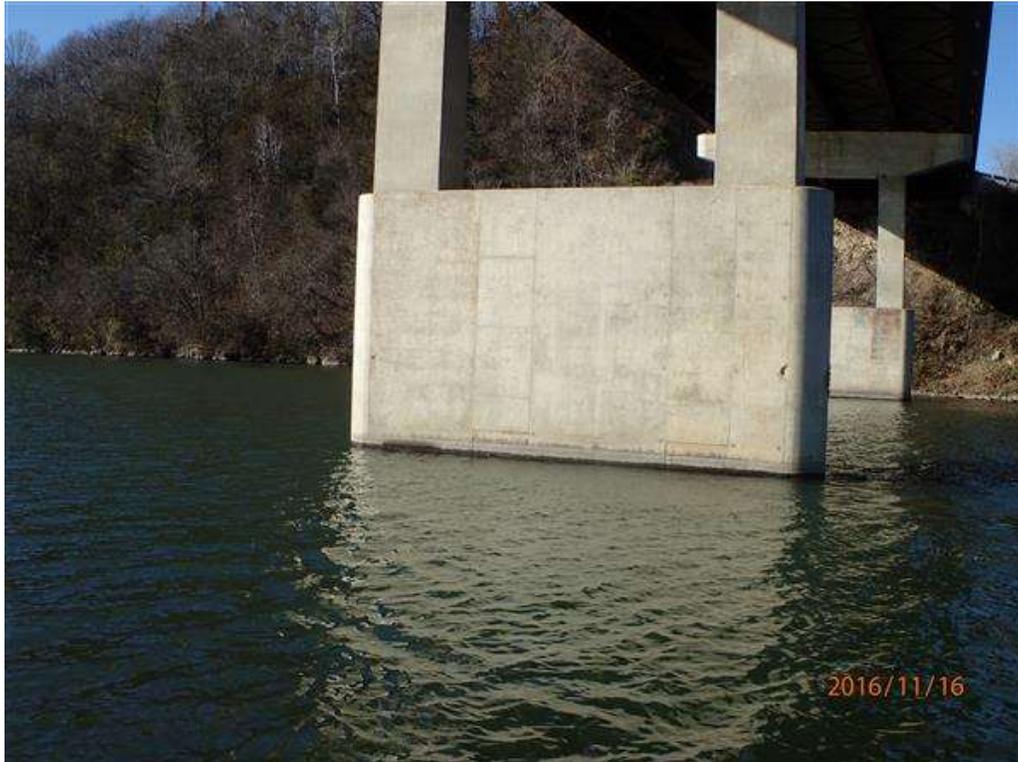
Photo 6 - View of Pier 2, looking west.

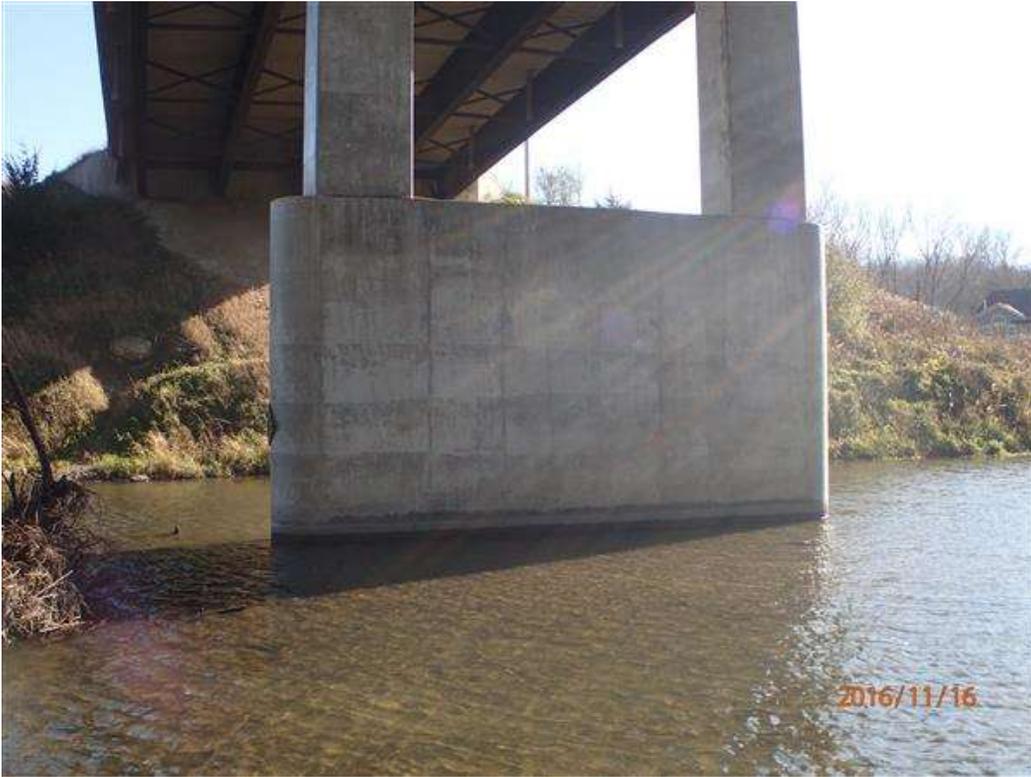
Photo 7 - View of Pier 3, looking east.

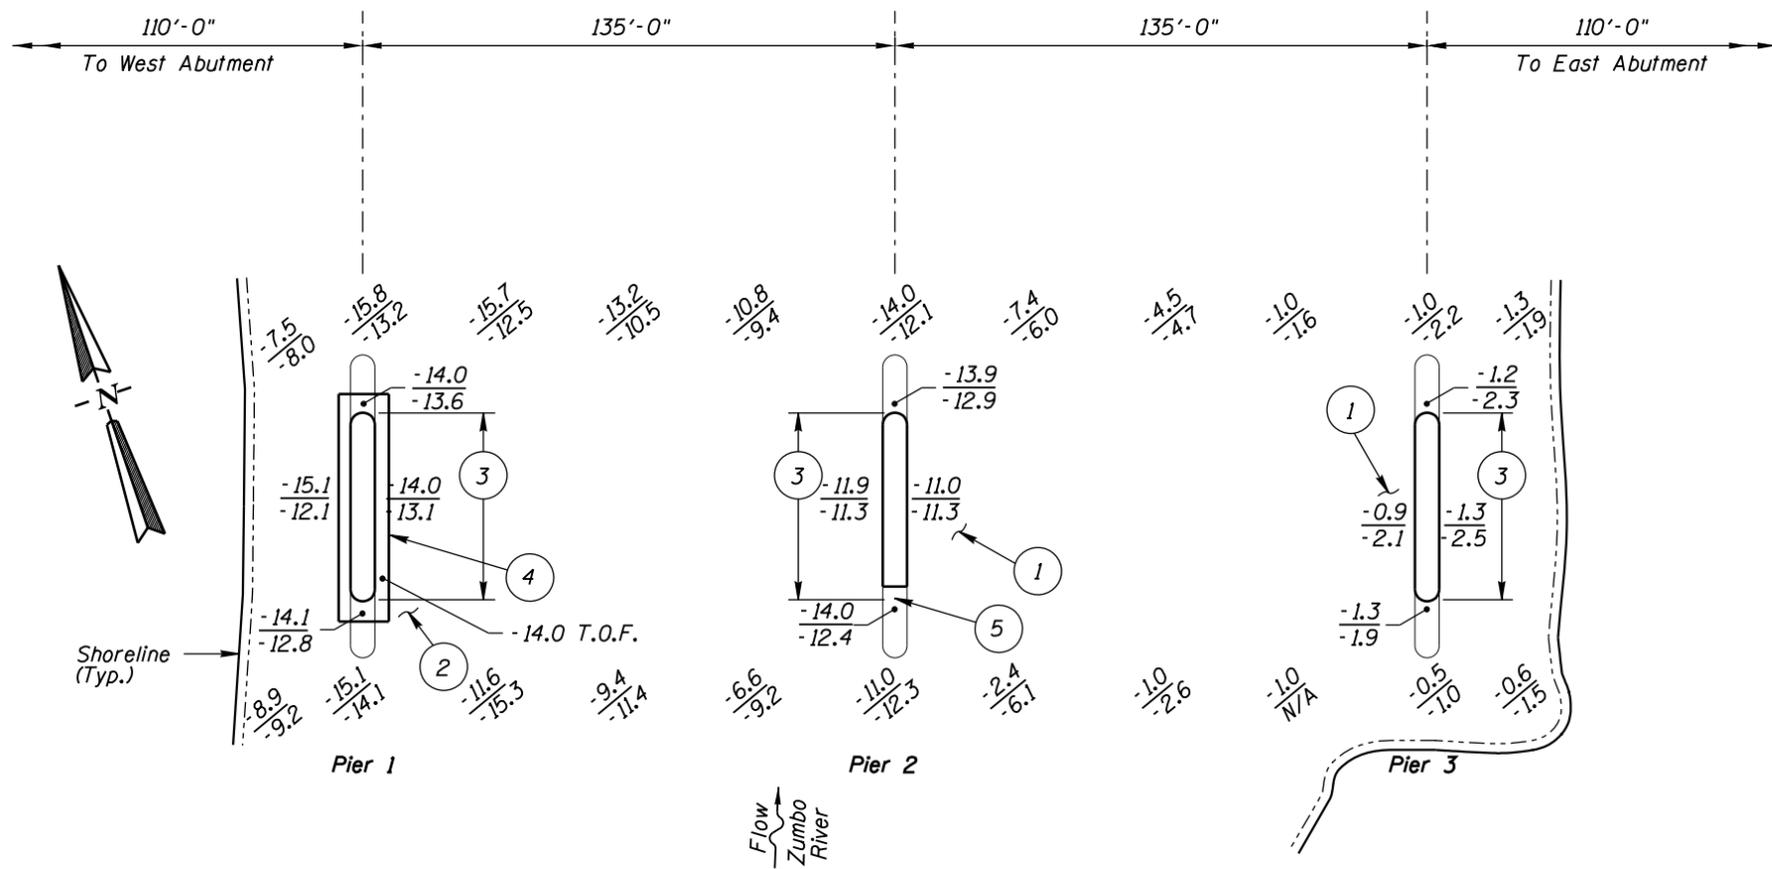
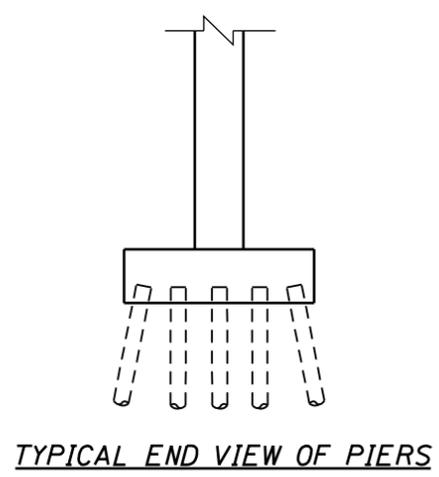
**SOUNDING PLAN**

- 1 The channel bottom around Piers 2 and 3 consisted of fine silty organics with greater than 2 feet of probe rod penetration.
- 2 The channel bottom material around Pier 1 consisted of 6 to 12 inches of soft silt over firm clay.
- 3 Minor voids due to poor consolidation of the concrete were observed at various locations along the piers, typically up to 1 inch in diameter with up to 1/2 inch of penetration.
- 4 The footing was exposed on all faces of Pier 1 with a maximum vertical face exposure of 2.5 foot. The surface of the footing was rough and irregular.
- 5 The upstream nose of Pier 2 stops at 6.5 feet below water and cuts back 1.5 feet.
