2016 UNDERWATER BRIDGE INSPECTION REPORT

BRIDGE # 6564 CSAH 11 over ZUMBRO RIVER

DISTRICT: District 6 COUNTY: Wabasha CITY/TOWNSHIP: Hammond
STATE: Minnesota

Date of Inspection: 07/25/2016

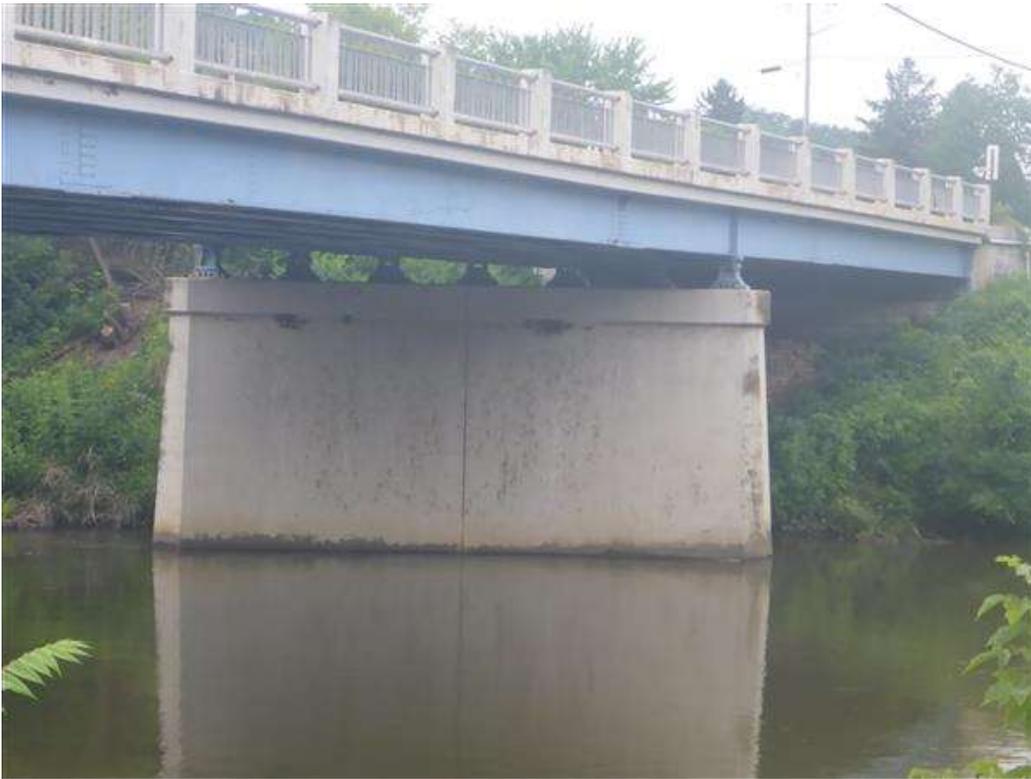
Photo 3 - Typical View of Pier 1 Looking Southwest

- ② The channel bottom material consisted of silty sand and gravel allowing 3 inches of probe rod penetration.
- ③ Moderate accumulation of timber debris, consisting of 1 foot diameter and smaller drift pieces, was observed from the channel bottom to 2 feet below the waterline between the shore and the west face of Pier 1.

- ④ The footing was partially exposed from the northwest corner of Pier 1 around the upstream nose to the upstream 1/4-point along the east face of the pier with a maximum vertical face exposure of 1.8 feet. The top of the footing was located at approximately 6.8 feet below the water surface.

- (A) Monitor the extent of footing exposure as well as timber debris accumulation during future underwater inspections.
- (B) Reinspect the submerged substructure units at the normal maximum recommended (NBIS) interval of sixty (60) months.

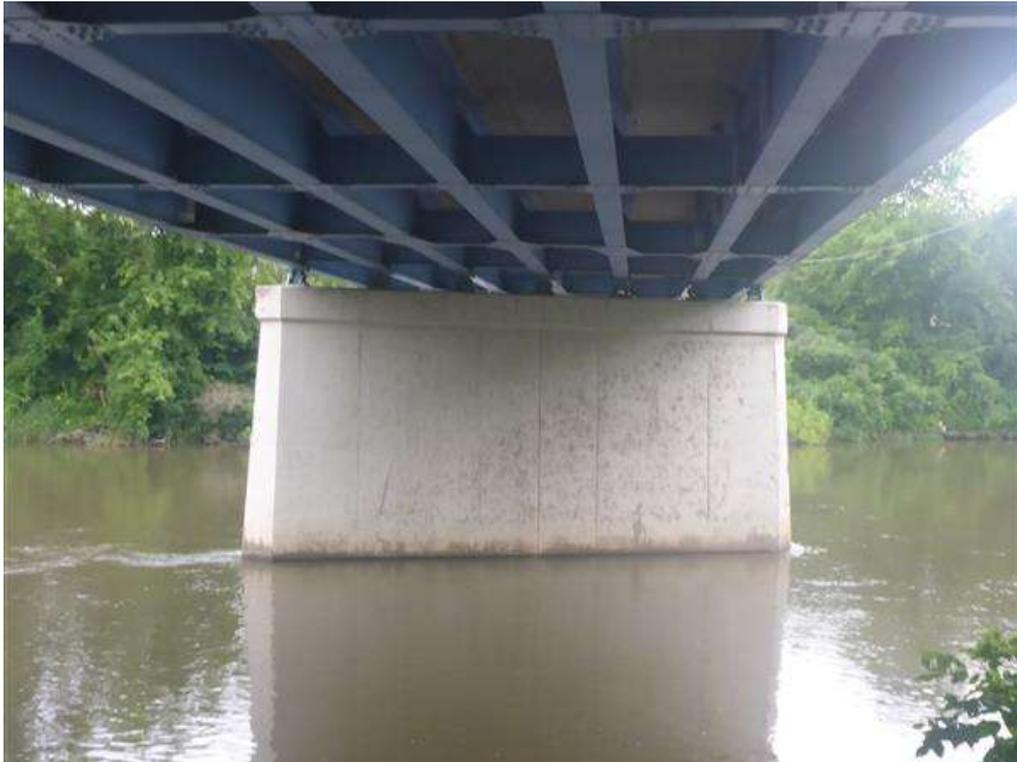
Photo 4 - Typical View of Pier 2 Looking West

Structure No. 6564, was found to be generally in good condition with no defects of structural significance observed below the water. The channel bottom was silty sand and gravel. Pier 1 had timber debris accumulation present along the west face of the pier extending up to 5 feet above the waterline. Partial footing exposure was observed near the upstream end of Pier 1 with a maximum vertical face exposure of 1.5 feet. Pier 2 exhibited a scour depression at the upstream nose with a maximum depth of 2 feet.

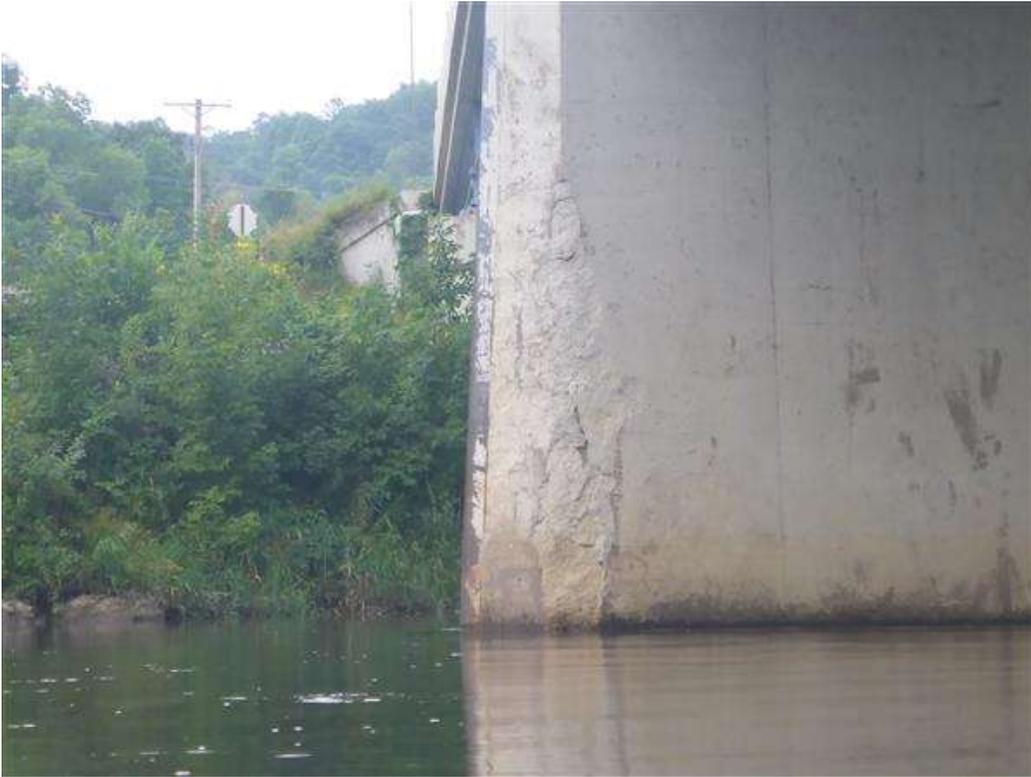
Photo 5 - View of Spall Noted at Pier 2 Looking East

- ⑤ An 18 inch wide by 10 foot vertical corner spall up to 2 inches deep with exposed rebar extended 9 inches below the waterline.

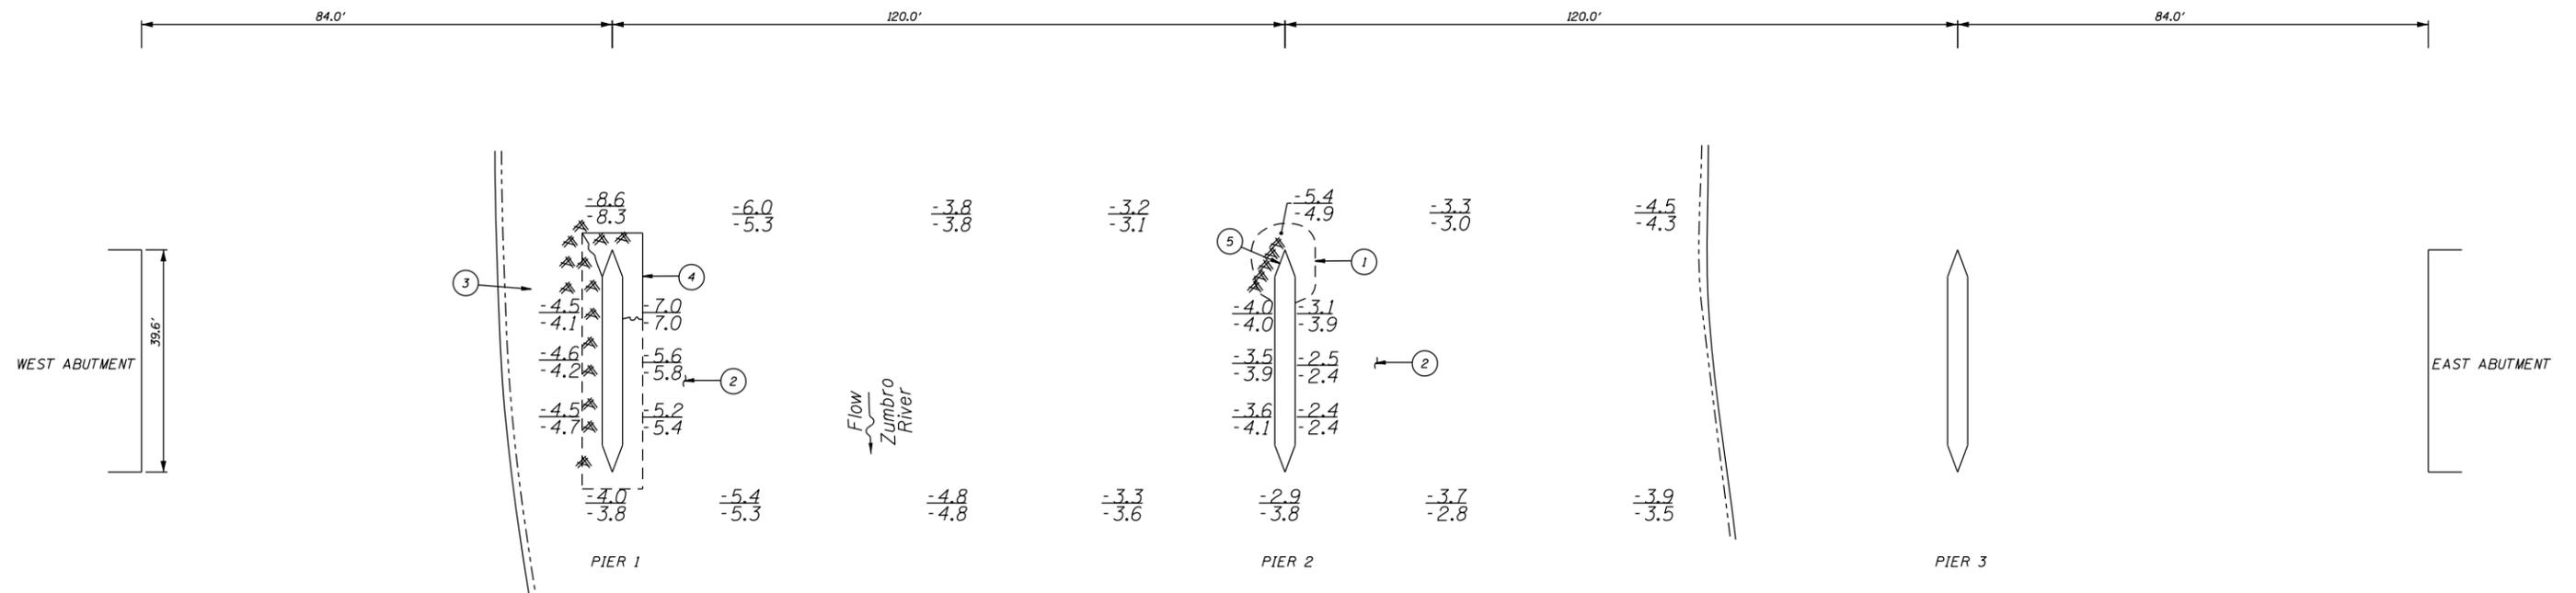
END VIEW OF PIER

- ① There was a 3 foot radius by 2 foot deep scour depression at the upstream nose of Pier 2. There was also a single 8 inch diameter log present in the depression.
