# 2016 UNDERWATER BRIDGE INSPECTION REPORT

## BRIDGE # 66520 TWP 51 over STRAIGHT RIVER

Date of Inspection: 05/25/2016

Contractor: Collins Engineers, Inc.

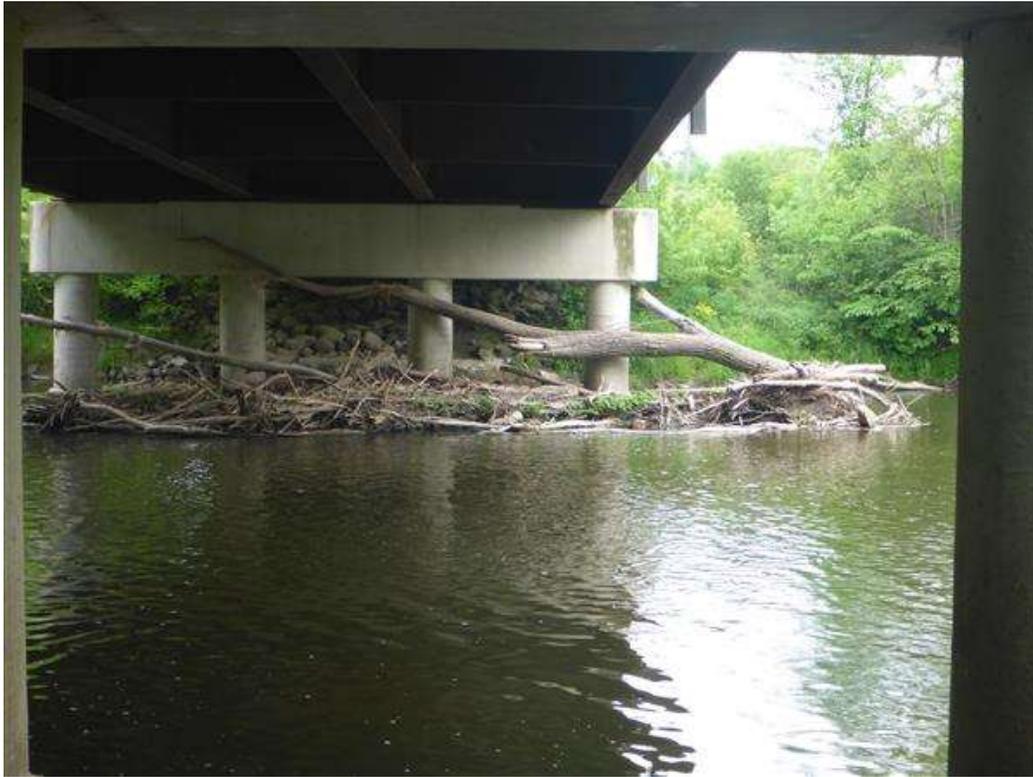
Photo 3 - Pier 1 and Timber Debris, Looking East

(F) Timber debris up to 5 inches in diameter is present near the upstream piles of Pier 1.

- 5 A hard bottom was found up to 3 feet to the east upstream end of Pier 2.
- 6 Timber debris up to 5 inches in diameter is present near the upstream piles of Pier 1.

(B) Remove timber debris at the piers.

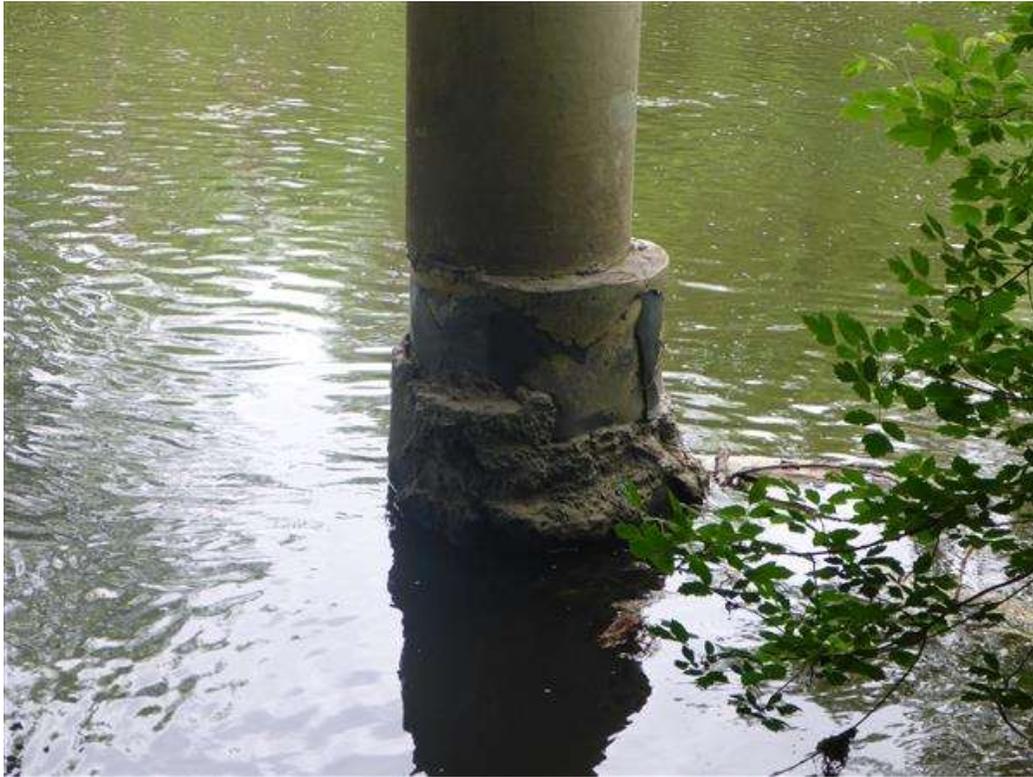
Photo 5 - Spalling on Upstream Pile of Pier 1, Looking East

(C) The columns of Pier 1 were encased in up to 6 inches of additional concrete from the channel bottom to 2.8 feet above the waterline. The encasements exhibited form irregularities (embedded form boards) and spalling with up to 6 inches of penetration.

- 3 The columns of Pier 1 were encased in up to 6 inches of additional concrete from the channel bottom to 2.8 feet above the waterline. The encasements exhibited form irregularities (embedded form boards) and spalling with up to 6 inches of penetration.

(A) Monitor concrete deterioration at the concrete column encasements during future underwater inspections.

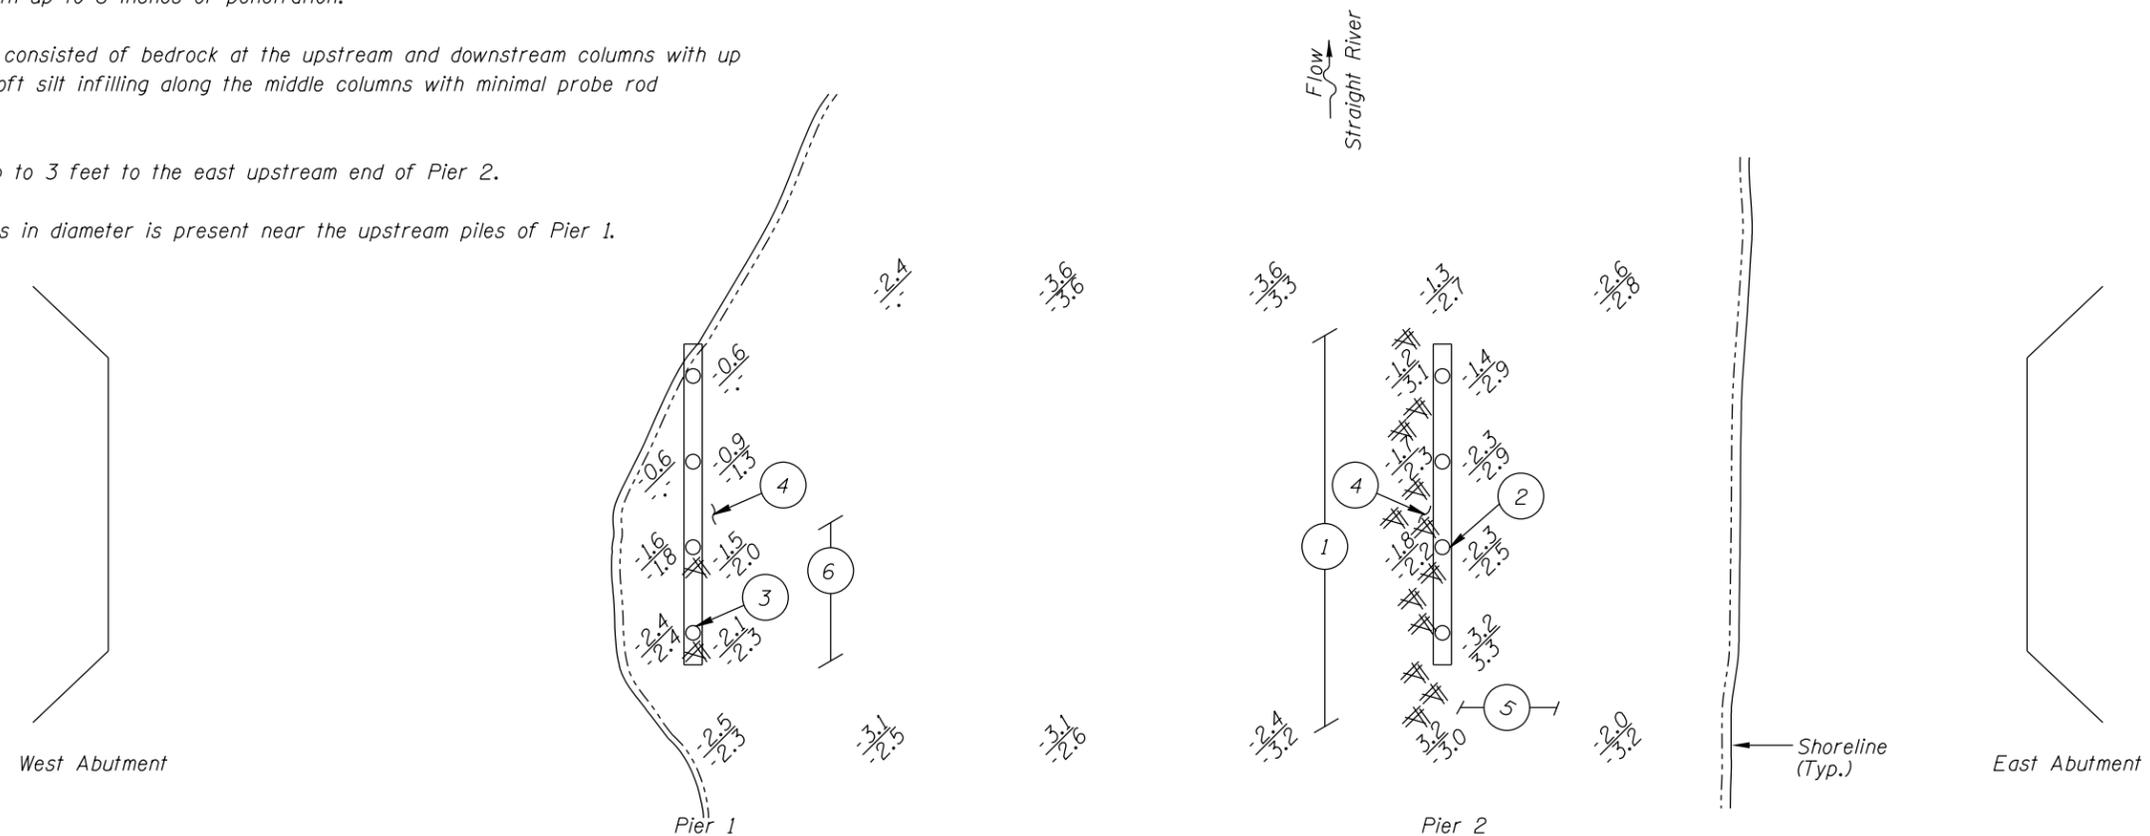
SOUNDING PLAN

- 1 Timber debris was observed along the west face of Pier 2 that consisted of a full tree and smaller branches and extended from the channel bottom to the bottom of the cap.

- 2 The columns of Pier 2 were encased in up to 6 inches of additional concrete from the channel bottom to 1.1 feet above the waterline. The encasements exhibited form irregularities (embedded form boards) and spalling with up to 3 inches of penetration.

- 4 The channel bottom material consisted of bedrock at the upstream and downstream columns with up to 2 inches of gravel and soft silt infilling along the middle columns with minimal probe rod penetrations.
