2016 UNDERWATER BRIDGE INSPECTION REPORT

BRIDGE # 66547 2 AVE NW(MSAS 123) over CANNON RIVER

DISTRICT: District 6 **COUNTY:** Rice **CITY/TOWNSHIP:** Faribault
STATE: Minnesota

Date of Inspection: 05/26/2016

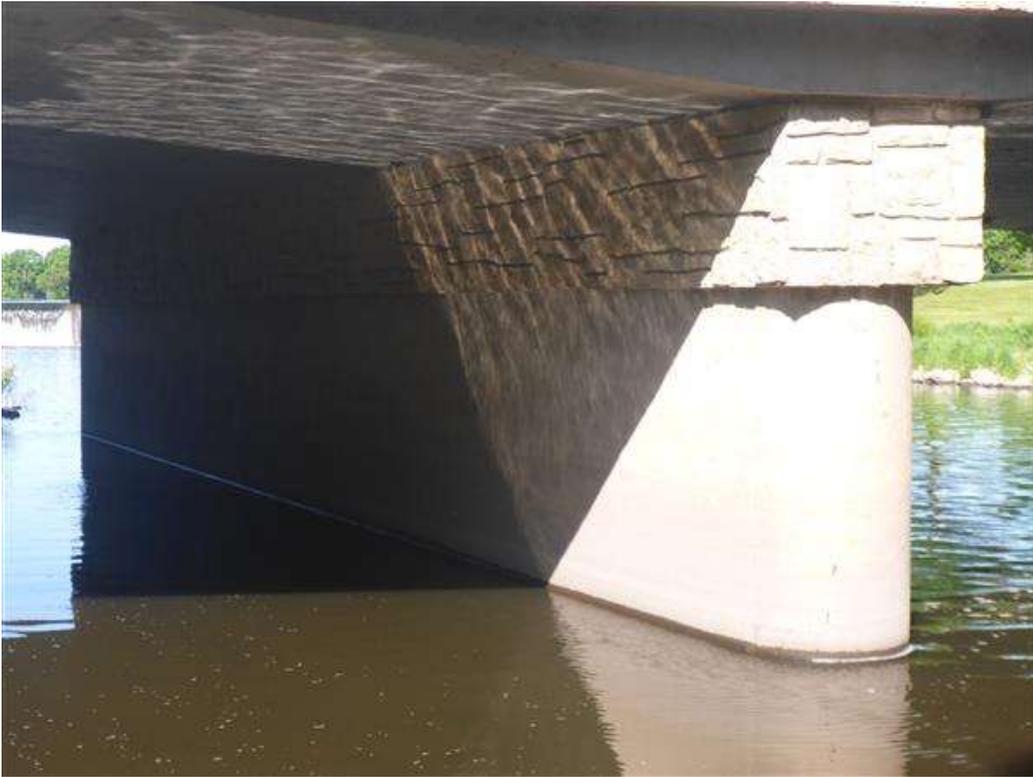
Photo 3 - Pier 1, Looking North

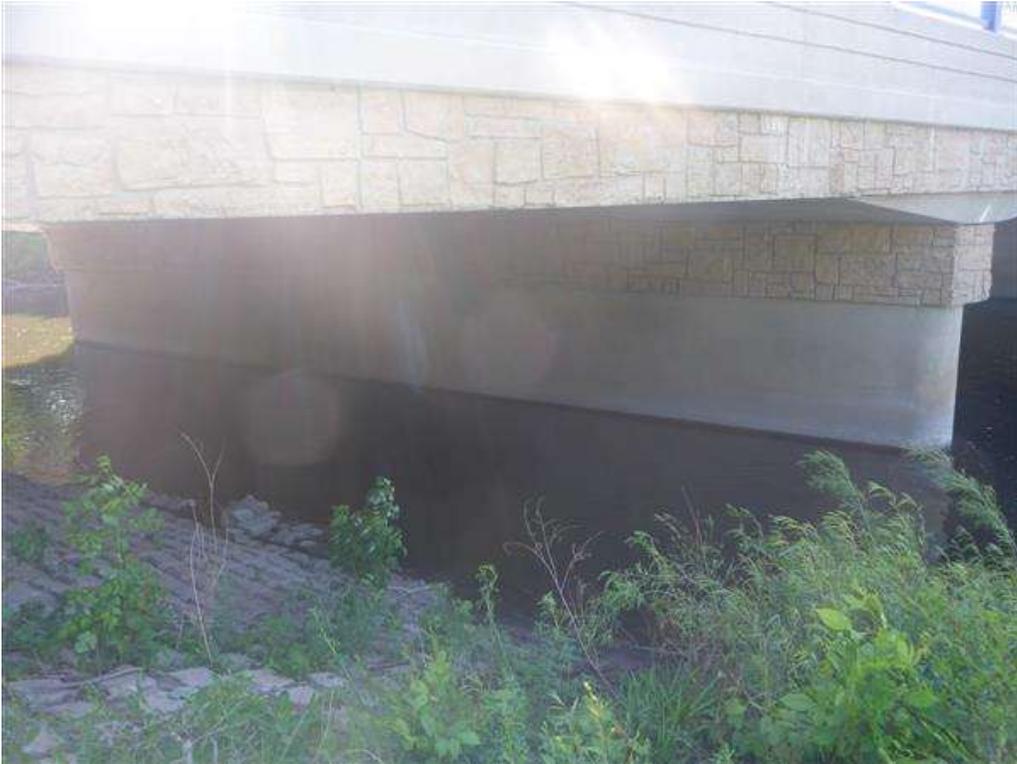
- (A) The north and south embankment slopes were lined with an articulated concrete revetment mat from top of slope to 1 foot below waterline within the immediate vicinity of the bridge.
- (B) An area of soft, heavily scaled concrete 3 feet wide with 2 inches of maximum penetration from water line up 1 foot was located near the upstream ¼ point on both faces of Pier 2.
- (C) Slope protection mat was missing many blocks in several random areas on both slopes. Largest missing section was 8 feet by 3 feet by 1 foot deep and was located on the south slope.
- (E) A 14 inch diameter log was found at the upstream end of Pier 1.
- (F) A 2.5 foot deep by 1.5 foot wide scour depression was present from downstream nose to downstream ¼ point.

Photo 4 - Typical View of Pier 2, Looking South

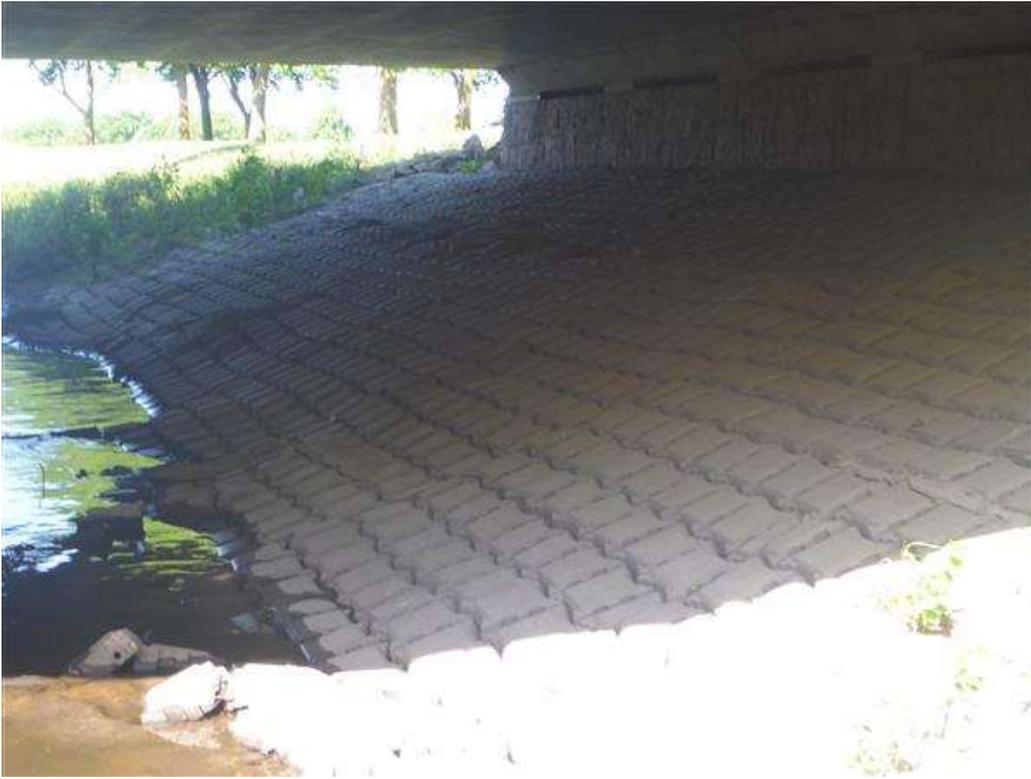
Photo 7 - Typical Slope Mat and North Bank, Looking West

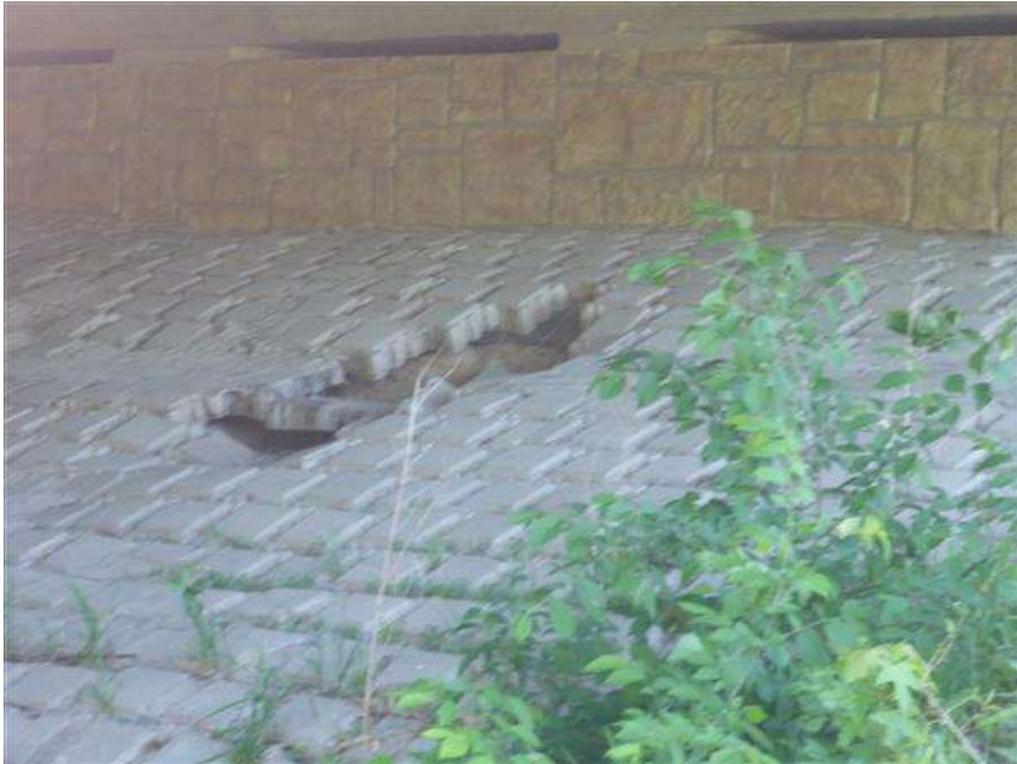
The substructure units inspected below water at Bridge No. 66547, Piers 1 and 2, were found to be generally in good condition. However, an area of soft/scaled concrete with maximum 2 inch penetration was observed along both faces of Pier 2. The remainder of the concrete was smooth and sound. A 2.5 foot deep by 1.5 foot wide scour depression was present from downstream nose to downstream ¼ point. The slope protection mat was damaged in several random areas with many missing or displaced blocks.

Photo 8 - View of Damaged Mat on South Slope, Looking South

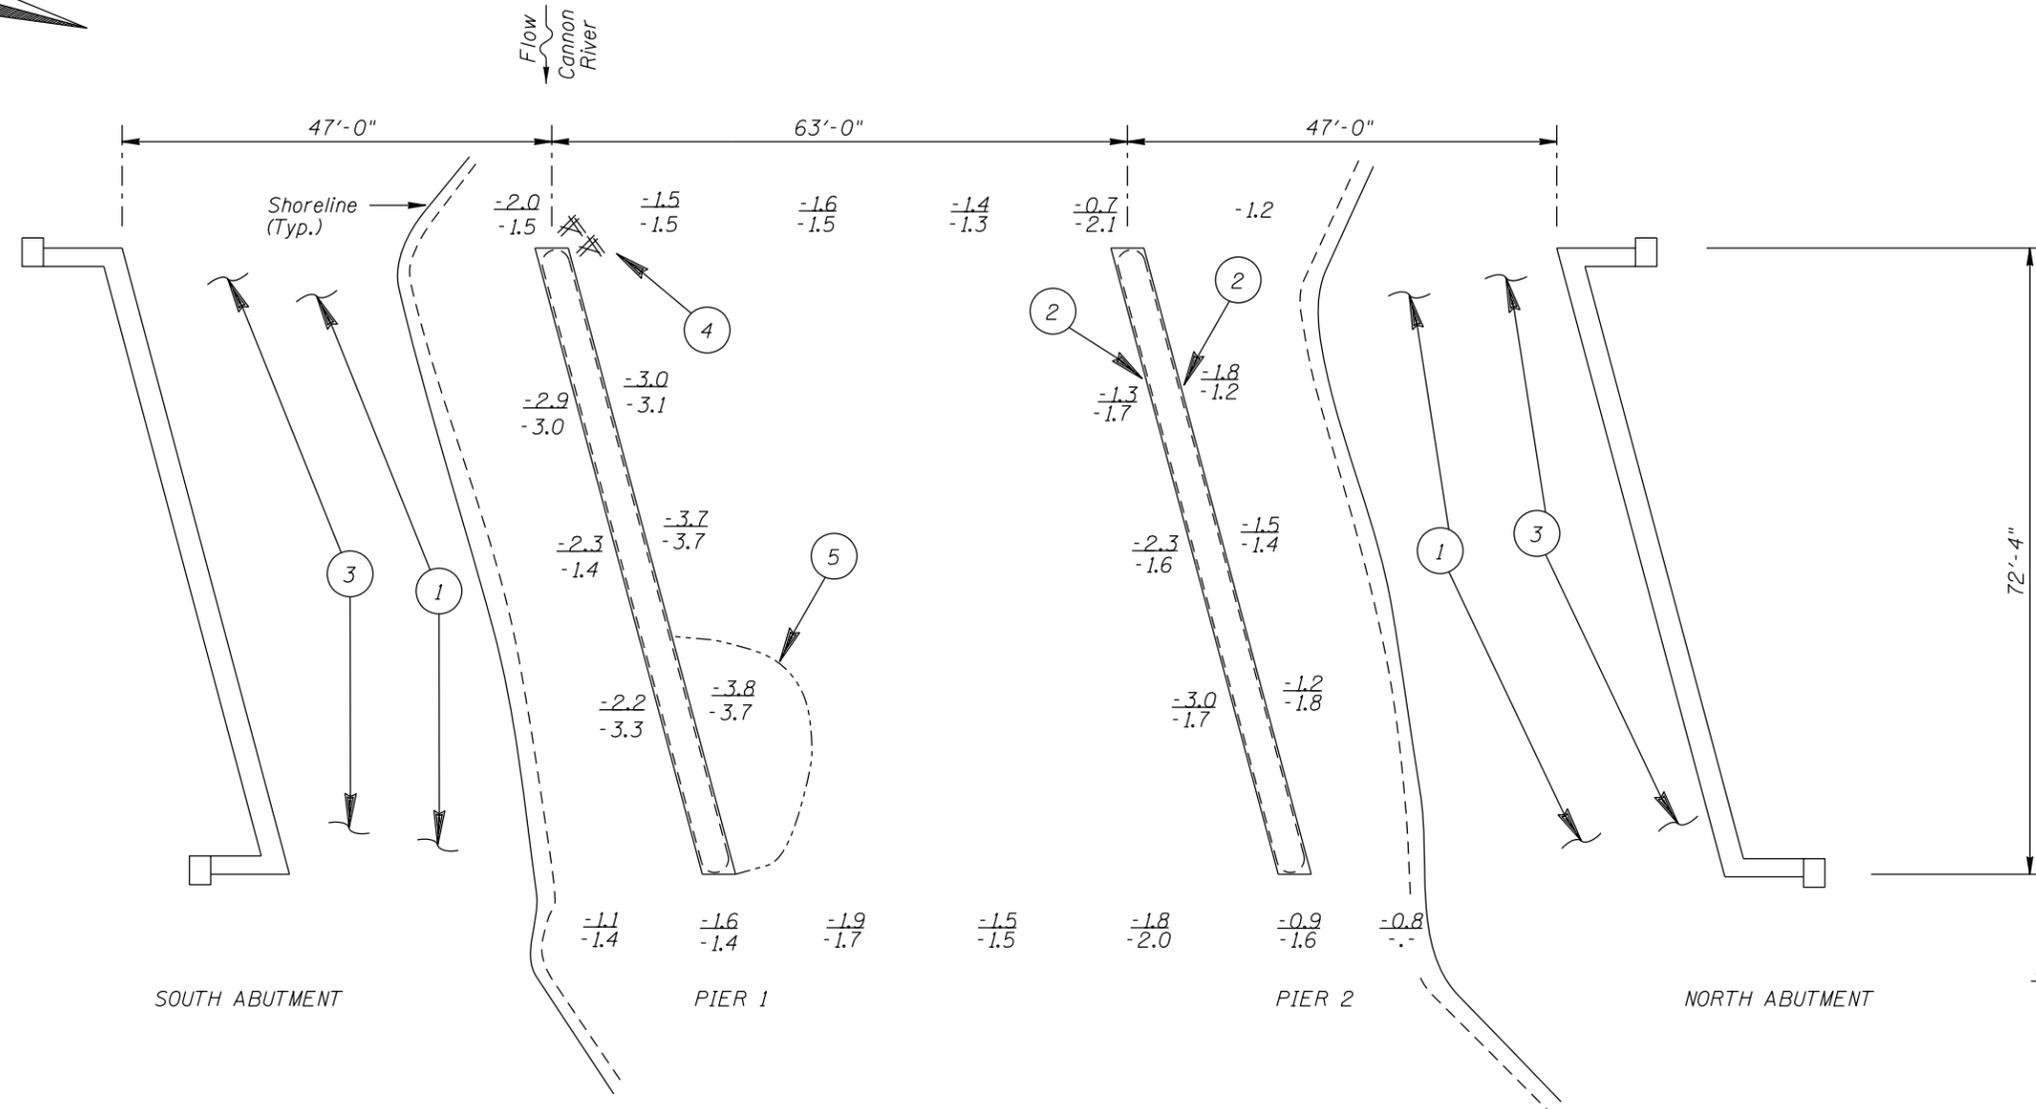
SOUNDING PLAN

- 1 The north and south embankment slopes were lined with an articulated concrete revetment mat from top of slope to 1 foot above waterline within the immediate vicinity of the bridge
- 2 An area of soft, heavily scaled concrete 3 feet wide with 2 inches of maximum penetration from water line up 1 foot was located near the upstream 1/4 point on both faces of Pier 2.
- 3 Slope protection mat missing many blocks in several random areas. Largest missing sections is 8 feet by 3 feet and 1 foot deep.
- 4 A 14 inch diameter log was found at the upstream end of Pier 1.
- 5 2.5 foot deep by 1.5 foot wide scour depression from downstream nose to downstream 1/4 point.
