2016 UNDERWATER BRIDGE INSPECTION REPORT

BRIDGE # 93153 CR 107 over MID FK WHITEWATER RIVER

Date of Inspection: 06/14/2016

Contractor: Collins Engineers, Inc.

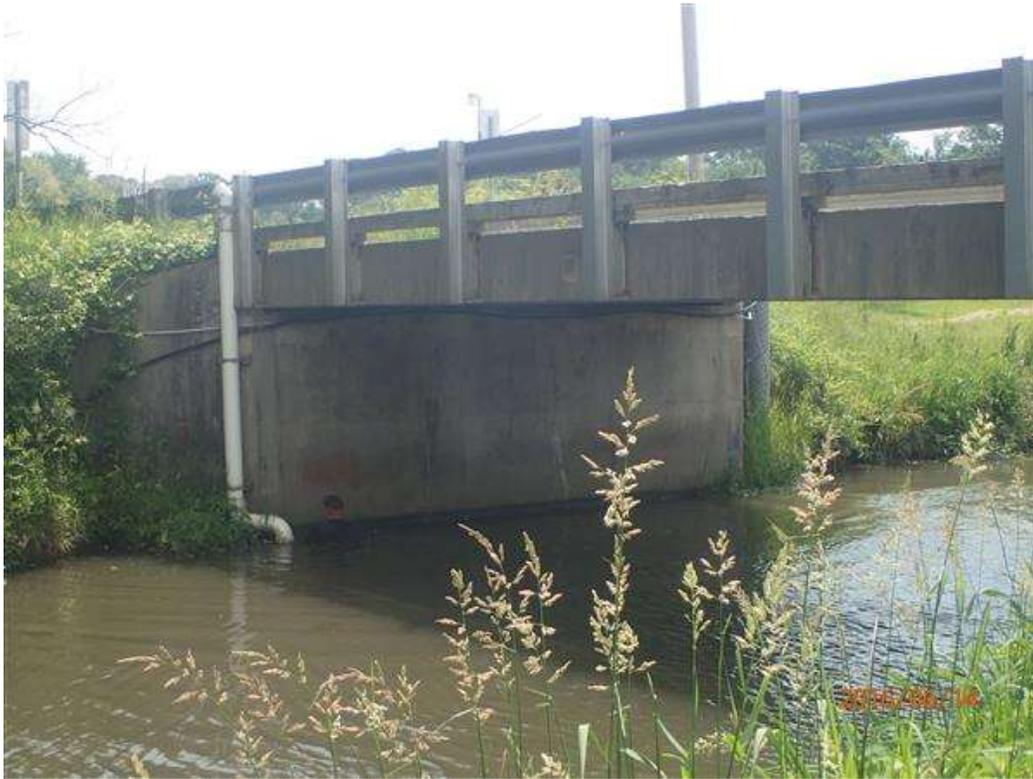
(A) The East Abutment was undermined along its entire length with the undermining cavity measuring up to 2 feet vertically with 3.5 feet of horizontal penetration. Three steel H-piles were exposed within the cavity and appeared to be in good condition.

Photo 2 - View of East Abutment, looking east.

(A) Based on the extent and severity of the undermining and evidence of loss of fill material behind the East Abutment, it is recommended that corrective action be taken to stabilize the channel bottom in the vicinity of the East Abutment and to prevent further scour/erosion.

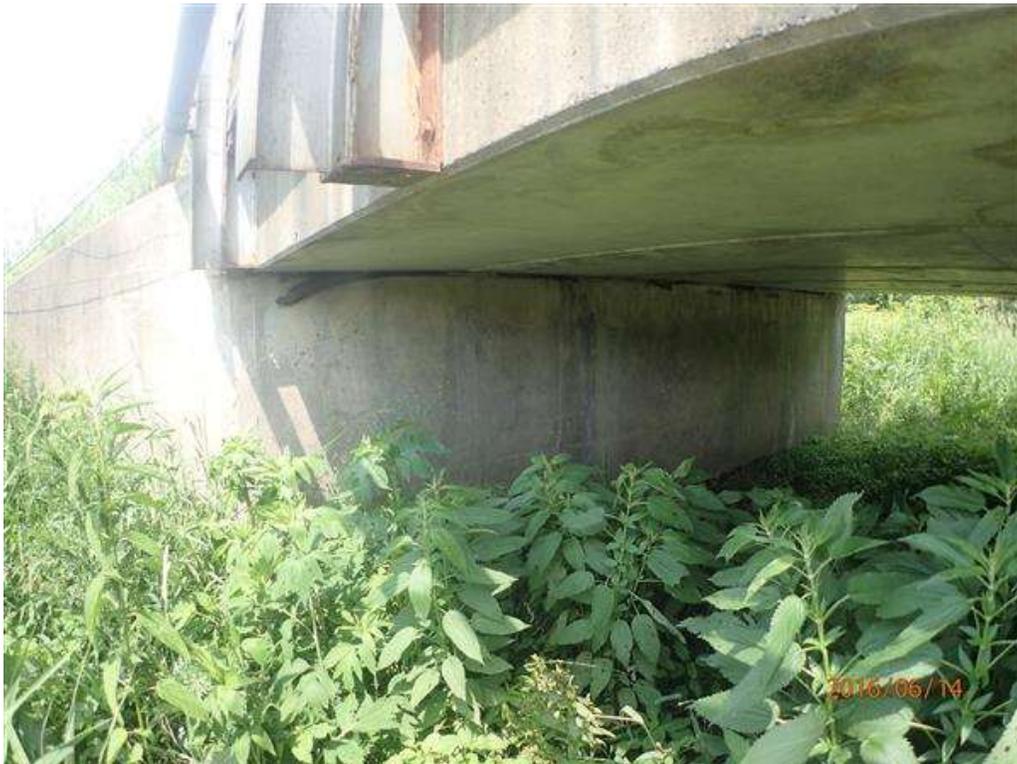
Photo 3 - View of West Abutment, looking west.

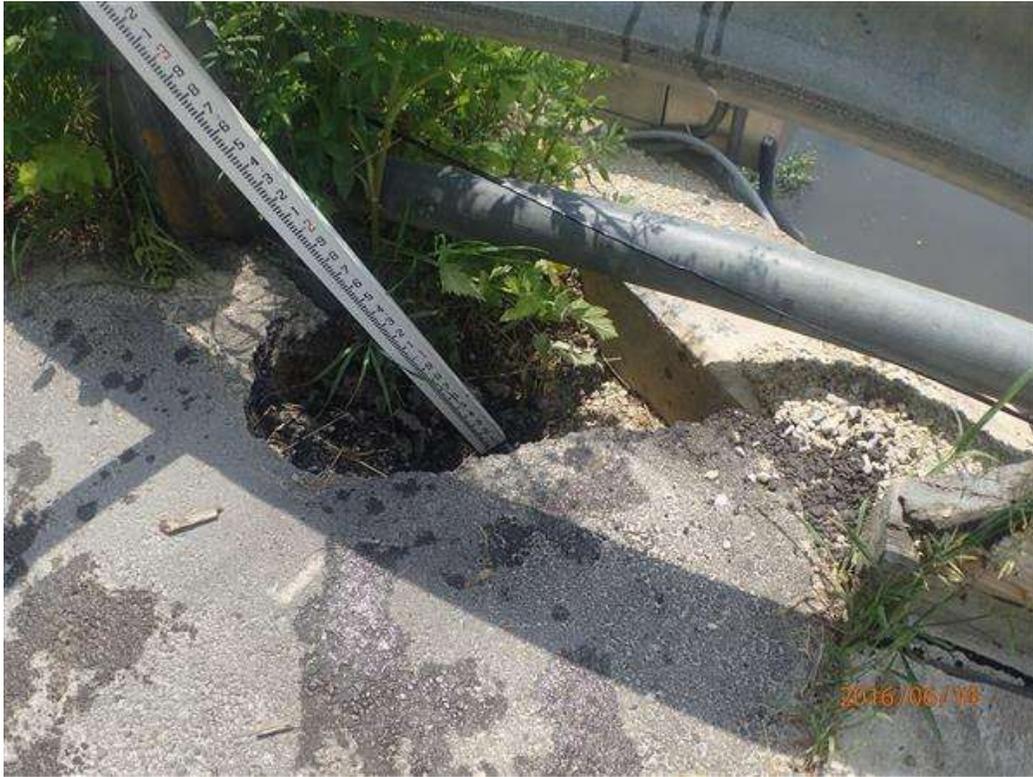
(B) Approximately 2.5 foot diameter by 1.5 feet deep area of loss of fill (erosion sink hole) was observed at the southeast corner of the back side of the East Abutment.

Photo 4 - View of sinkhole at the southeast corner of the backside of the East Abutment, looking down.

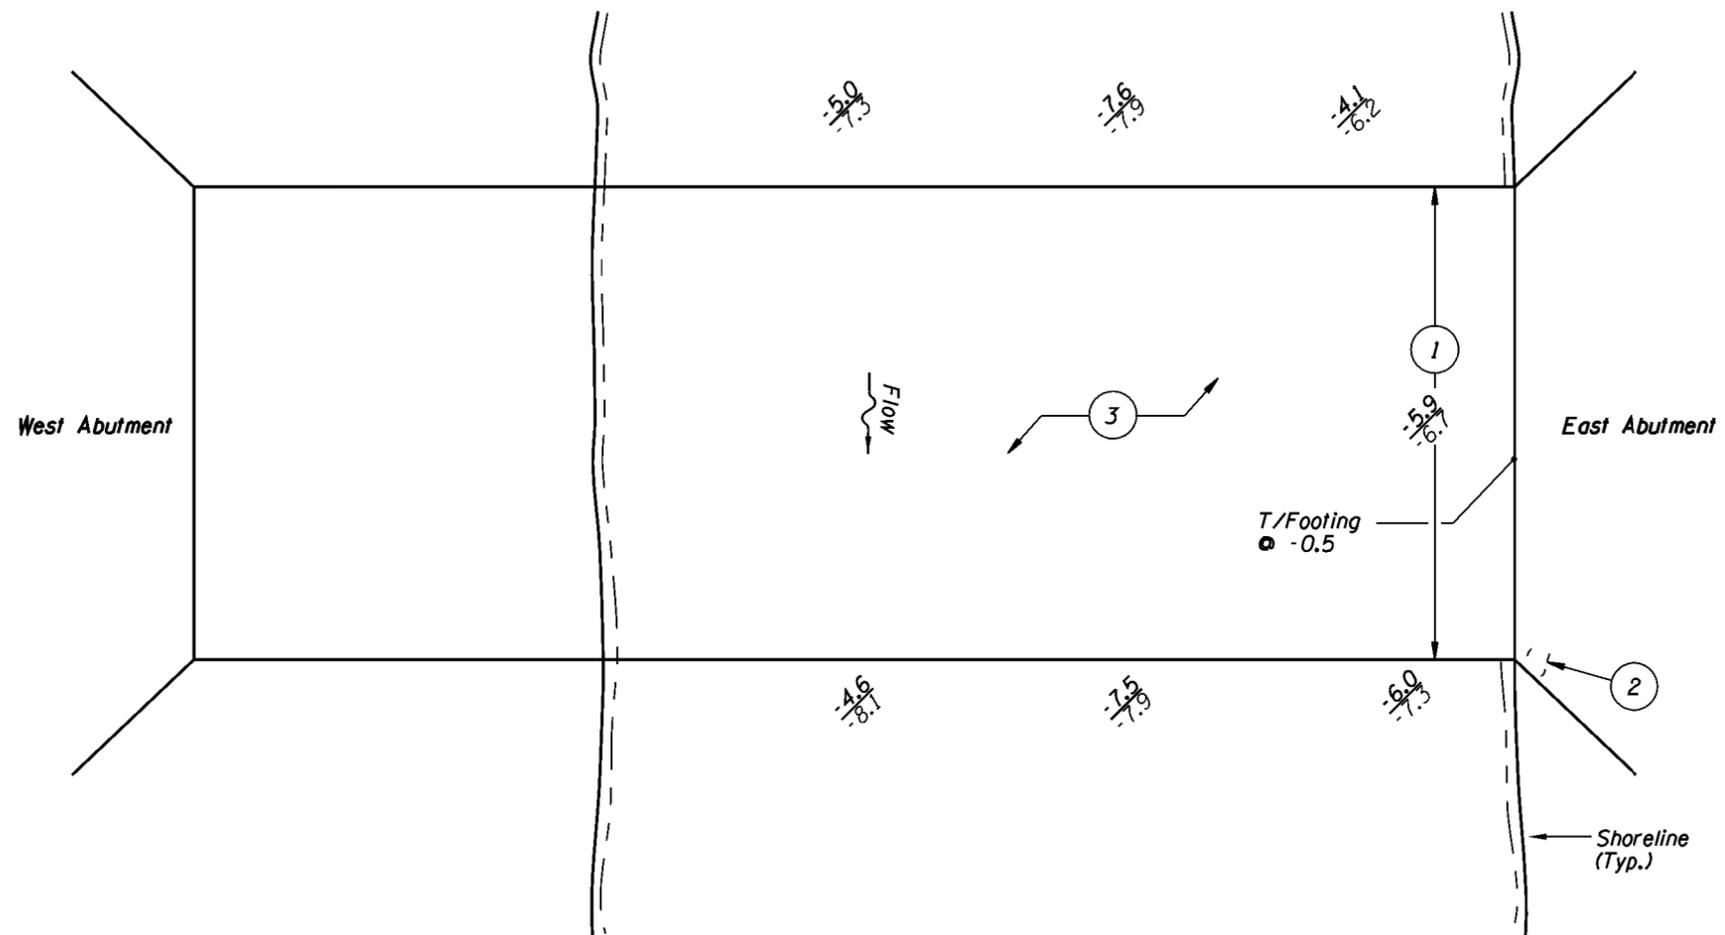
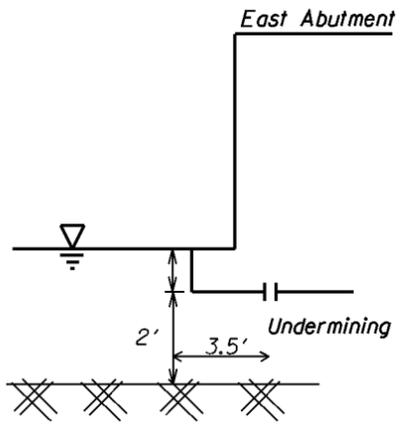
SOUNDINGS PLAN

- INSPECTION NOTES:**
- 1 The East Abutment was undermined along its entire length a maximum of 2 feet vertically with 3.5 feet of penetration. Three steel H-piles were exposed and were in good condition. The footing was 2.5 feet thick on the north end and 4.0 feet thick on the south end.
 - 2 A sinkhole measuring 2.5 feet diameter by 1.5 feet deep was observed at the southeast corner of the back side of the East Abutment.
 - 3 The channel bottom consisted of silty sand and random scattered 6 to 12 inch diameter stone with 18 inch penetration .
