UNDERWATER BRIDGE INSPECTION REPORT

STRUCTURE NO. 07514

BLUE EARTH RIVER

MINNESOTA DEPARTMENT OF TRANSPORTATION
UNDERWATER BRIDGE INSPECTION

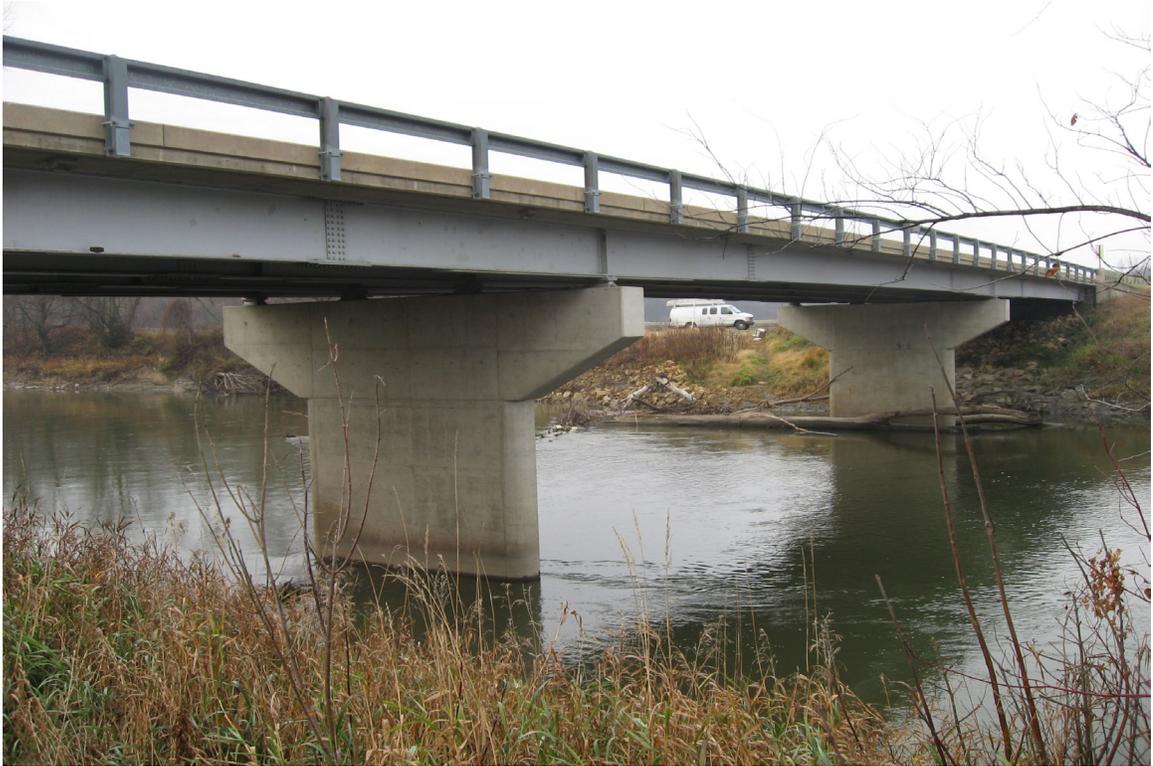
Photograph 1. Overall View of Bridge, Looking Southwest.

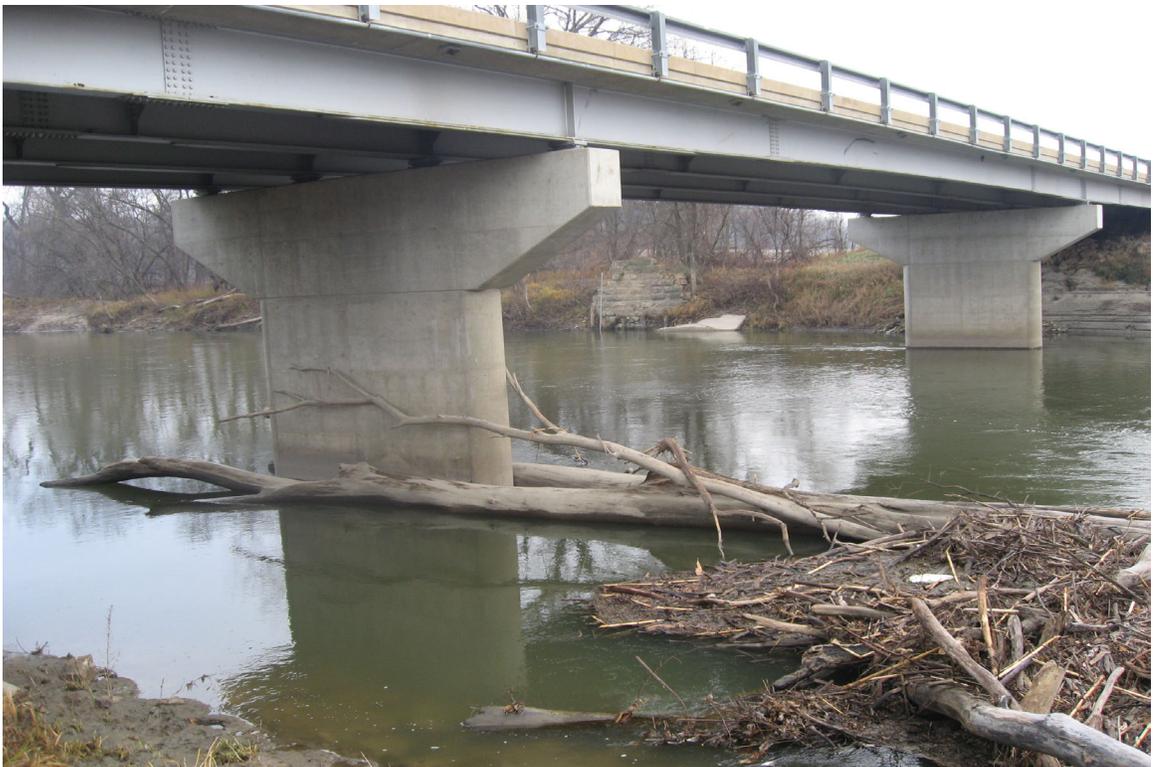
- (A) Minor areas of poor consolidation were observed in the concrete of Pier 1 at the upstream nose.
- (B) A 1/16-inch-wide vertical crack was observed on the upstream nose of Pier 1 and extended from the waterline to 3 feet above the waterline.

- (D) A Heavy accumulation of timber debris, with pieces up to 2.5 feet in diameter, was observed at the upstream nose and along both sides of Pier 1 extending from the channel bottom to above water.

Photograph 2. View of Pier 1, Looking Northeast.

- (A) Remove the timber debris at the piers before accumulations can further increase and adversely affect the piers and/or surrounding channel bottom.
- (B) Reinspect the submerged substructure units at the normal maximum recommended (NBIS) interval of five (5) years.

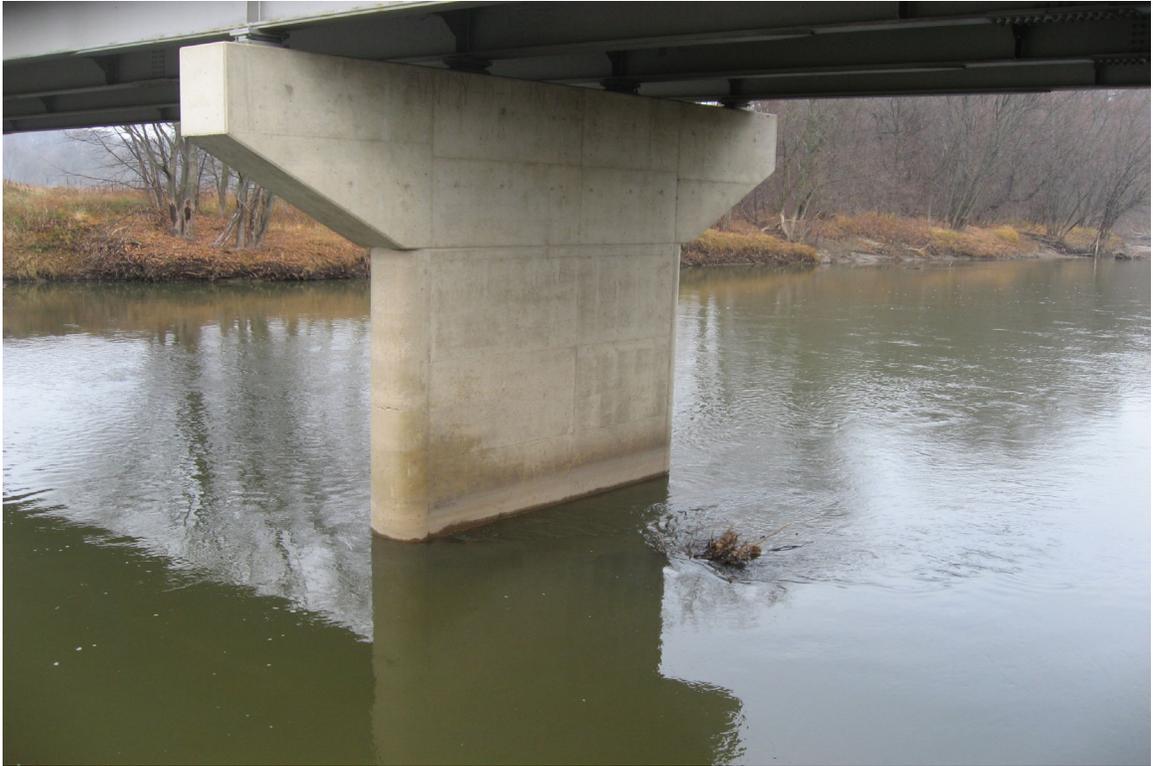
- (E) A light to moderate accumulation of timber debris, with pieces up to 6 inches in diameter, was observed at the upstream nose and east side of Pier 2.

Photograph 3. View of Pier 2, Looking Northwest.

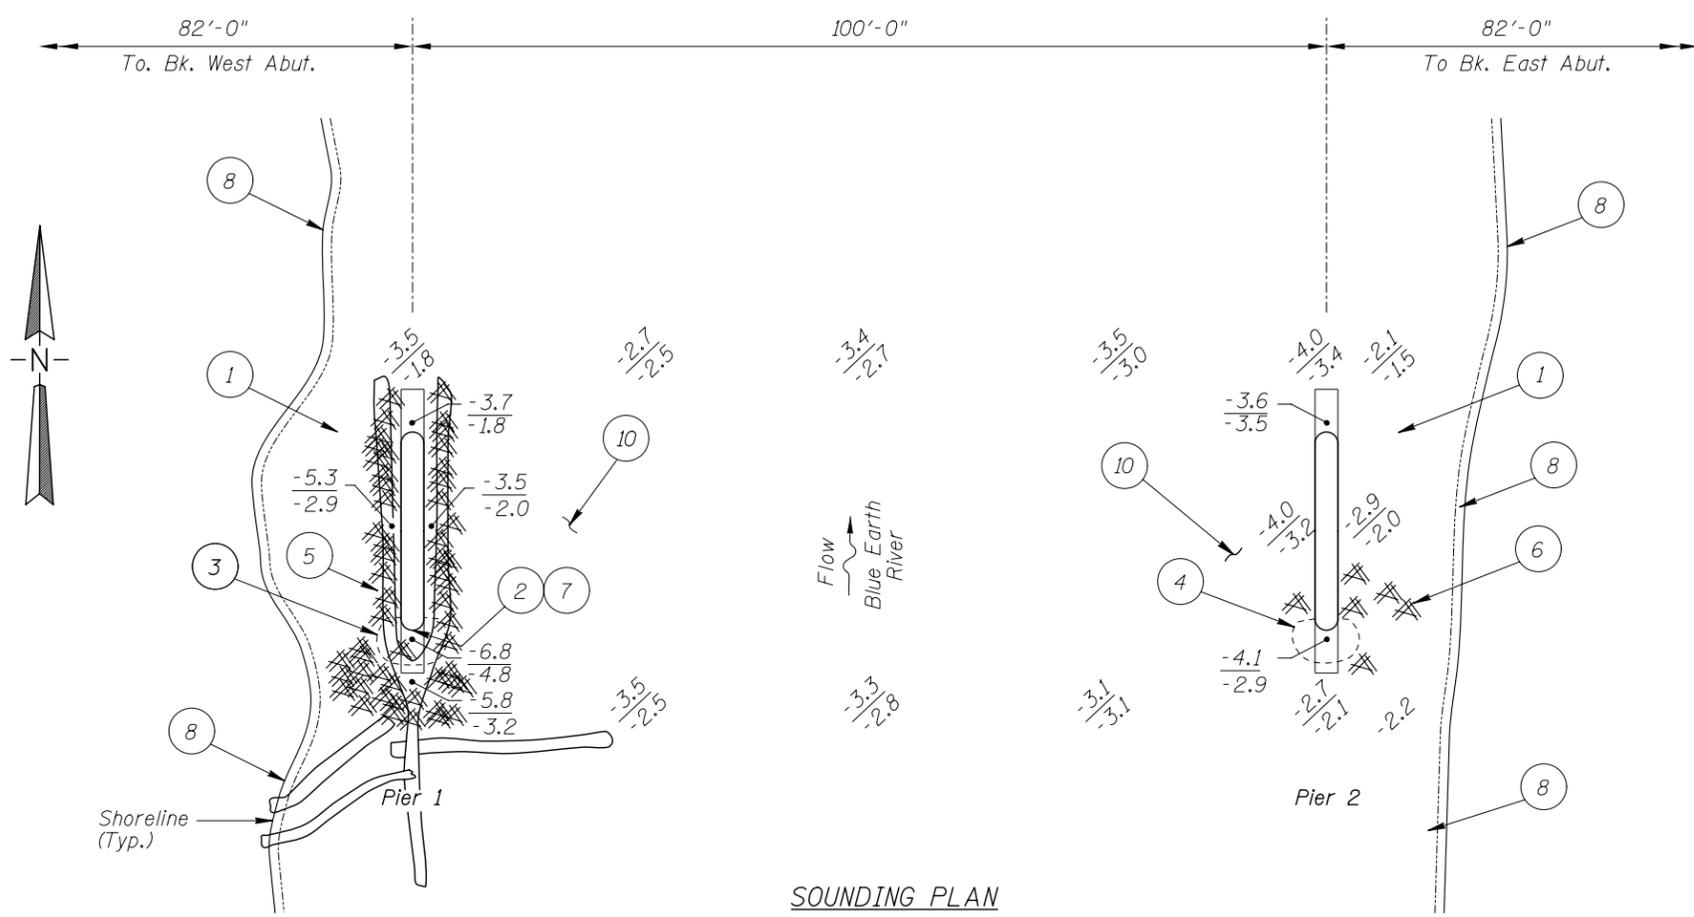
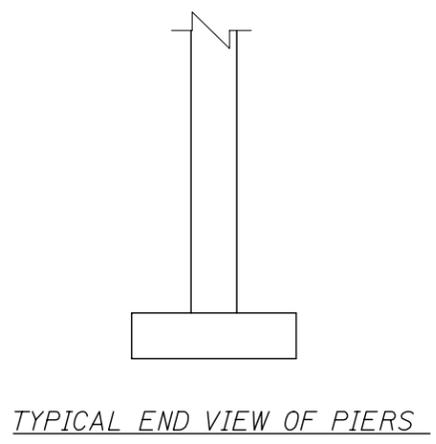
- ① The channel bottom consisted of soft silty sand with up to 8 inches of probe rod penetration.
- ② Minor areas of poor consolidation were observed in the concrete of Pier 1 at the upstream end.

- ③ A scour depression, 10 feet in radius and 3 feet deep, was observed at the upstream nose of Pier 1 due to timber debris.
- ④ A scour depression, 4 feet in radius and 1.5 feet deep, was observed at the upstream nose of Pier 2.

- ⑤ A heavy accumulation of timber debris, with pieces up to 2.5 feet in diameter, was observed at the upstream nose and along both faces of Pier 1. A tree 2.5 feet in diameter and 60 feet long was forked at the upstream end of the pier.

- ⑥ A light to moderate accumulation of timber debris, with pieces up to 6 inches in diameter, was observed at the upstream nose of Pier 2 and extended to the east embankment.

- ⑦ A 1/16-inch-wide vertical crack was observed on the upstream nose of Pier 1 and extended from the waterline to 3 feet above the waterline.
- ⑧ Minor vertical bank erosion was observed at the east embankment and upstream and downstream of the structure along both shorelines.

- ⑨ The concrete of the piers was smooth and sound.
- ⑩ The channel bottom consisted of gravel with 2 inches of probe rod penetration.
