2017 UNDERWATER BRIDGE INSPECTION REPORT

BRIDGE # 07532 CSAH 20 over WILLOW CREEK

Date of Inspection: 12/01/2016

Contractor: Collins Engineers, Inc.

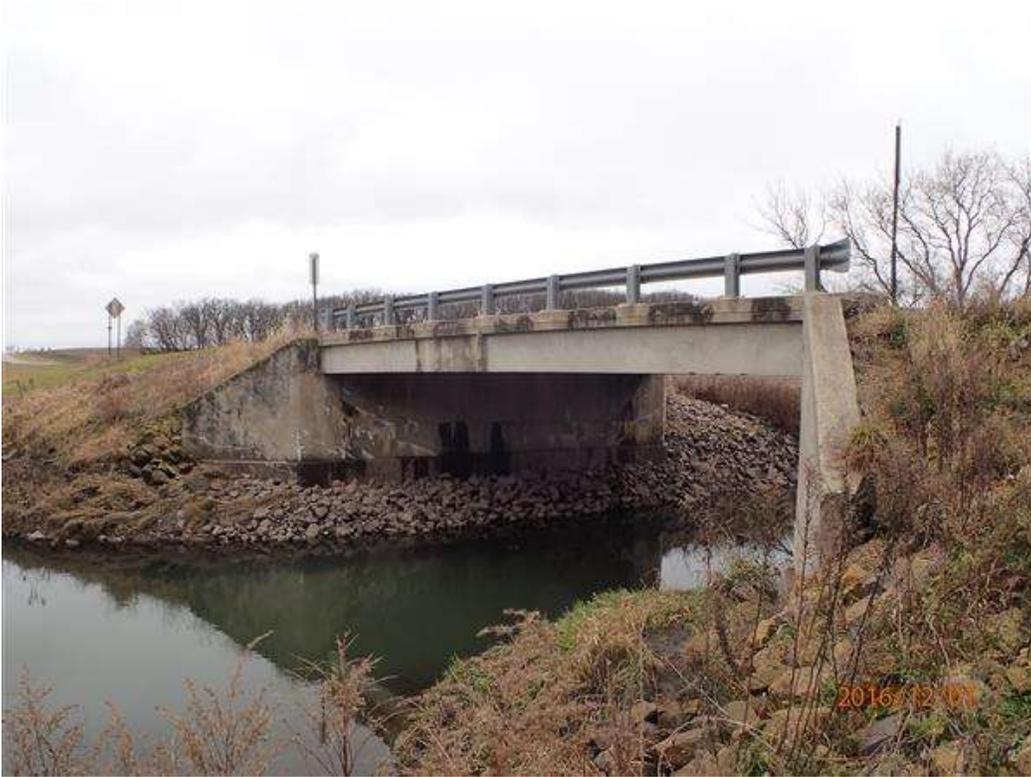
Photo 1 - Overall looking west.

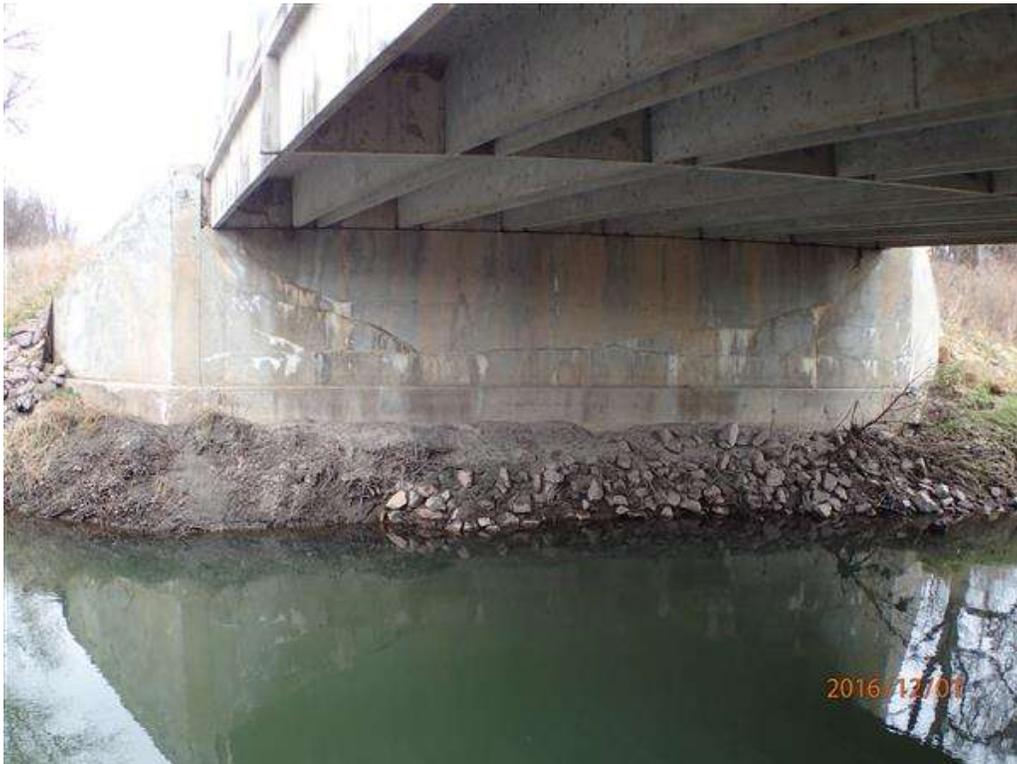
- (A) 1 to 1.5 ft diameter riprap was armoring the North and South Abutments.
- (B) The channel bottom material in the channel typically consisted of firm gravel, cobbles, and 1 ft diameter riprap with no probe rod penetration.

Photo 2 - South Abutment looking south.

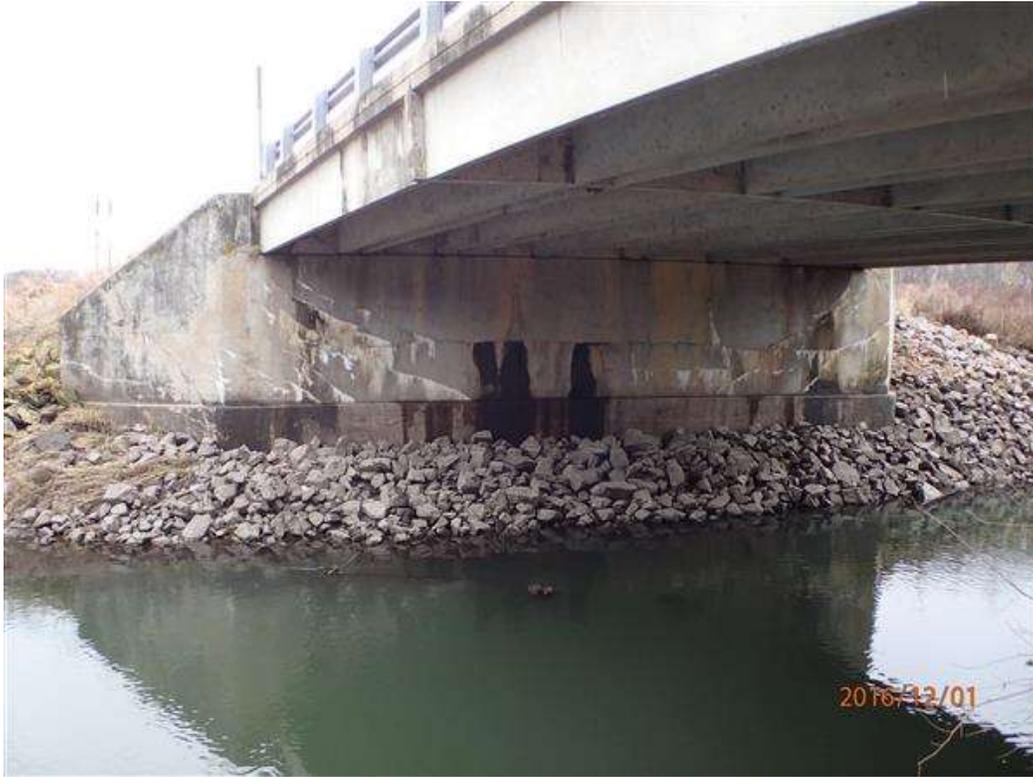
Photo 3 - North Abutment looking north.

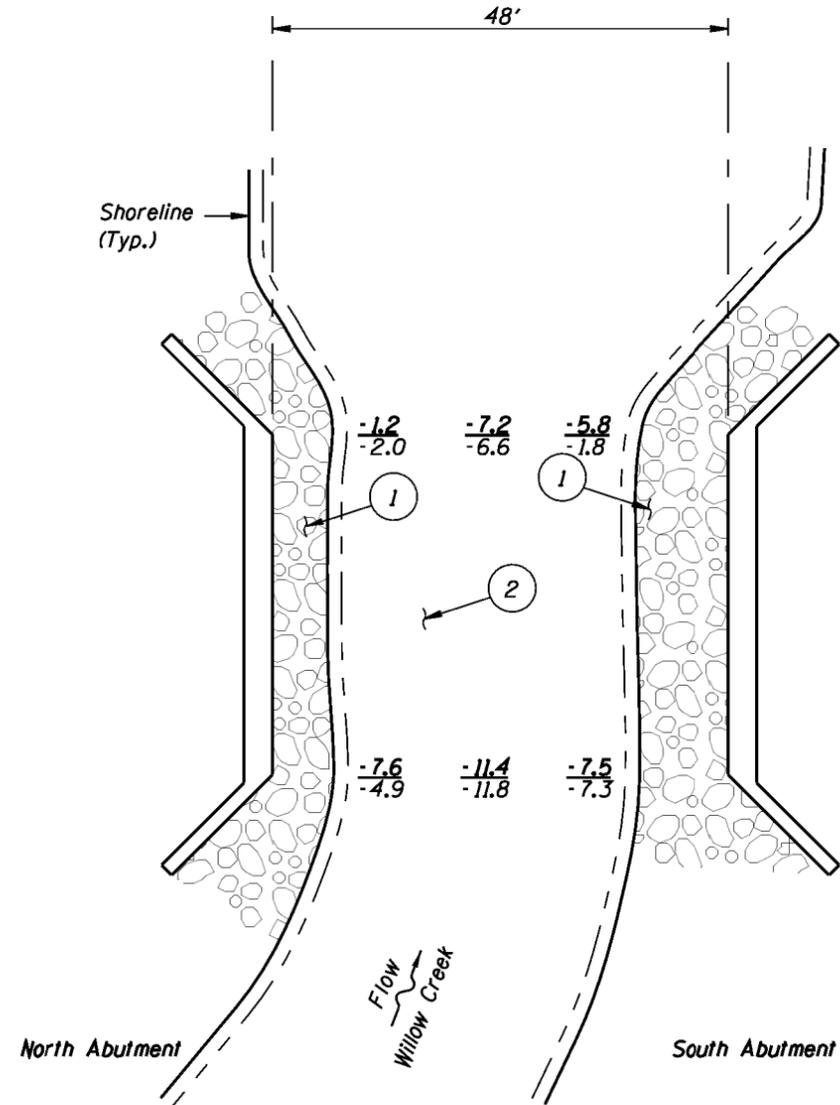
SOUNDING PLAN

- 1 1 to 1.5 foot diameter riprap was armoring the North and South Abutments.
- 2 The channel bottom material typical consisted of firm gravel, cobbles and 1 foot diameter riprap allowing no appreciable probe rod penetration.

- (A) Recommend removing structure from underwater inspection list.
