2017 UNDERWATER BRIDGE INSPECTION REPORT

BRIDGE # 08527 CSAH 13 over MINNESOTA RIVER

Date of Inspection: 05/03/2017

Contractor: Collins Engineers, Inc.

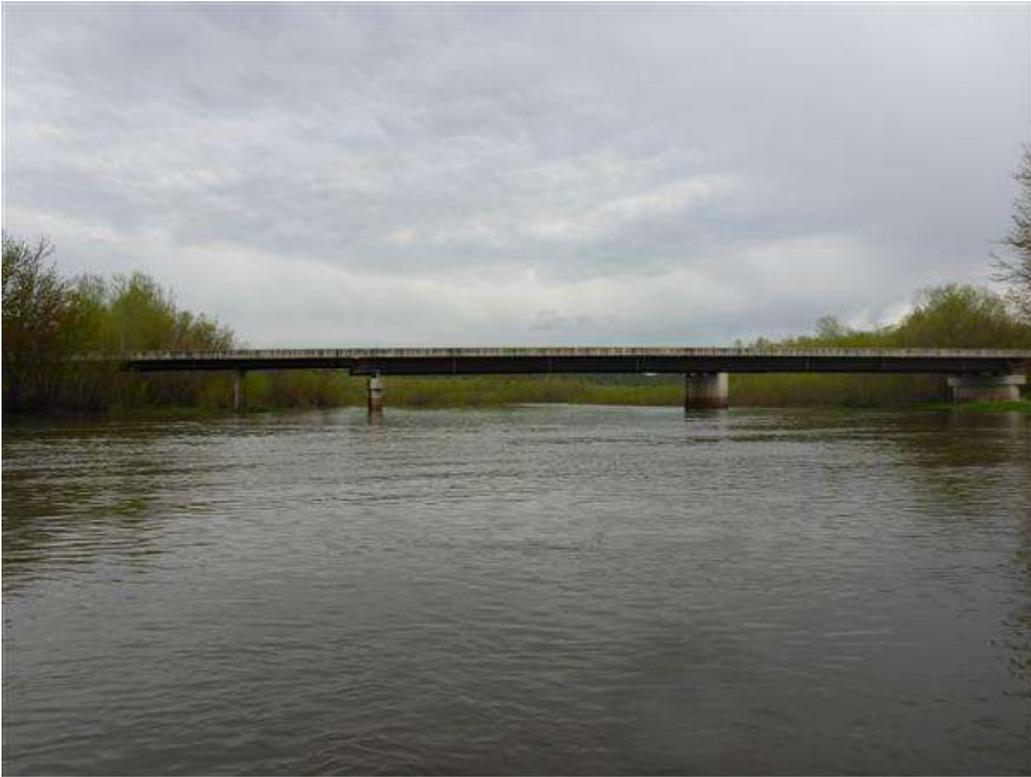
Photo 1 - Downstream Elevation Looking Southeast

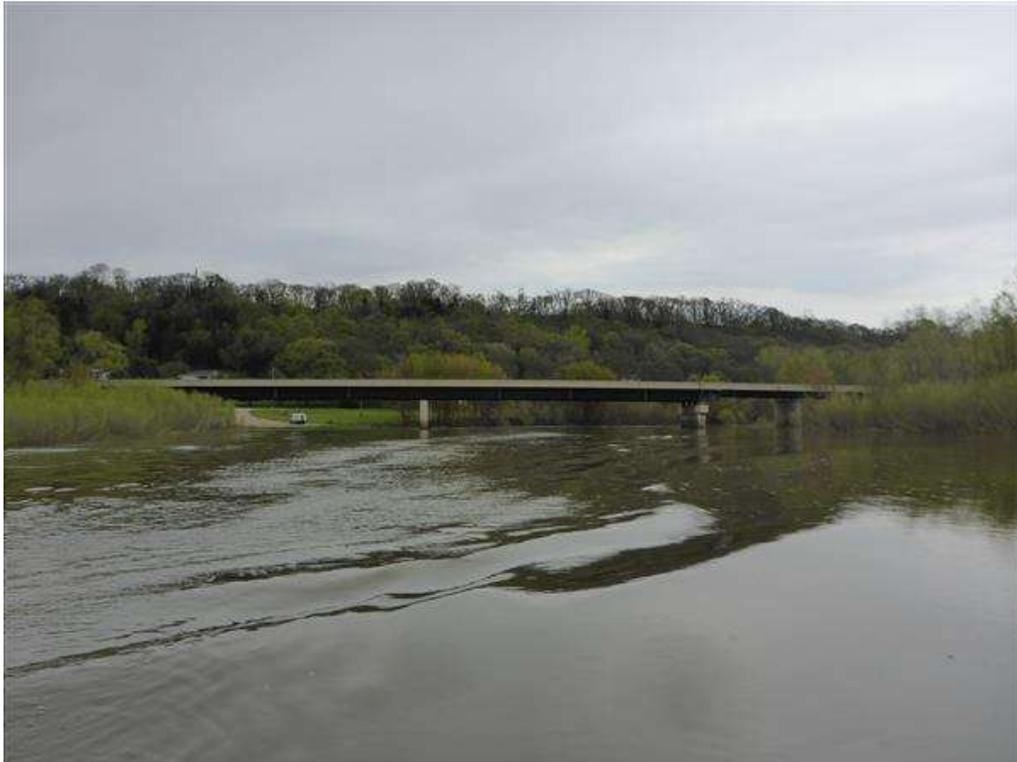
Photo 2 - Upstream Elevation Looking Northeast

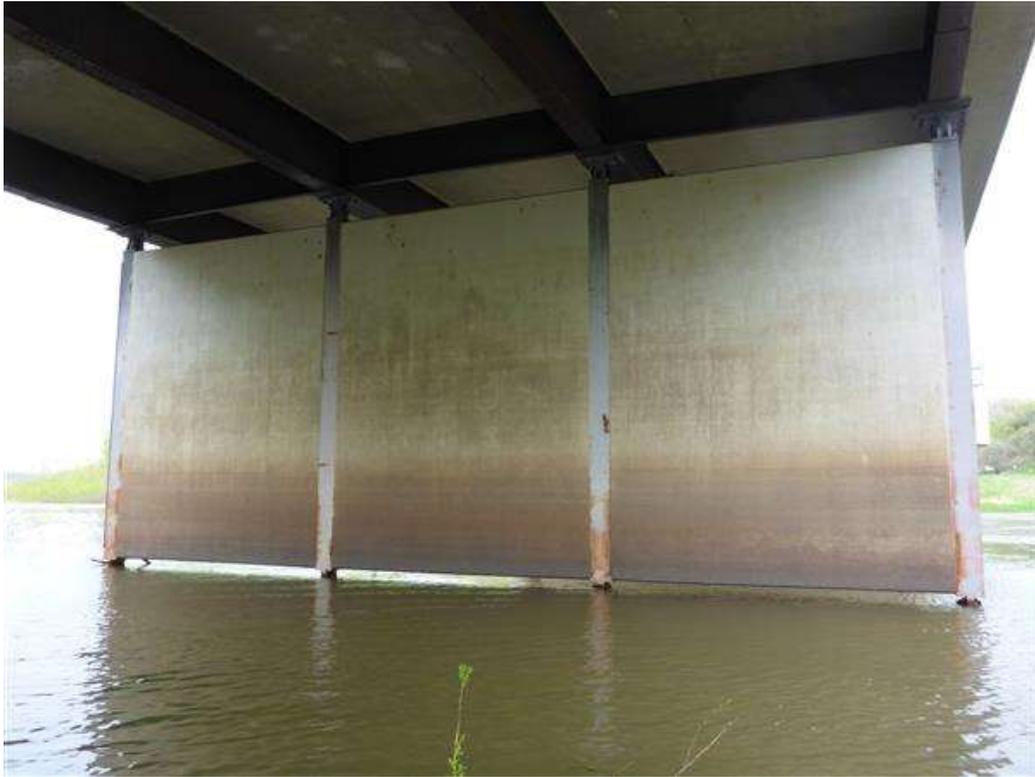
Photo 3 - Bent 2 Looking Northwest

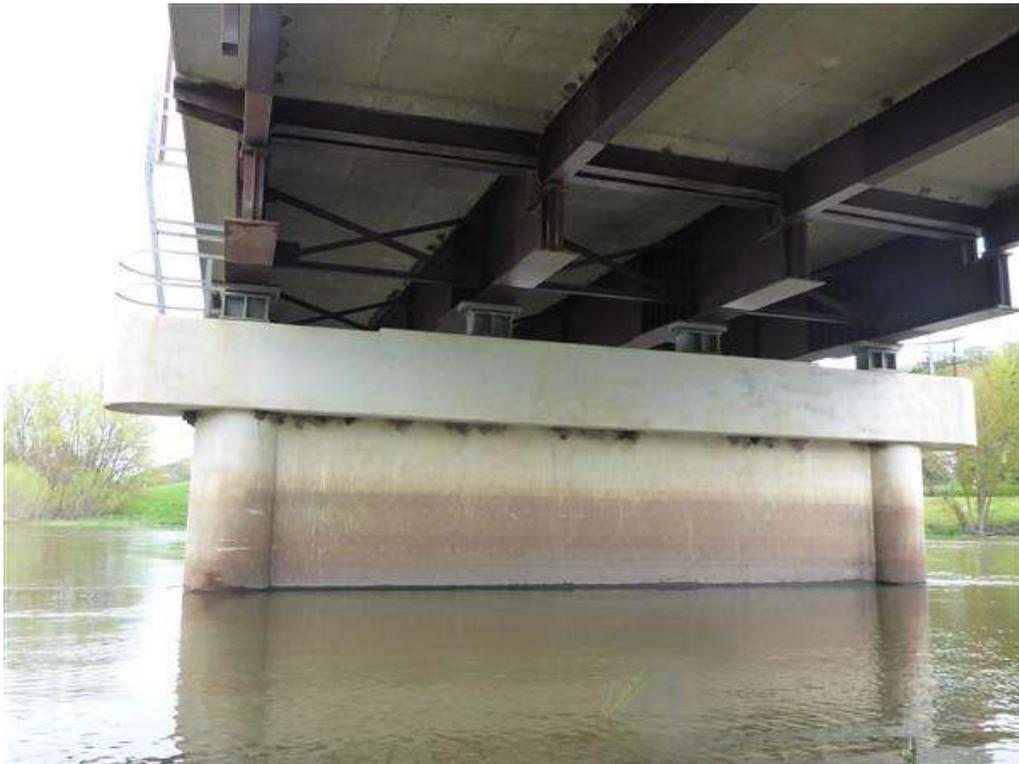
Photo 4 - Pier 1 Looking Northwest

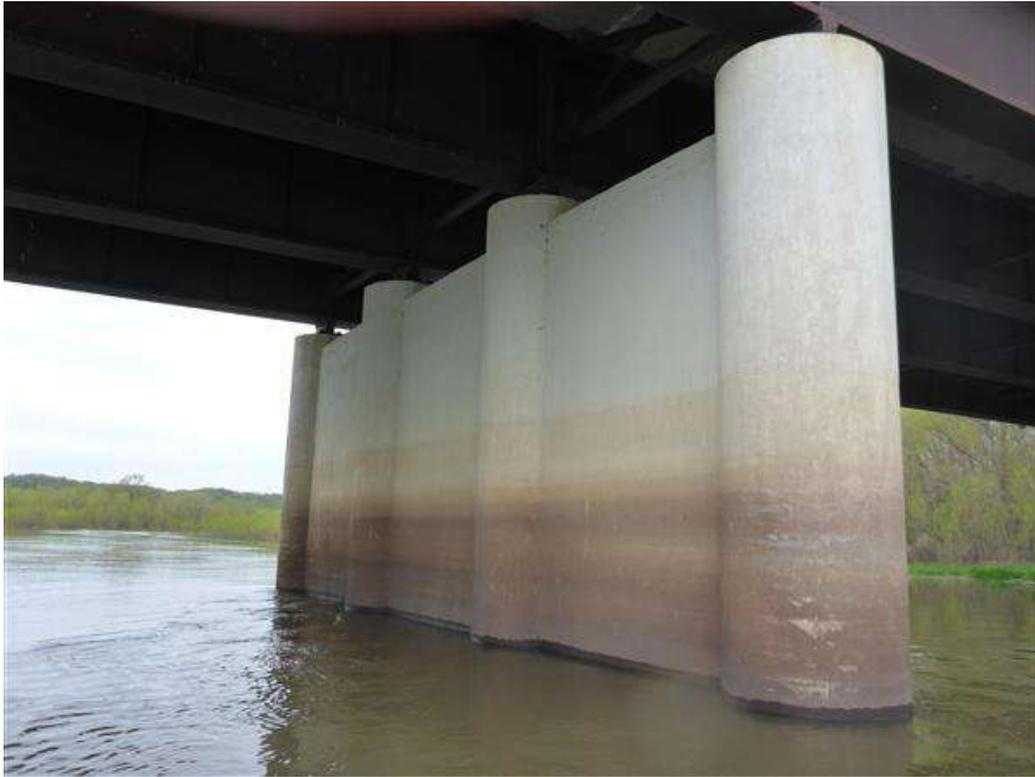
- (A) Channel bottom material consisted of silty sand with 1.5 feet of maximum probe rod penetration.
- (B) Minor scour depression observed, with a 5 foot radius and a 1 to 2 foot depth, at the upstream end of Pier 2.
- (C) Moderate accumulation of timber debris consisting of 1 foot diameter and smaller logs and branches was observed at the upstream end of Pier 2 from the channel bottom up 5 feet.

| ELEM NBR | ELEMENT NAME | REPORT TYPE | INSP. DATE | QUANTITY | QTY CS 1 | QTY CS 2 | QTY CS 3 | QTY CS 4 |
|--|---|---|---|---|---|---|---|---|
| Notes: [2017] Underwater Inspection - Minor scour depression with a 5 foot radius and up to 2 foot depth at the upstream end of Pier 2. | | | | | | | | |

Photo 5 - Pier 2 Looking Southwest

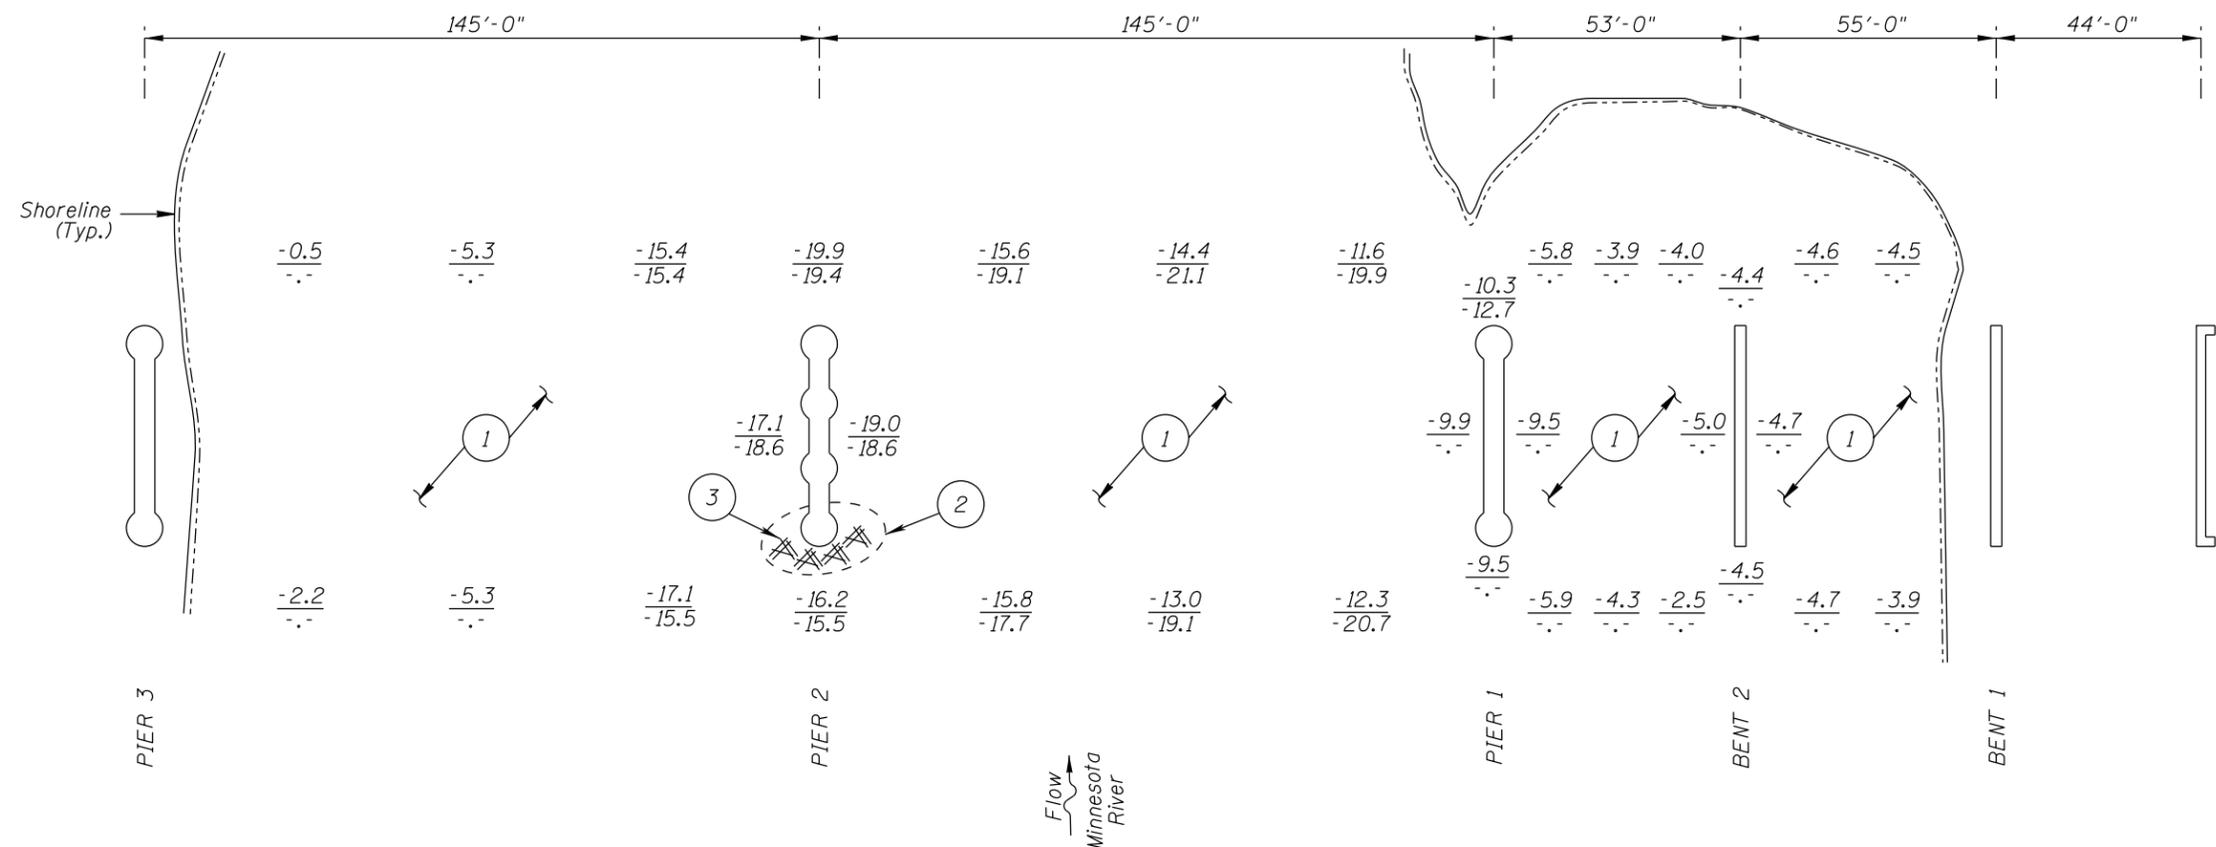
| INSPECTION AND SOUNDING PLAN | | |

- ① Channel bottom material consisted of silty sand with 1.5 feet of maximum probe rod penetration.
- ② Minor scour depression observed, with a 5 foot radius and a 1 to 2 foot depth, at the upstream end of Pier 2.
- ③ Moderate accumulation of timber debris consisting of 1 foot diameter and smaller logs and branches was observed at the upstream end of Pier 2 from the channel bottom up 5 feet.
