2016 UNDERWATER BRIDGE INSPECTION REPORT

BRIDGE # 7105 CSAH 14 over DES MOINES RIVER

DISTRICT: District 7 COUNTY: Jackson CITY/TOWNSHIP: Jackson
STATE: Minnesota

Date of Inspection: 06/16/2016

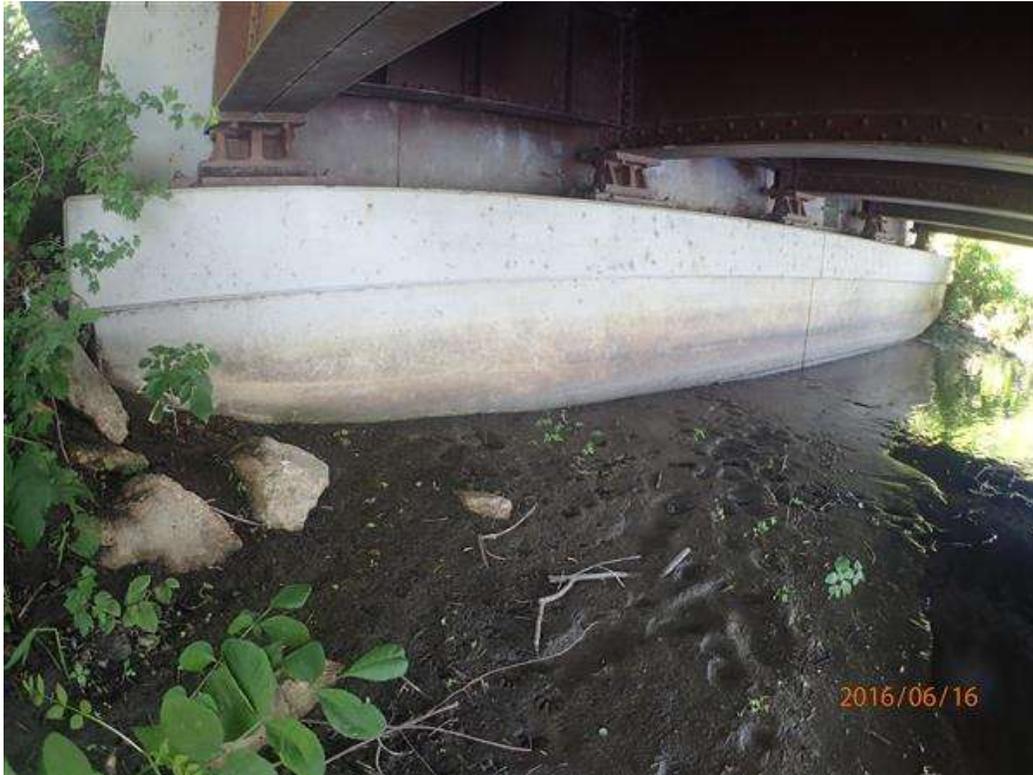
Photo 2 - View of East Abutment, looking southeast.

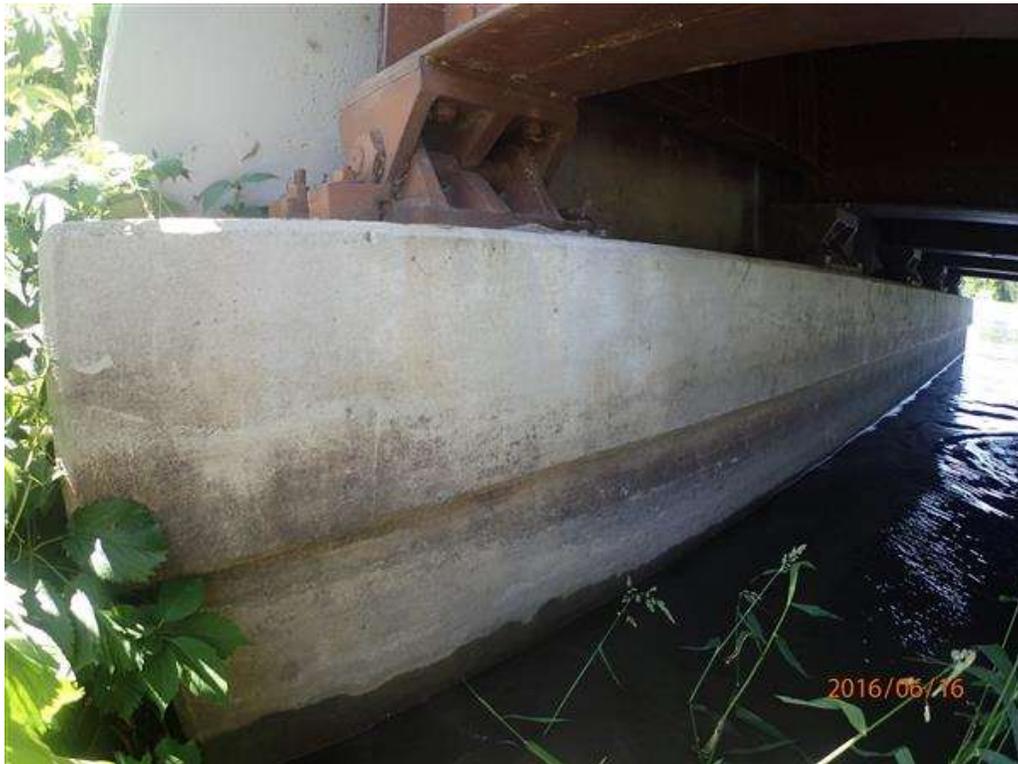
Photo 3 - View of West Abutment, looking northwest.

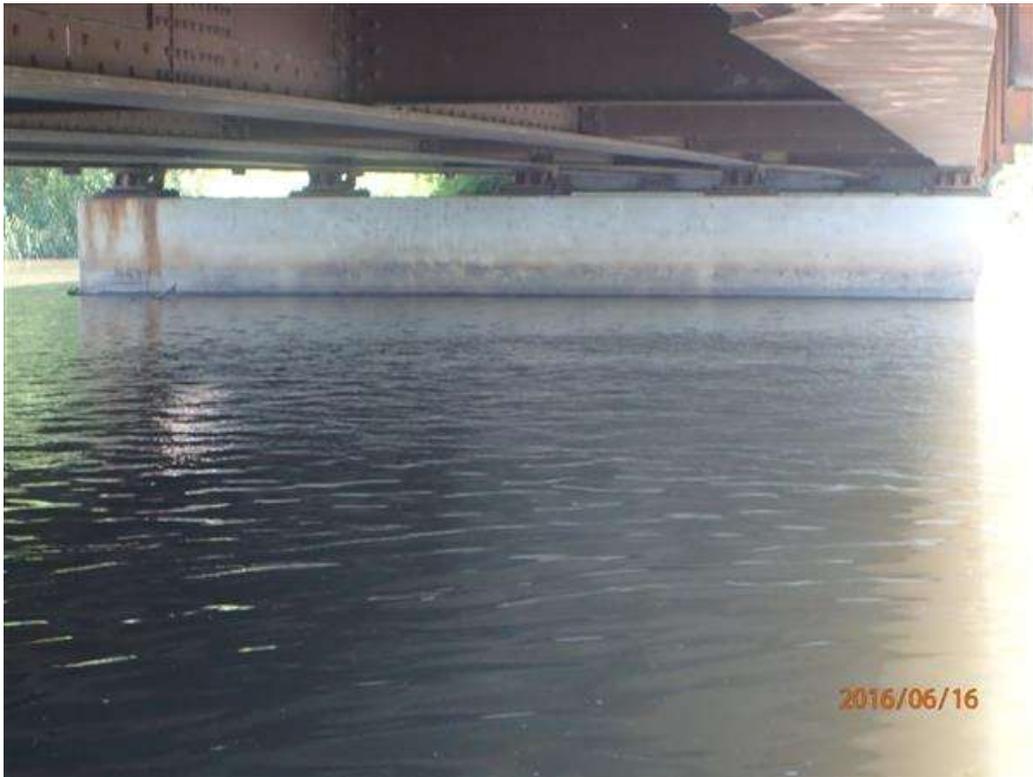
(A) Random areas of honeycombing were observed on the downstream column of Pier 1 measuring up to 10 inches in diameter and 1 inch deep

(B) A moderate accumulation of debris, consisting of abandoned piles and boulders, was observed around each column at Pier 1 from the streambed to 2 feet above waterline extending 4 feet away from the columns.

Photo 4 - View of Pier 1, looking east.

(A) Reinspect the submerged substructure units at the normal maximum recommended (NBIS) interval of sixty (60) months.

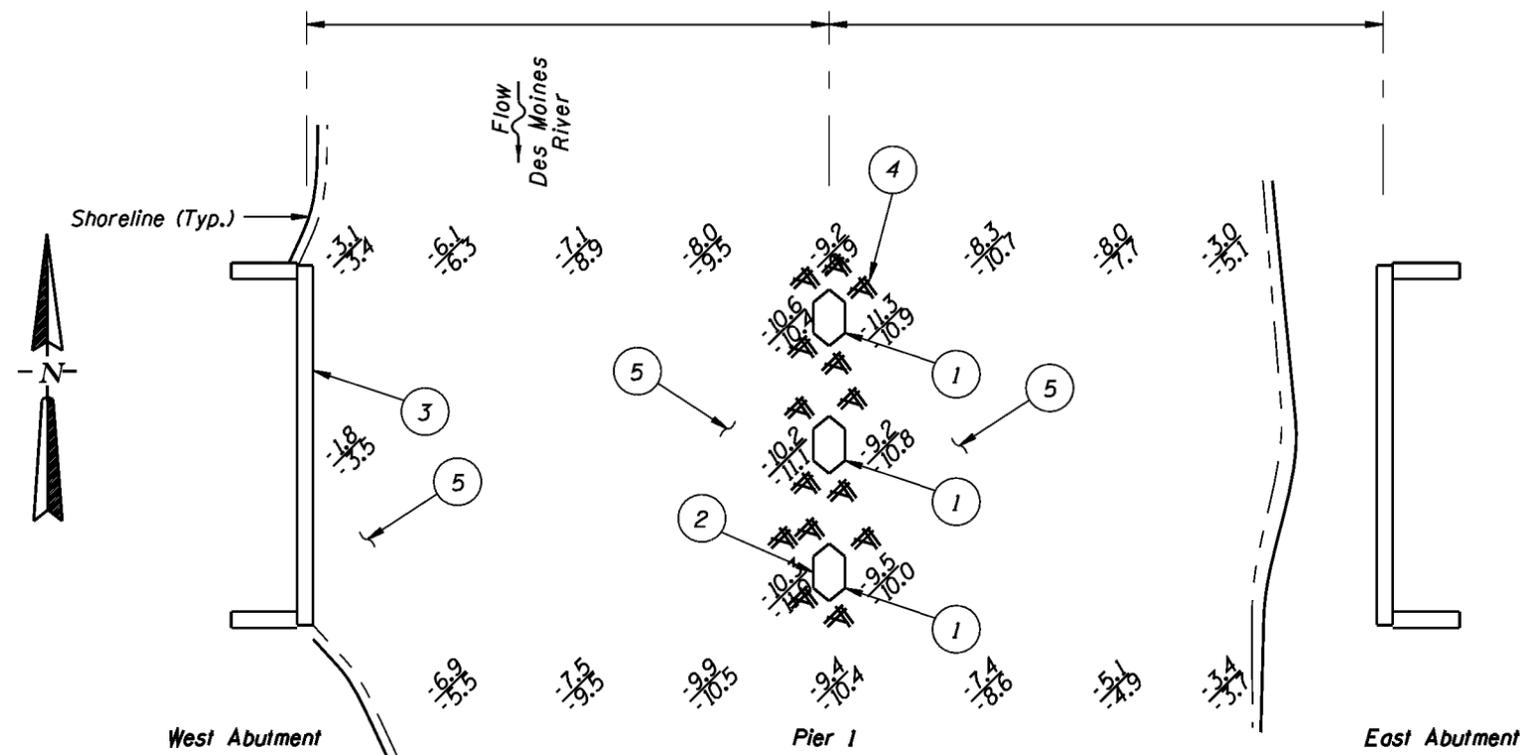
SOUNDING PLAN

- ① The concrete columns of Pier 1 were sound and in good condition with no structurally significant defects.
- ② Random areas of honeycombing were observed at the downstream column of Pier 1 up to 10 inches in diameter and 1 inch deep.
- ③ The concrete at the West Abutment was sound and in good condition with no structurally significant defects.
- ④ Moderate debris, consisting of abandoned piles and boulders, was observed around each column from the streambed to 2 feet above waterline and extending 4 feet away from the columns.
- ⑤ The channel bottom consisted of soft silt with 12 inches of penetration.
