2017 UNDERWATER BRIDGE INSPECTION REPORT

BRIDGE # 89478 CR 140 over WATKINS LAKE OUTLET

Date of Inspection: 04/05/2017

Contractor: Collins Engineers, Inc.

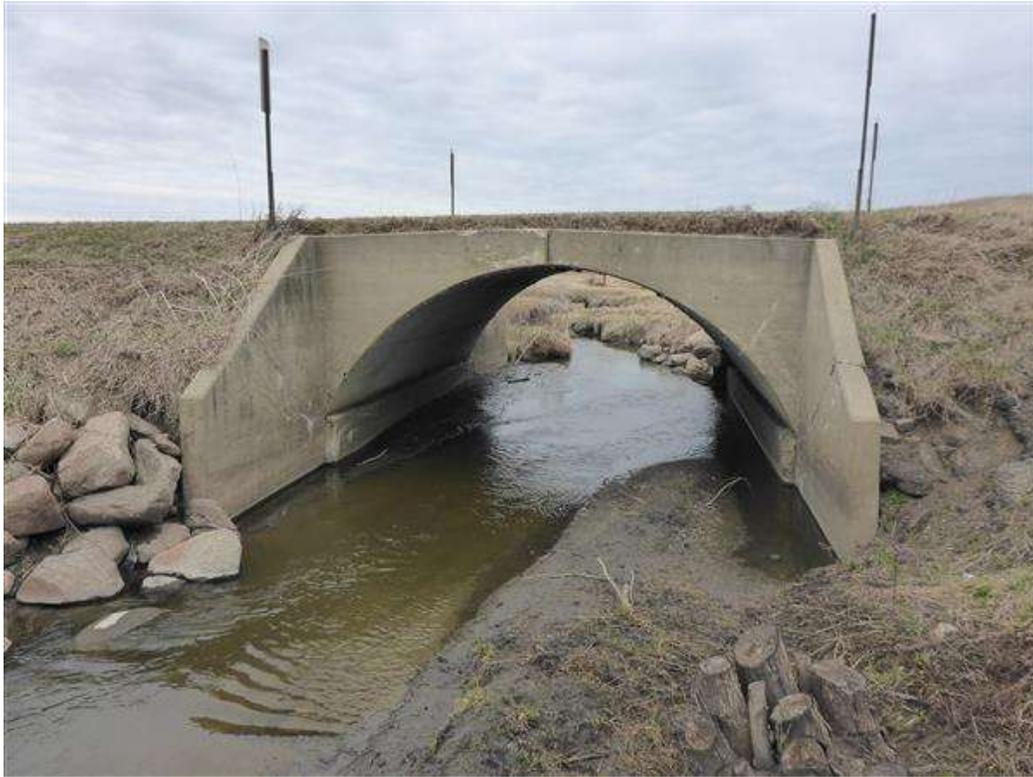
Photo 1 - South Elevation, Looking North.

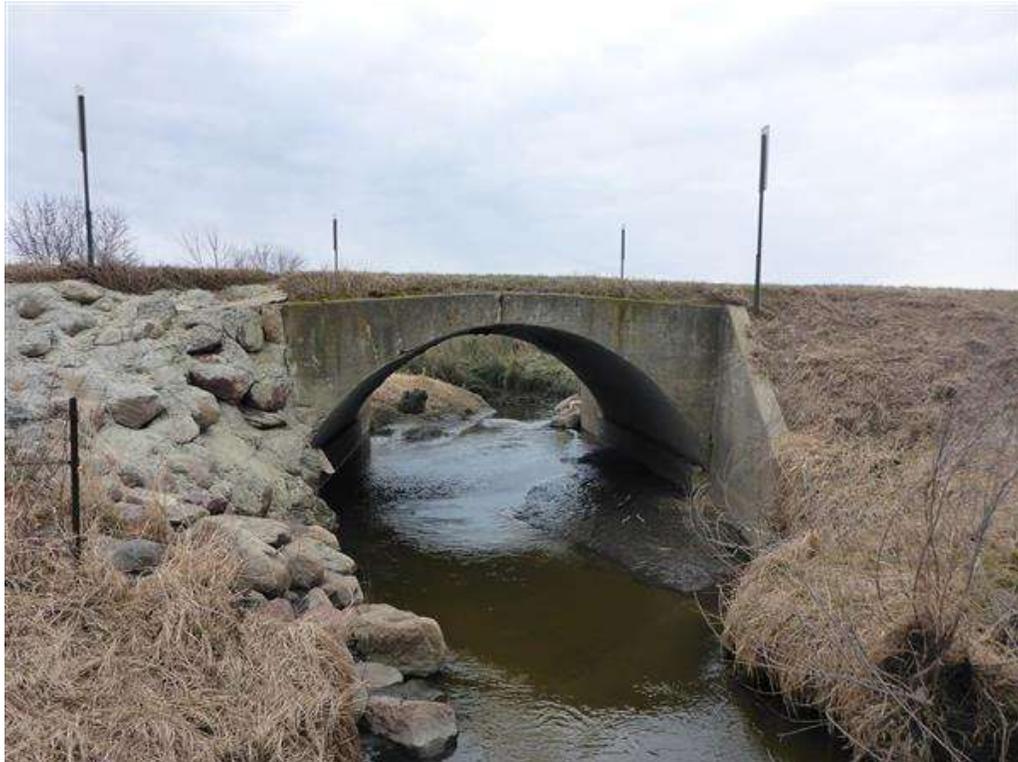
Photo 2 - North Elevation, Looking South.

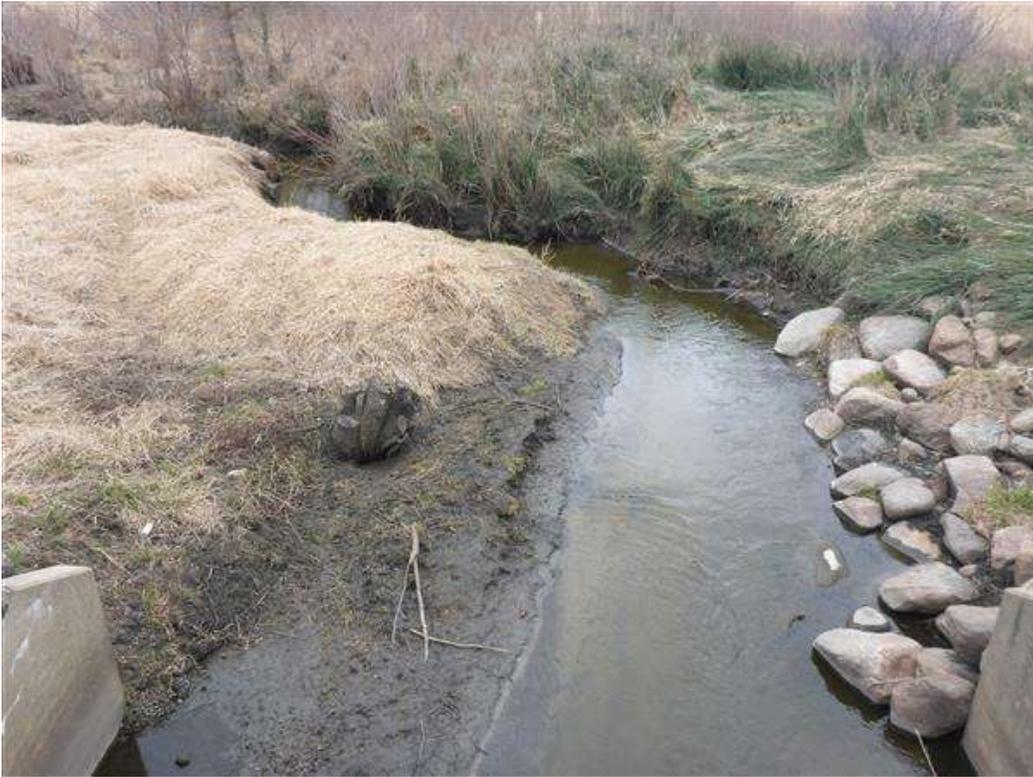
Photo 3 - Upstream View, Looking South.

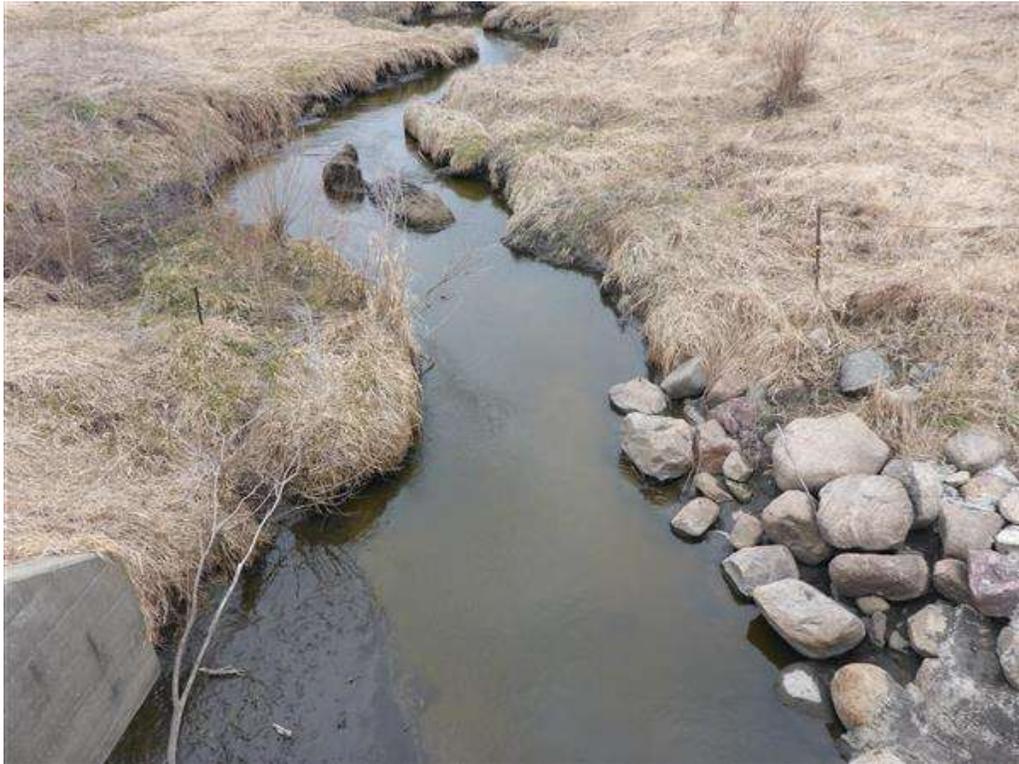
Photo 4 - Downstream View, Looking North.

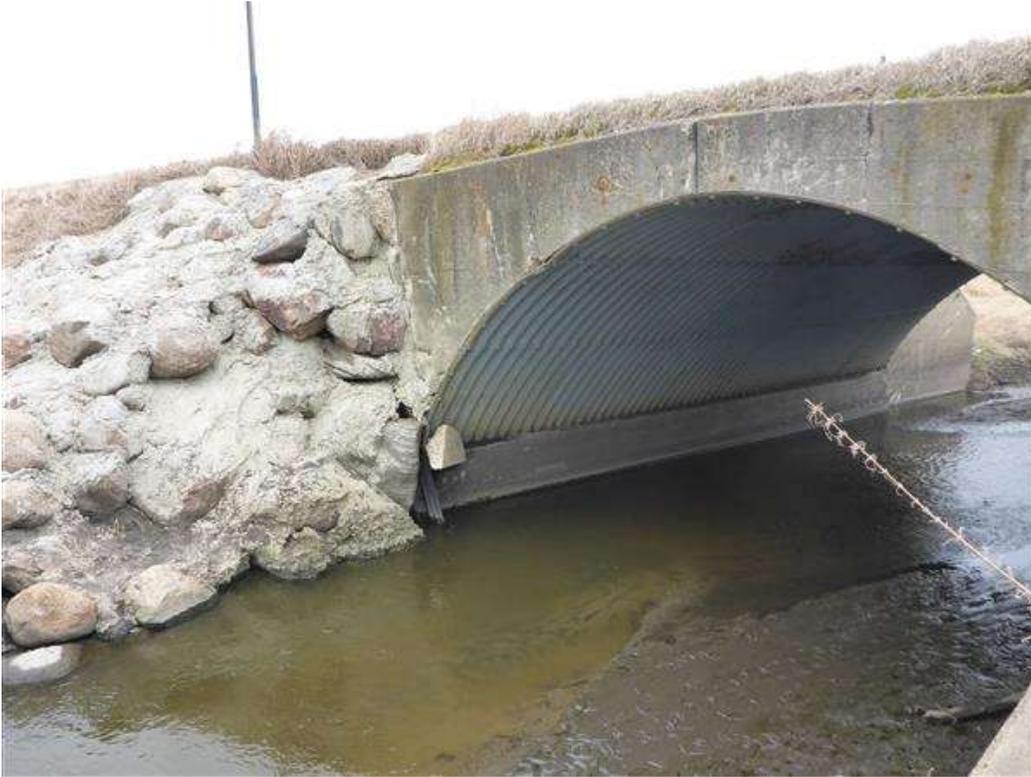
- (A) The channel bottom consisted of riprap covered with silty sand allowing up to 12 inches of probe rod penetration.
- (B) Scour observed along the north half of the eastern side of the barrel, extending up to 12 inches into the barrel and ranging from 6 to 12 inches in depth.
- (C) Footing exposure observed along entire eastern side of the barrel, with up to 1.1 feet of vertical exposure noted on the north end. No undermining noted.
- (D) The three wingwalls are rotated toward the channel; the southeast wingwall is rotated approximately $\frac{3}{4}$ inches, the northwest wingwall is rotated 1 inch, and the southwest wingwall is rotated $\frac{1}{4}$ inch from each wingwall's adjacent surface.
- (E) Northeast wingwall was replaced with grouted riprap.

Photo 5 - Grouted Riprap and East Barrel Interior, Looking Southeast.

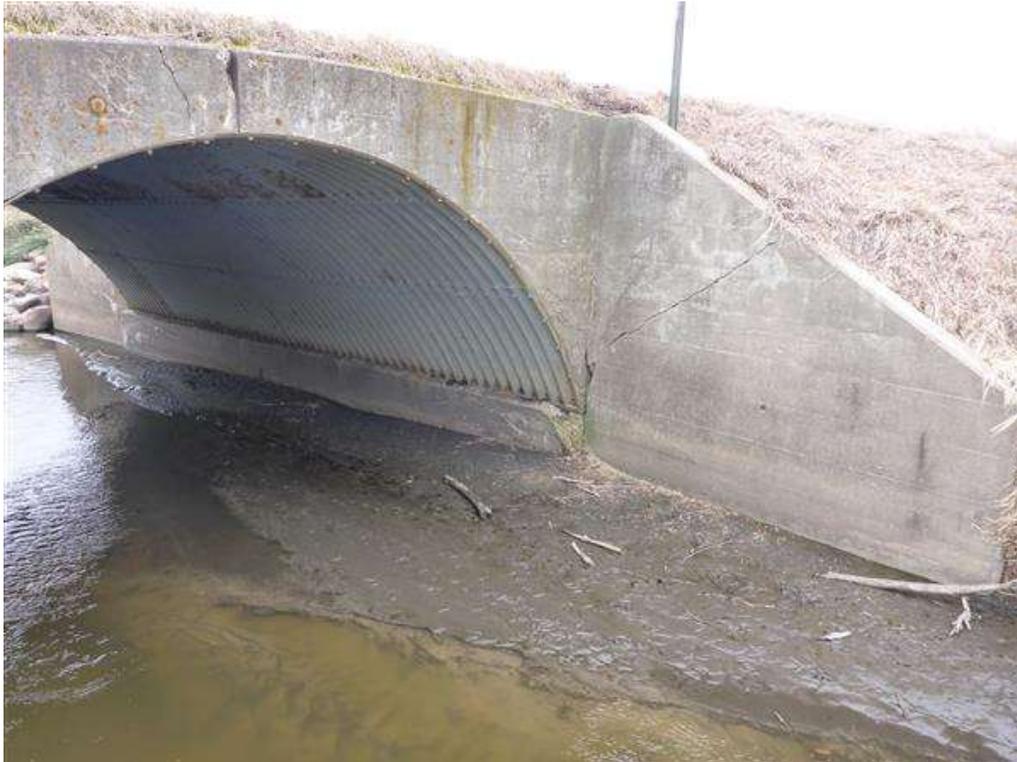
Photo 6 - Northwest Wingwall and Typical Barrel Interior, Looking Southwest.

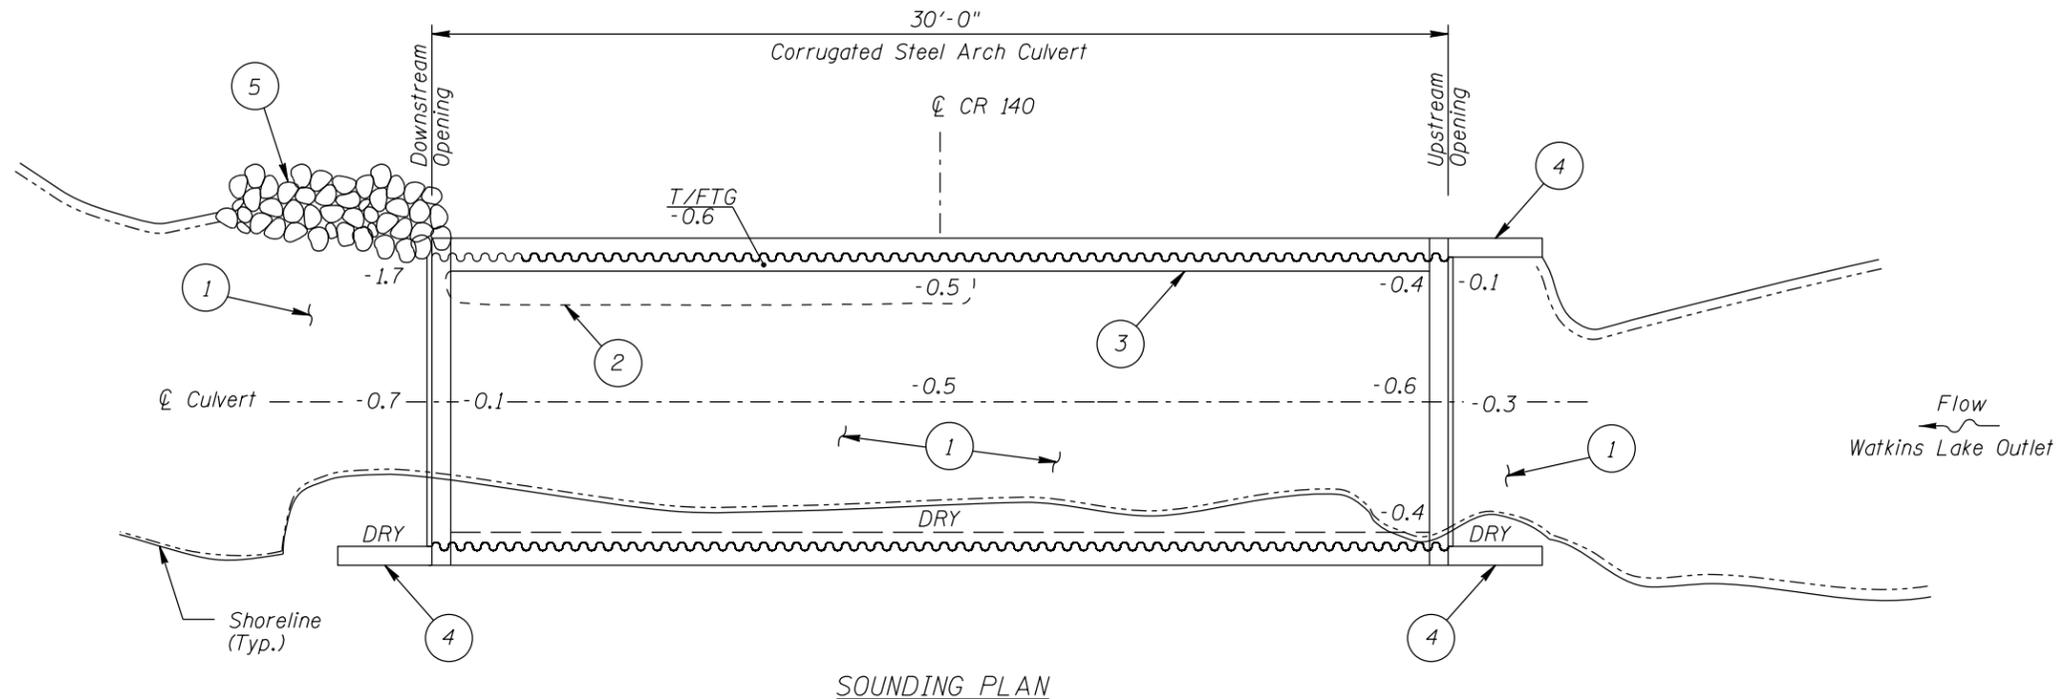
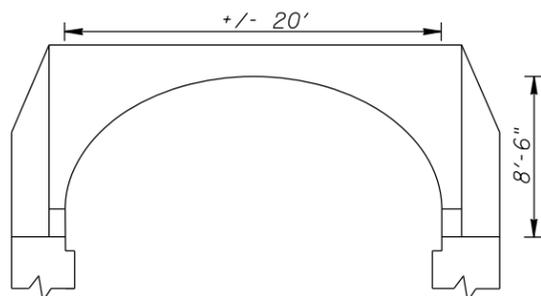
SOUNDING PLAN

- 1 The channel bottom consisted of riprap covered with silty sand allowing up to 12 inches of probe rod penetration.
- 2 Scour observed along the north half of the eastern side of the barrel, extending up to 12 inches into the barrel and ranging from 6 to 12 inches in depth.
- 3 Footing exposure observed along entire eastern side of the barrel, with up to 1.1 feet of vertical exposure noted on the north end. No undermining noted.
- 4 The three wingwalls are rotated toward the channel; the southeast wingwall is rotated approximately 3/4 inches, the northwest wingwall is rotated 1 inch, and the southwest wingwall is rotated 1/4 inch from each wingwall's adjacent surface.
- 5 Northeast wingwall was replaced with grouted riprap.

- (A) Monitor footing exposure on east side during periods of high flow. Consider installing scour countermeasures if extents of exposure increase over time.
- (B) Reinspect the submerged substructure units at the normal maximum recommended (NBIS) interval of sixty (60) months.
