UNDERWATER BRIDGE INSPECTION REPORT

STRUCTURE NO. 87513

MINNESOTA RIVER

DISTRICT 8 - YELLOW MEDICINE COUNTY

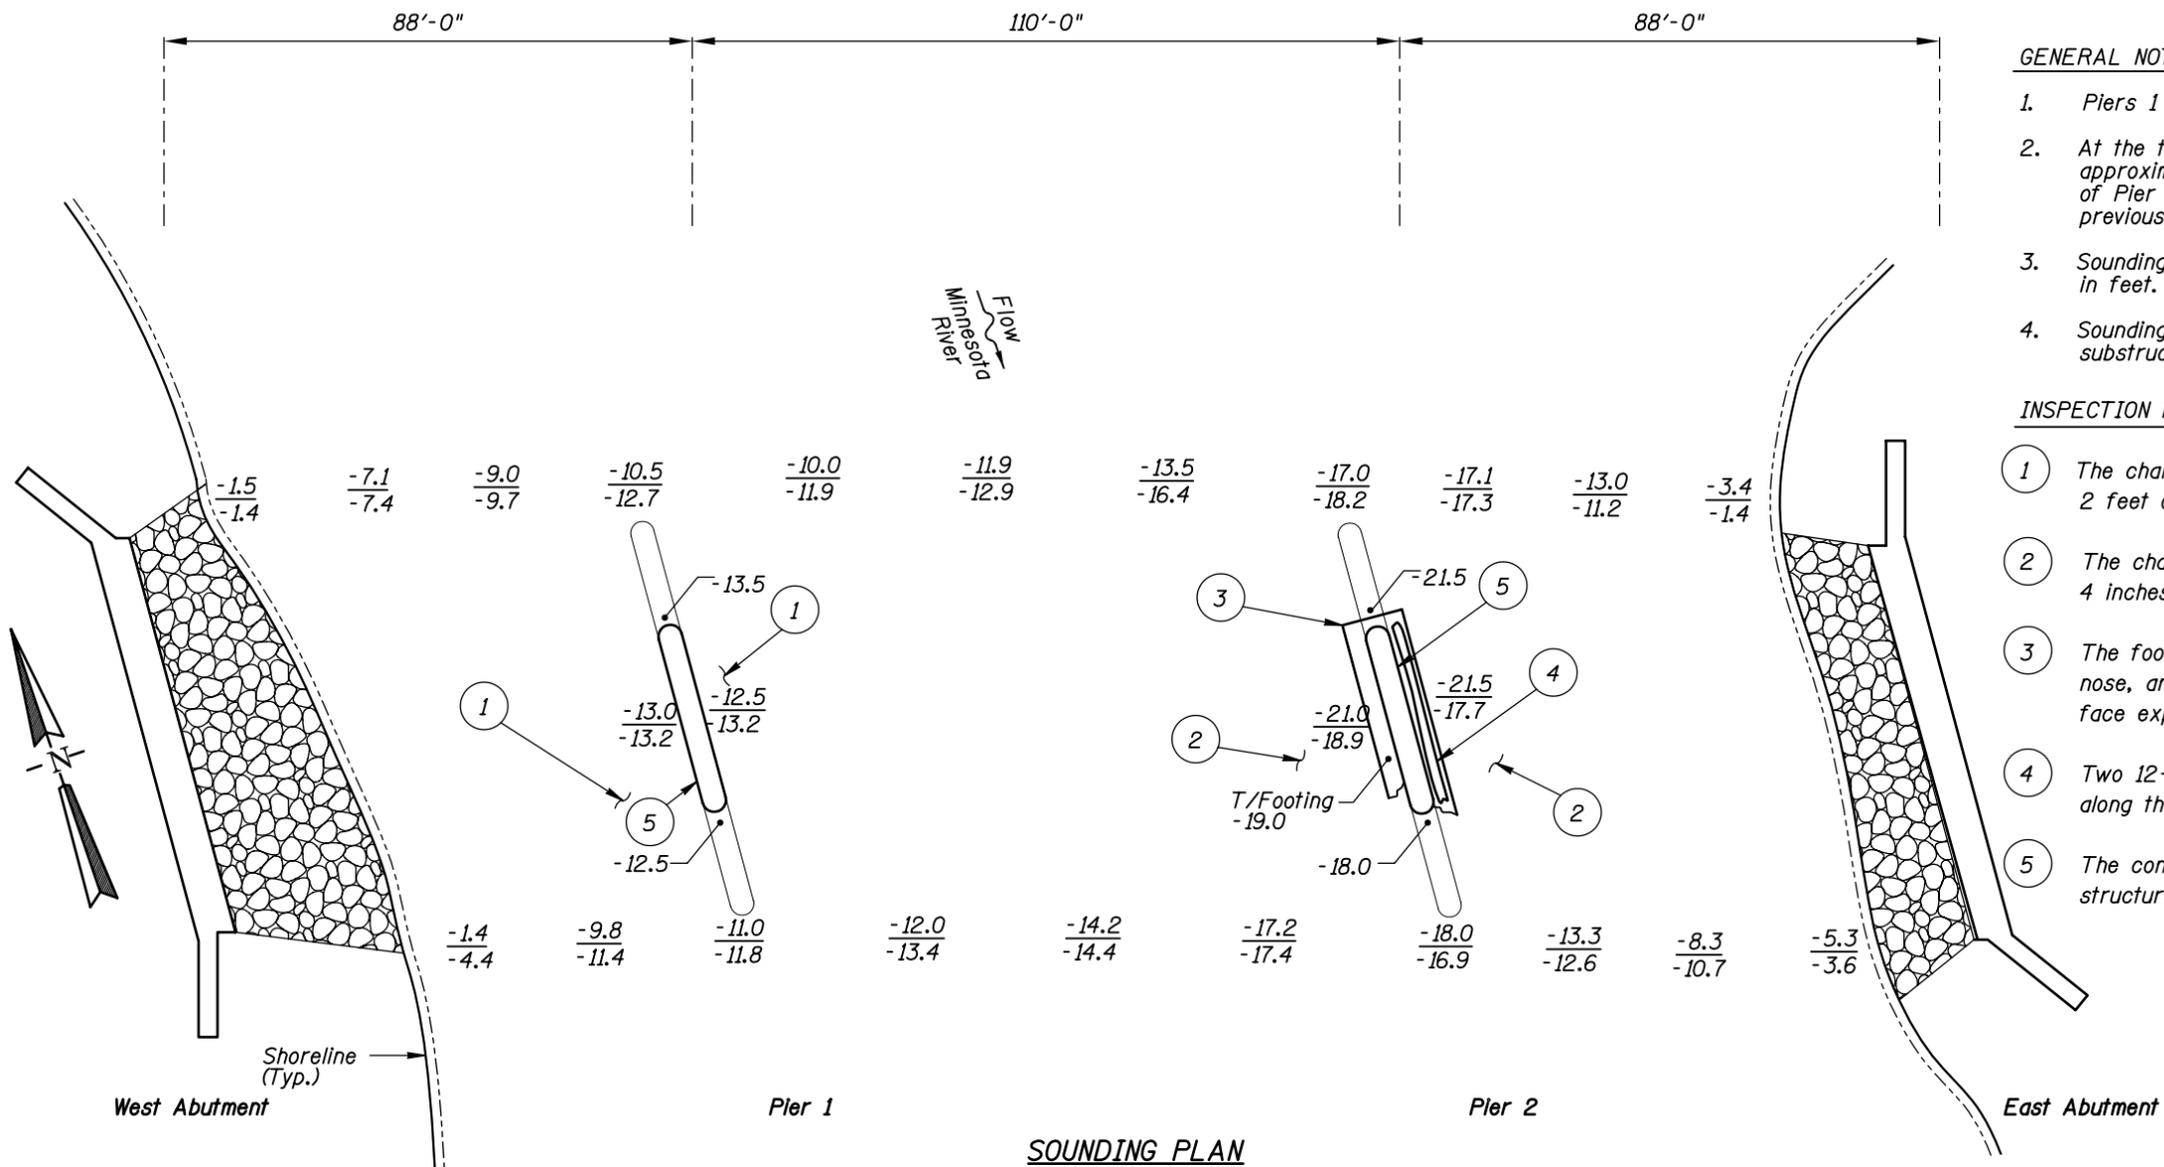
- ① The channel bottom consisted of soft silt over gravel with up to 2 feet of probe rod penetration.
- ② The channel bottom consisted of bedrock overlaid with up to 4 inches of silt.
- ③ The footing was exposed along the west face, around the upstream nose, and along the east face of Pier 2 with up to 2.5 feet of vertical face exposure at the upstream nose.
- ④ Two 12-inch-diameter logs were observed on the channel bottom along the east face of Pier 2.
- ⑤ The concrete surfaces were in good and sound condition with no structurally significant defects.

- (A) Monitor the footing/bedrock interface at Pier 2 during future inspections for any detrimental erosion and/or gaps along the interface.

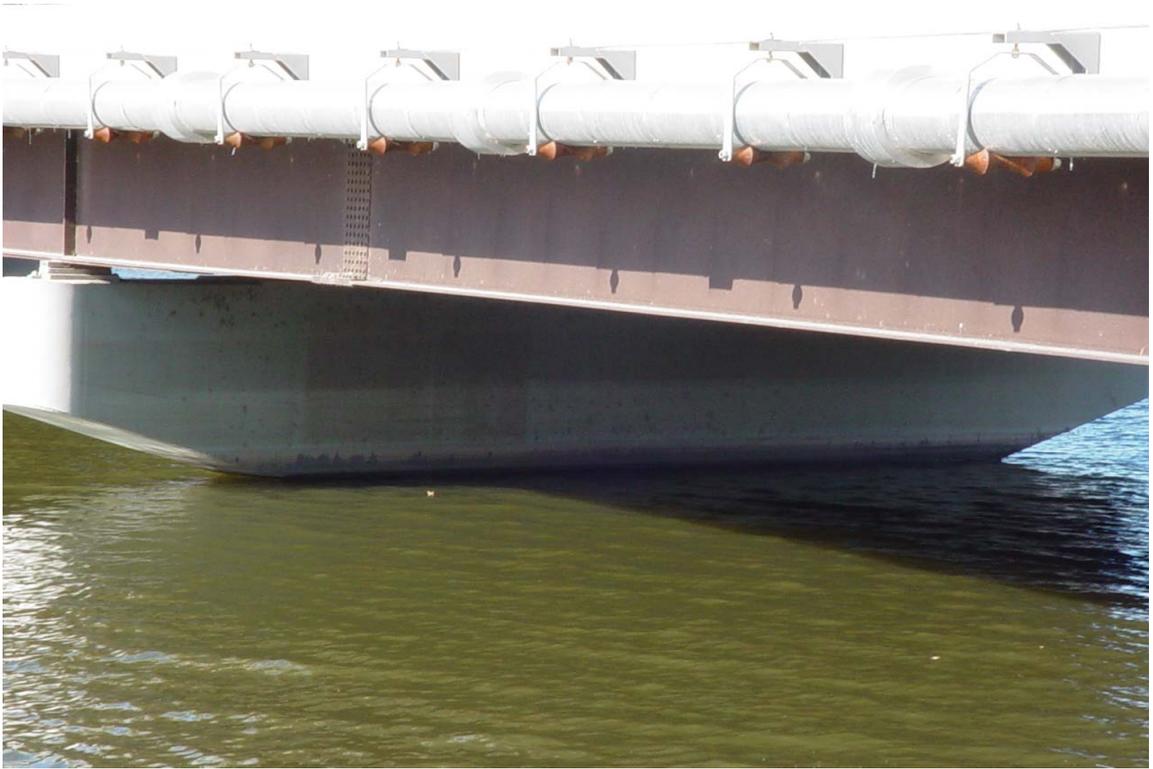
- (A) The footing was exposed along the west face, around the upstream nose, and along the east face of Pier 2 with up to 2.5 feet of vertical face exposure at the upstream nose. The footings of the substructure were keyed into rock according to design plans. The footing/rock joint was snug with little or no gaps between the surfaces.
- (B) Two 12-inch-diameter legs were on the channel bottom around Pier 2.
- (C) The concrete surfaces of the piers were smooth and sound with no significant defects.

Photograph 3. View of Pier 2, Looking Northwest.
