UNDERWATER BRIDGE INSPECTION REPORT

STRUCTURE NO. 7202

MINNESOTA RIVER

MINNESOTA DEPARTMENT OF TRANSPORTATION
UNDERWATER BRIDGE INSPECTION

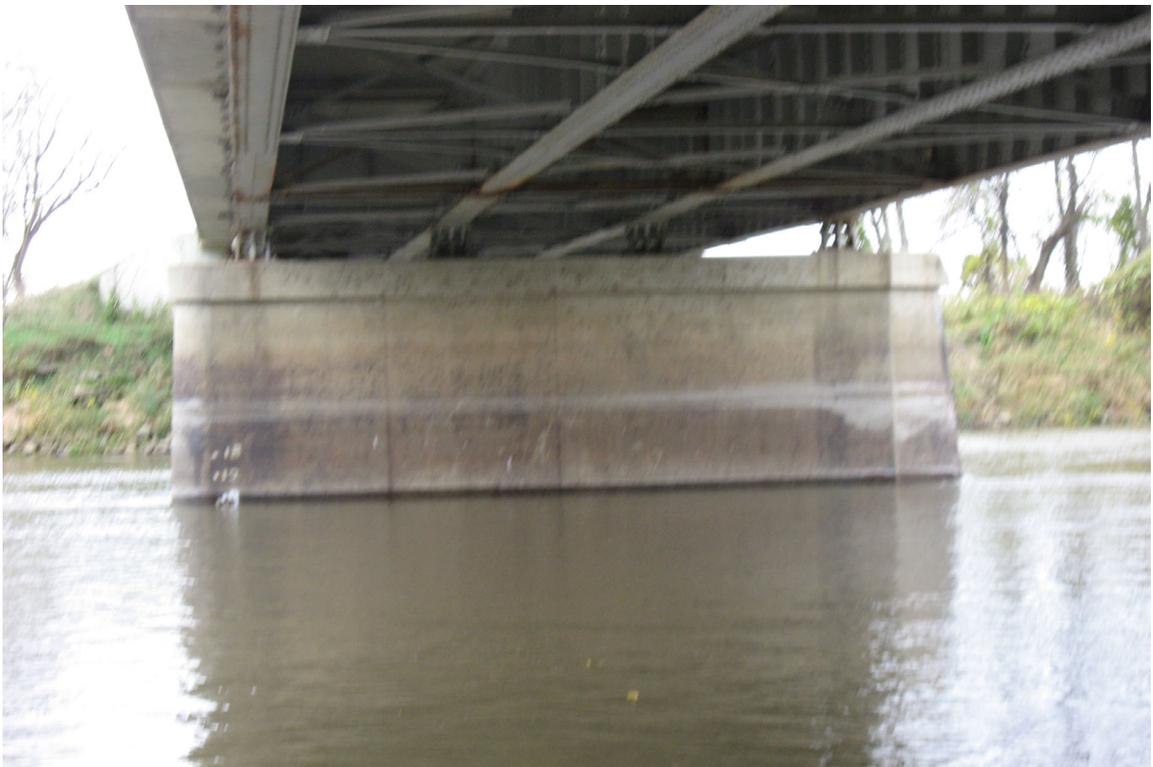
- (A) A 1.5-foot-diameter log and some smaller timber debris were observed off the upstream nose of Pier 2.
- (B) Two areas of section loss on the shaft of Pier 2 were observed 6 feet above the waterline measuring 3 to 6 inches in diameter with up to 1/2 inch of penetration.

Photograph 2. View of Pier 2, Looking Southeast.

- (A) Monitor the timber debris at Pier 2, and if found to be increasing in the future, removal operations may become warranted.
- (B) Since the bridge is rated scour critical, monitor for a re-occurrence of footing exposure in future inspections and especially during or soon after any flood flows.

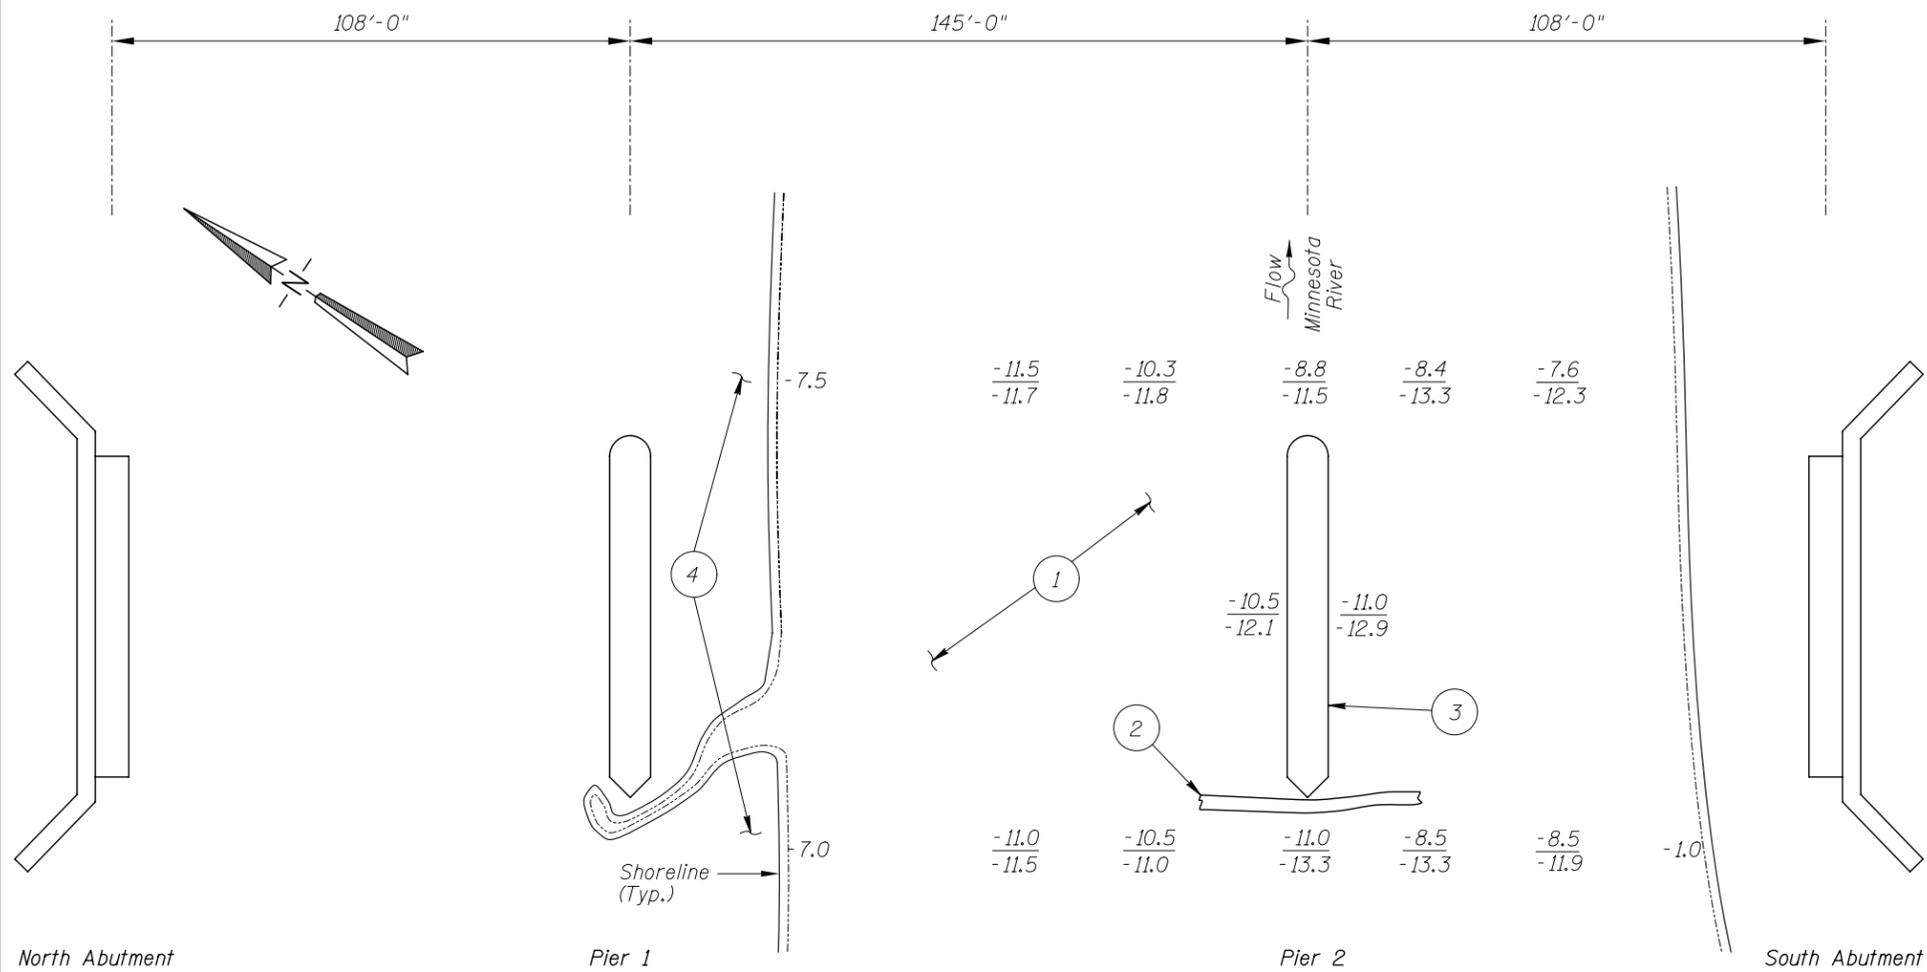
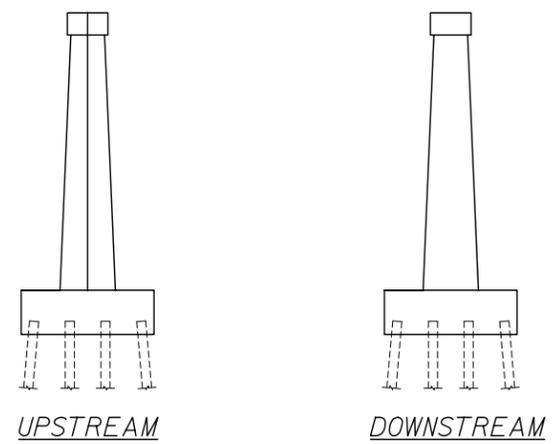
SOUNDING PLAN

- 1 The channel bottom around Pier 2 consisted of sandy infilling with up to 1 foot of probe rod penetration.
- 2 A 1.5 feet in diameter log and other scattered smaller timber drift were observed at the upstream end of Pier 2.
- 3 Two areas of section loss were observed 1 feet above the waterline measuring from 6 inches to 3 inches in diameter with up to 1/2 inch of penetration.
- 4 The north embankment exhibited steep vertical slopes due to significant bank erosion.
