UNDERWATER BRIDGE INSPECTION REPORT

STRUCTURE NO. 02531

RUM RIVER

DISTRICT 5 - ANOKA COUNTY

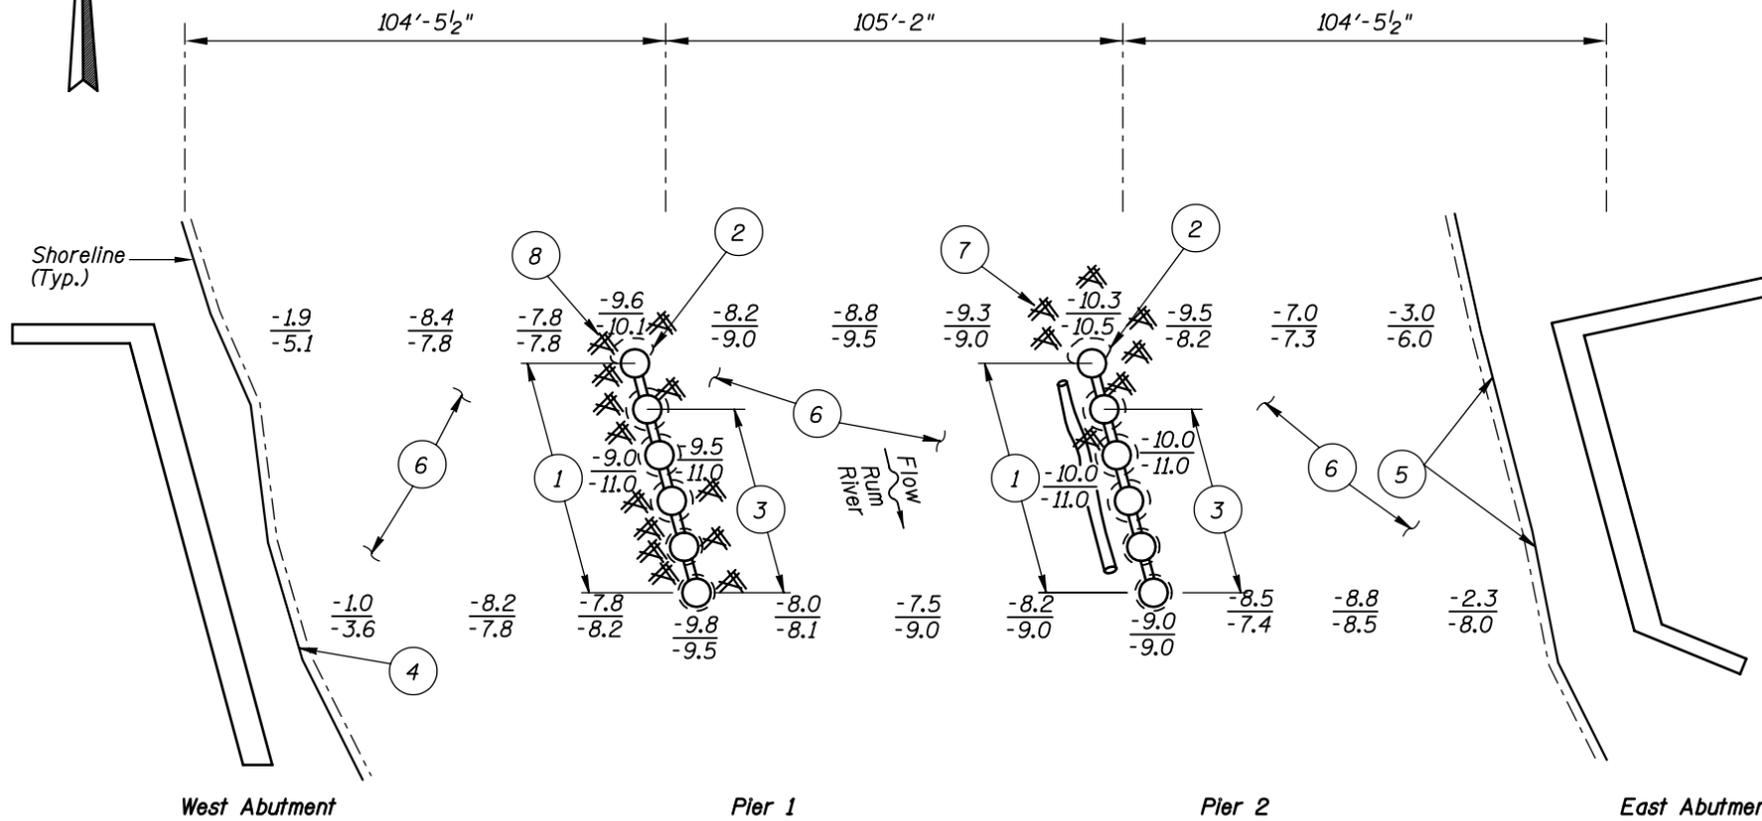
- 1 Minor scaling of the concrete was observed on the piers, from 2 feet below to 4 feet above the waterline, with a 1/4 inch maximum penetration.
- 2 Minor scour pocket, 3 feet in diameter by 2 feet deep, was observed at the upstream column.

- 3 Minor scour pockets were observed around columns with a maximum radius of 1 foot and maximum depth of 1 foot, diminishing in size towards the downstream end of the pier.

- 4 Concrete slope protection exhibited undermining, 4 feet long by 3 inches high, with 1 foot of penetration under the protection.
- 5 Portions of the concrete edge of the slope protection were broken off with undermining along the embankment up to a maximum height of 1 foot and maximum horizontal penetration under the protection of 1 foot.

- 6 The channel bottom material consisted of soft sand with a maximum probe rod penetration of 1 foot around the substructure units.
- 7 A light accumulation of timber debris at the three upstream columns and an eight-inch-diameter tree along the west side was observed at Pier 2.

- 8 A moderate accumulation of 4- to 6-inch-diameter timber debris was observed along the west side and lightly scattered around each of the columns at Pier 1.

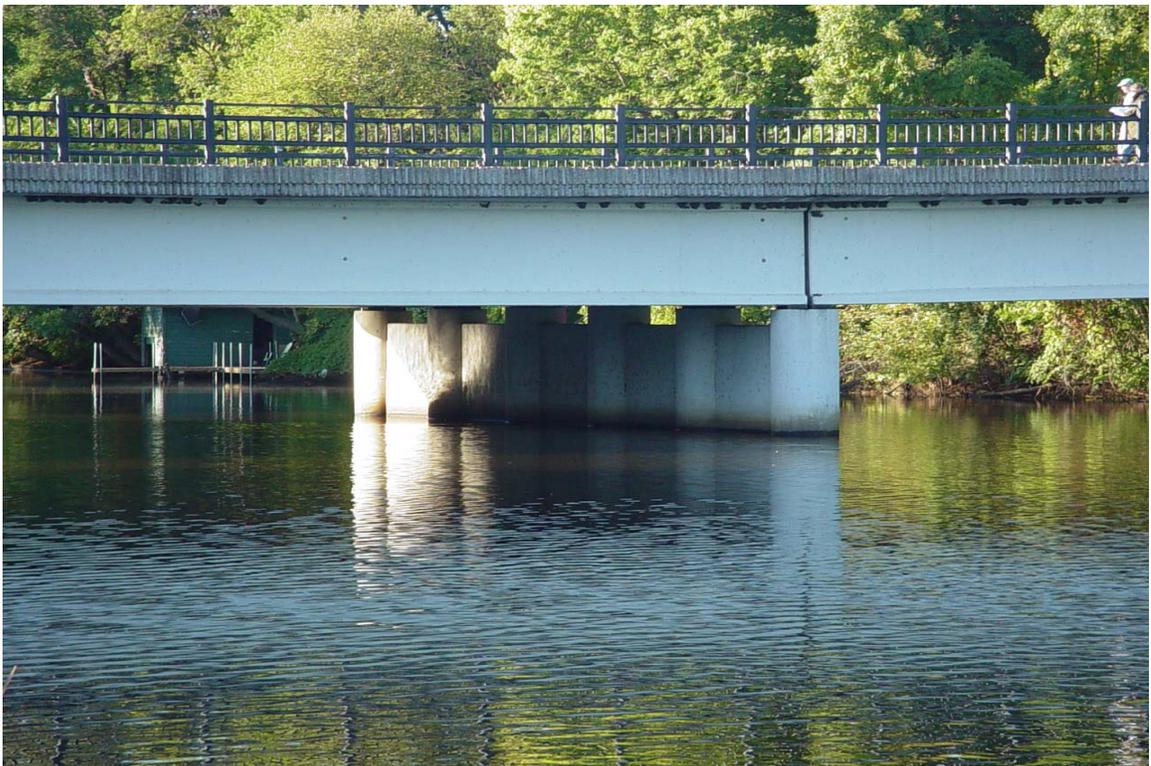
Photograph 2. View of Pier 1, Looking Southeast.

- (A) Monitor the drift at the piers during future inspections and if found to be progressing removal of the accumulations of timber debris from around the piers may be warranted at that time.
- (B) Reinspect the submerged substructure units at the normal maximum recommended (NBIS) interval of five (5) years.

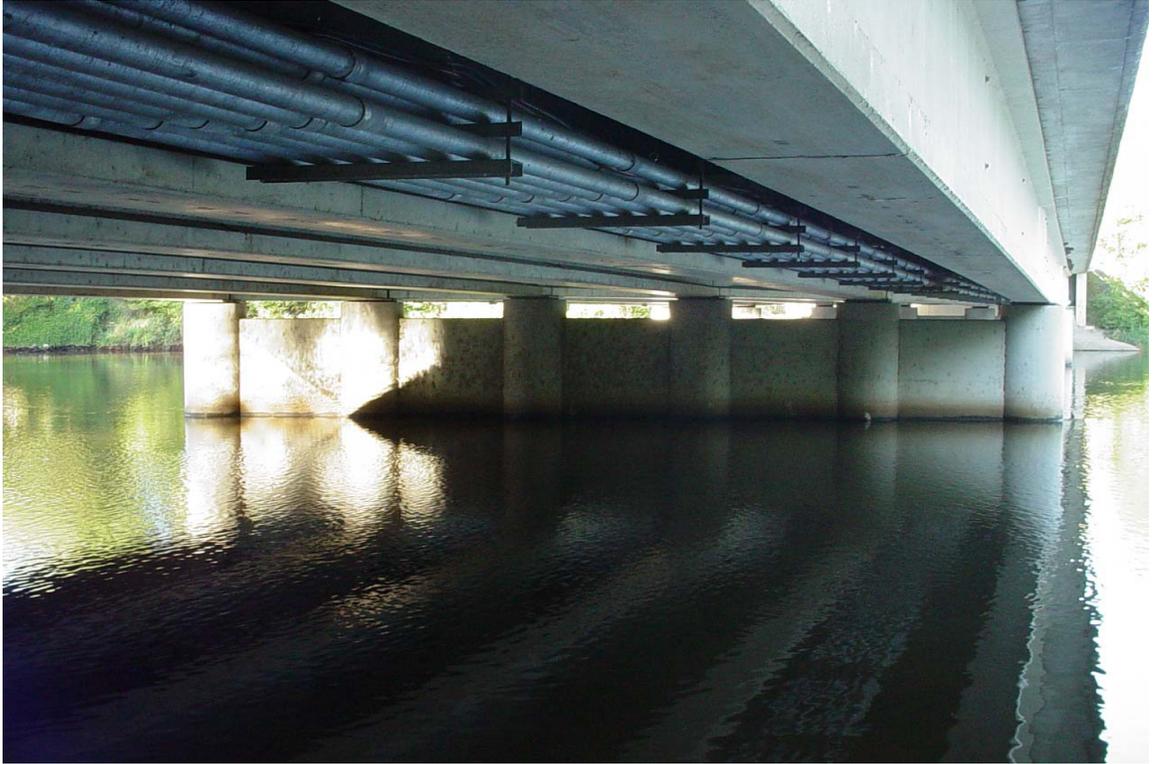
- (E) A light accumulation of timber debris at the three upstream columns and an eight-inch-diameter tree along the west side of the pier was observed at Pier 2. A moderate accumulation of 4- to 6-inch-diameter timber debris was observed along the west side and lightly scattered around each of the columns at Pier 1.

Photograph 3. View of Pier 2, Looking West.

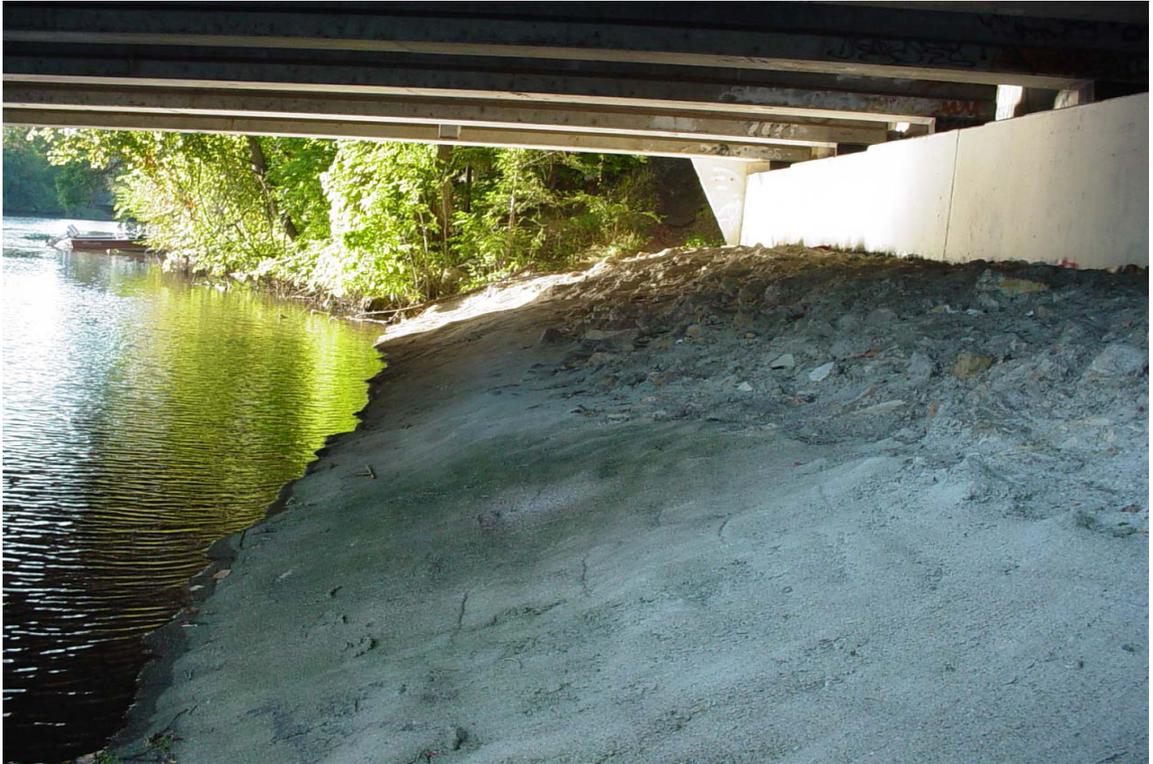
Photograph 4. View of West Slopewall, Looking South.
