UNDERWATER BRIDGE INSPECTION REPORT

STRUCTURE NO. 27608
BROADWAY AVENUE
OVER
THE MISSISSIPPI RIVER
DISTRICT 5 - HENNEPIN COUNTY

PREPARED FOR THE
MINNESOTA DEPARTMENT OF TRANSPORTATION
BY
COLLINS ENGINEERS, INC.
JOB NO. 3512 (CEI 116)

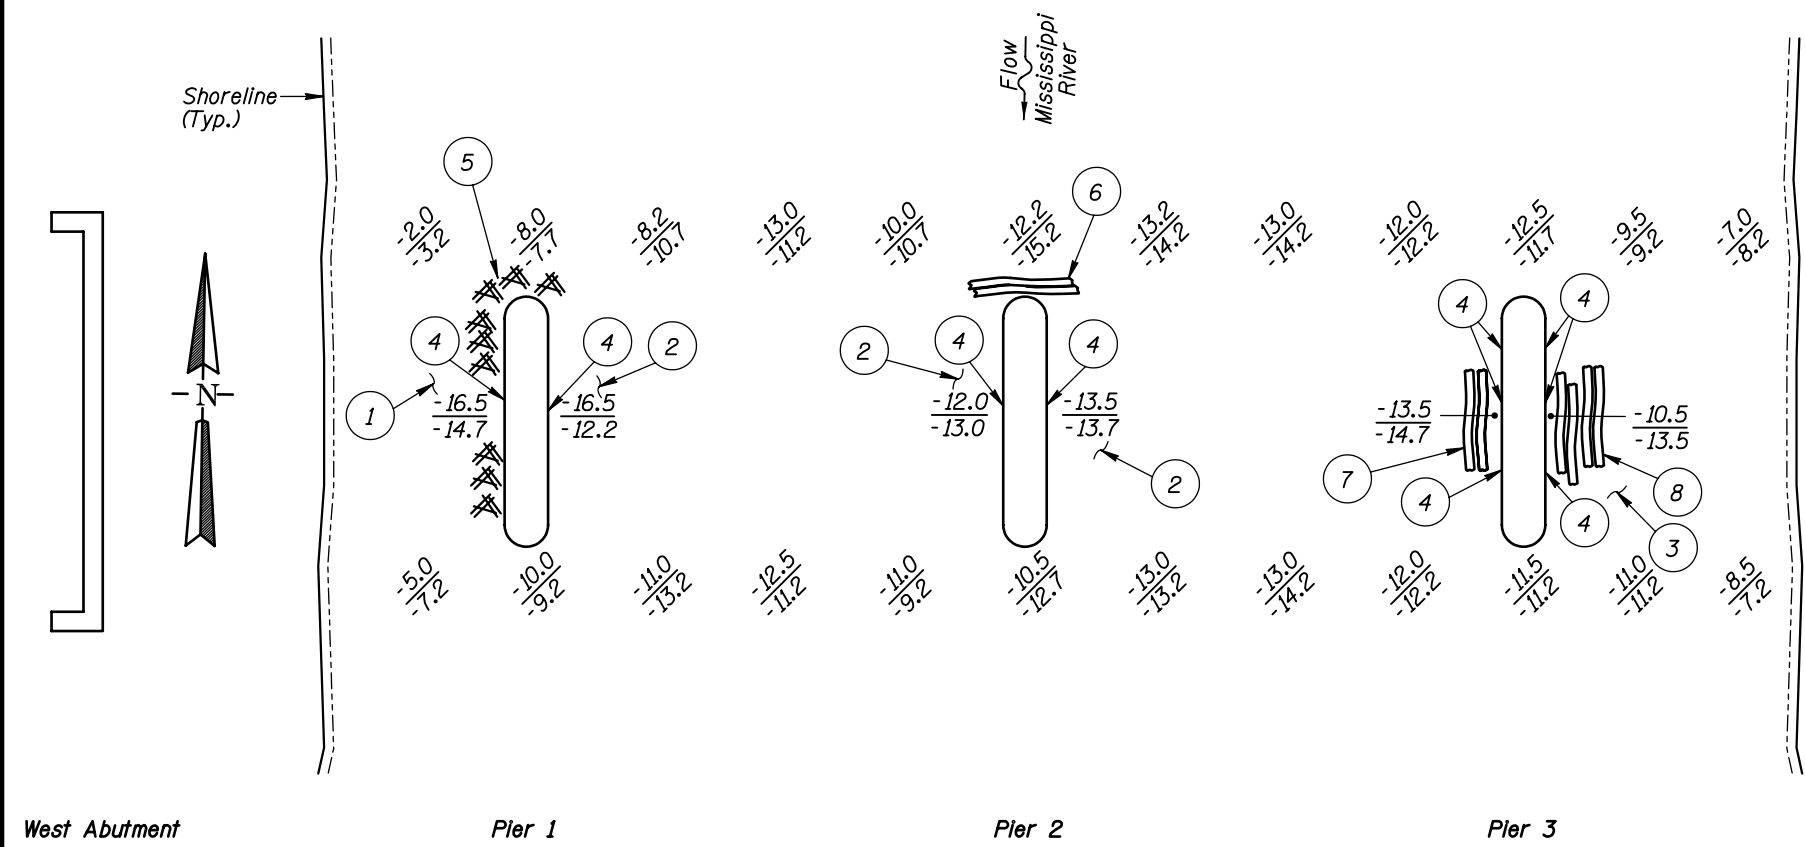
SOUNDING PLAN

- 1 The channel bottom consisted of riprap up to 2 feet in diameter along the west face of Pier 1.
- 2 The channel bottom consisted of silty sand with up to 1 foot of probe rod penetration.

- 3 Scattered riprap, up to 4 feet in diameter, and steel debris was observed on the channel bottom along the downstream east face of Pier 3.
- 4 A vertical hairline crack extended from the top of the above water step in the shaft portion on the pier to the waterline.

- 5 A moderate accumulation of timber debris, with pieces up to 2 feet in diameter, was observed at the upstream end of Pier 1 and extending along the west face of the pier.

- 6 A light accumulation of timber debris, with pieces up to 1 foot in diameter, was observed at the upstream end of Pier 2.
- 7 Timber debris consisting of two tree trunks, 18 inches in diameter, was observed along the west face of Pier 3.

- 8 Timber debris consisting of four tree trunks, up to 2 feet in diameter, was observed along the east face of Pier 3.

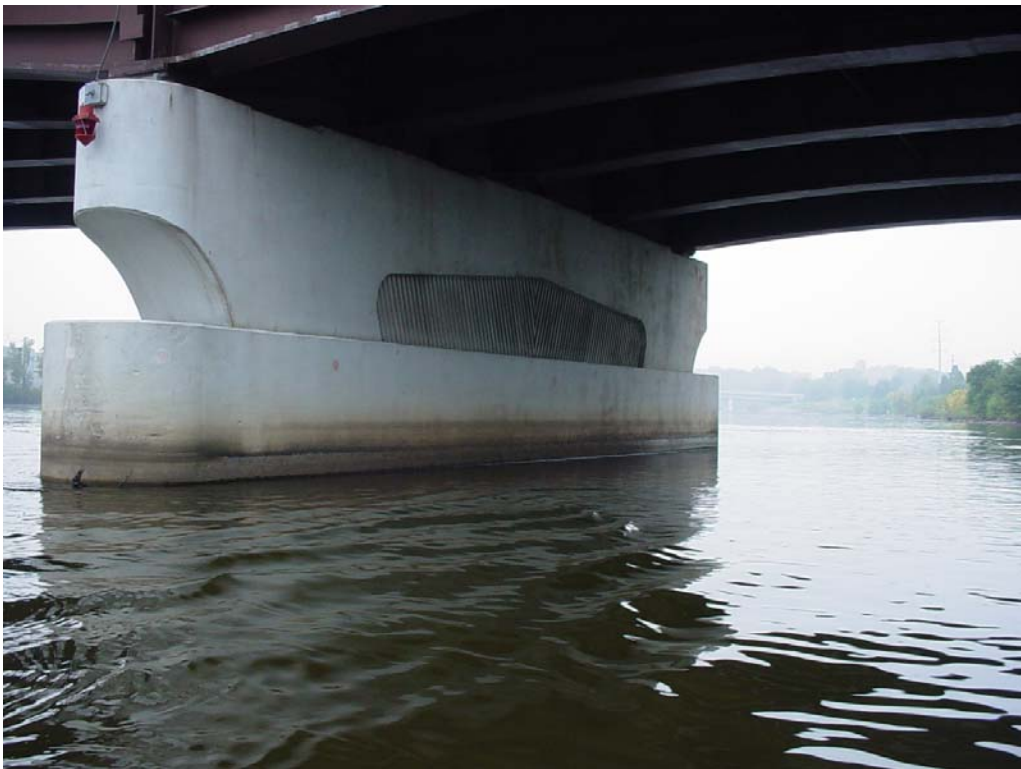
- (B) A moderate accumulation of timber debris, with pieces up to 2 feet in diameter, was observed at the upstream end of Pier 1, extending along the west face of the pier to the downstream nose.

Photograph 2. View of Pier 1, Looking Southeast

- (A) Monitor the timber debris at all of the piers, and if found to be increasing in the future, removal operations may become warranted.

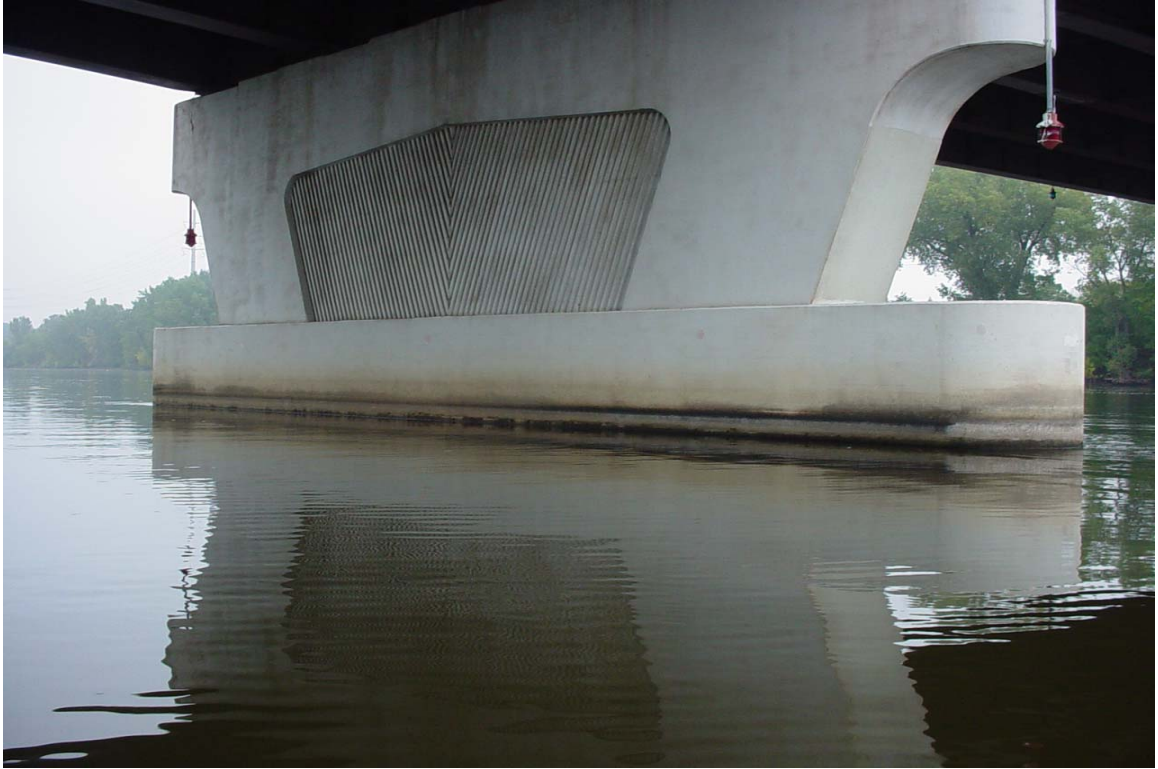
- (C) A light accumulation of timber debris, with pieces up to 1 foot in diameter, was observed at the upstream end of Pier 2 on the channel bottom.
- (D) A moderate to heavy accumulation of timber debris consisting of two tree trunks, each 18 inches in diameter, along the west face and four tree trunks, up to 2 feet in diameter, along the east face was observed at Pier 3.

Photograph 3. View of Pier 2, Looking Northeast.

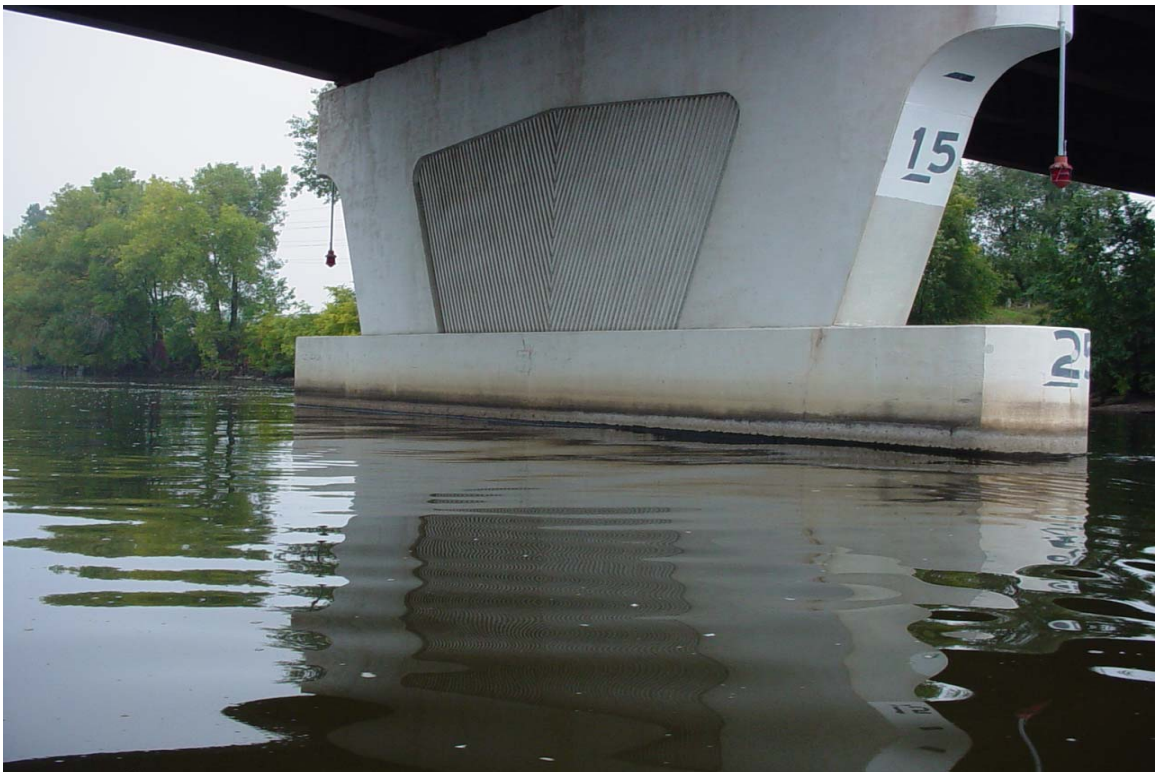
Photograph 4. View of Pier 3, Looking Southwest.

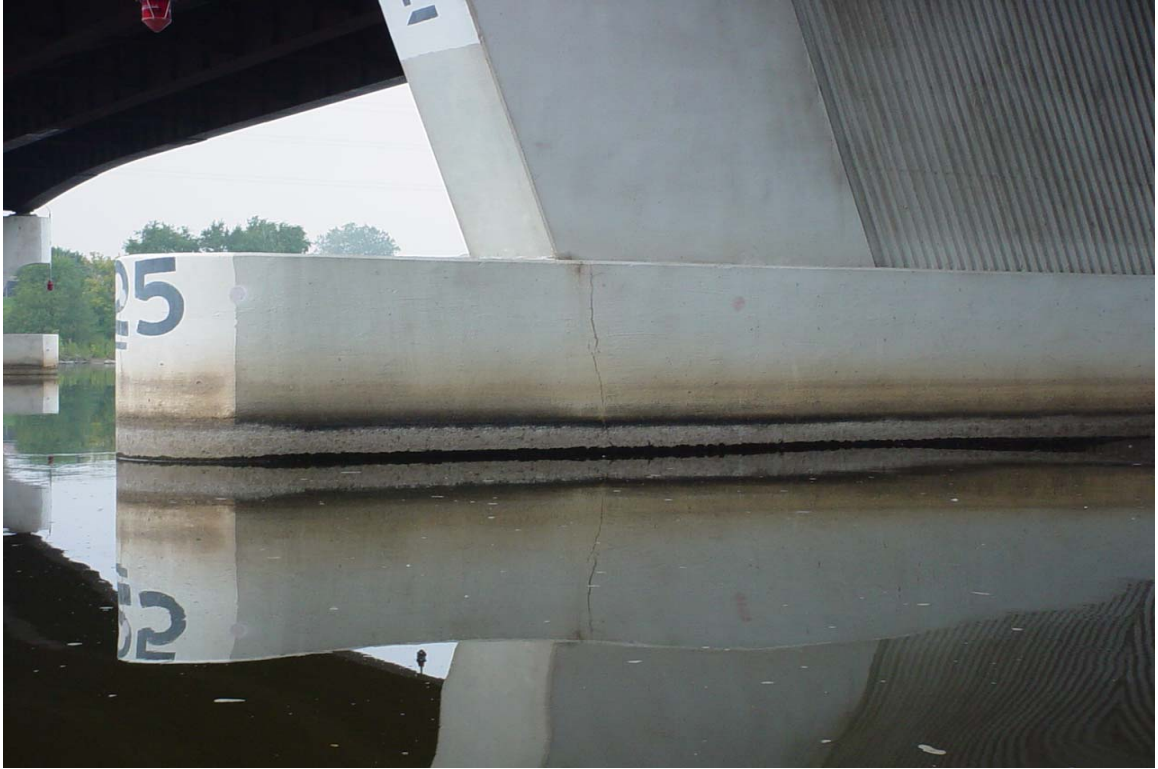
- (A) Piers 1, 2, and 3 exhibited vertical hairline cracks at the midpoint of the pier shaft, extending from the top of the above water step to the waterline on both faces. In addition, Pier 3 exhibited vertical hairline cracks at the upstream and downstream quarter points, extending from the top of the same step to the waterline on both faces.

Photograph 5. View of Pier 3 Crack at Downstream Quarter Point, Looking West
