UNDERWATER BRIDGE INSPECTION REPORT

STRUCTURE NO. 9360

MISSISSIPPI RIVER

MINNESOTA DEPARTMENT OF TRANSPORTATION
UNDERWATER BRIDGE INSPECTION

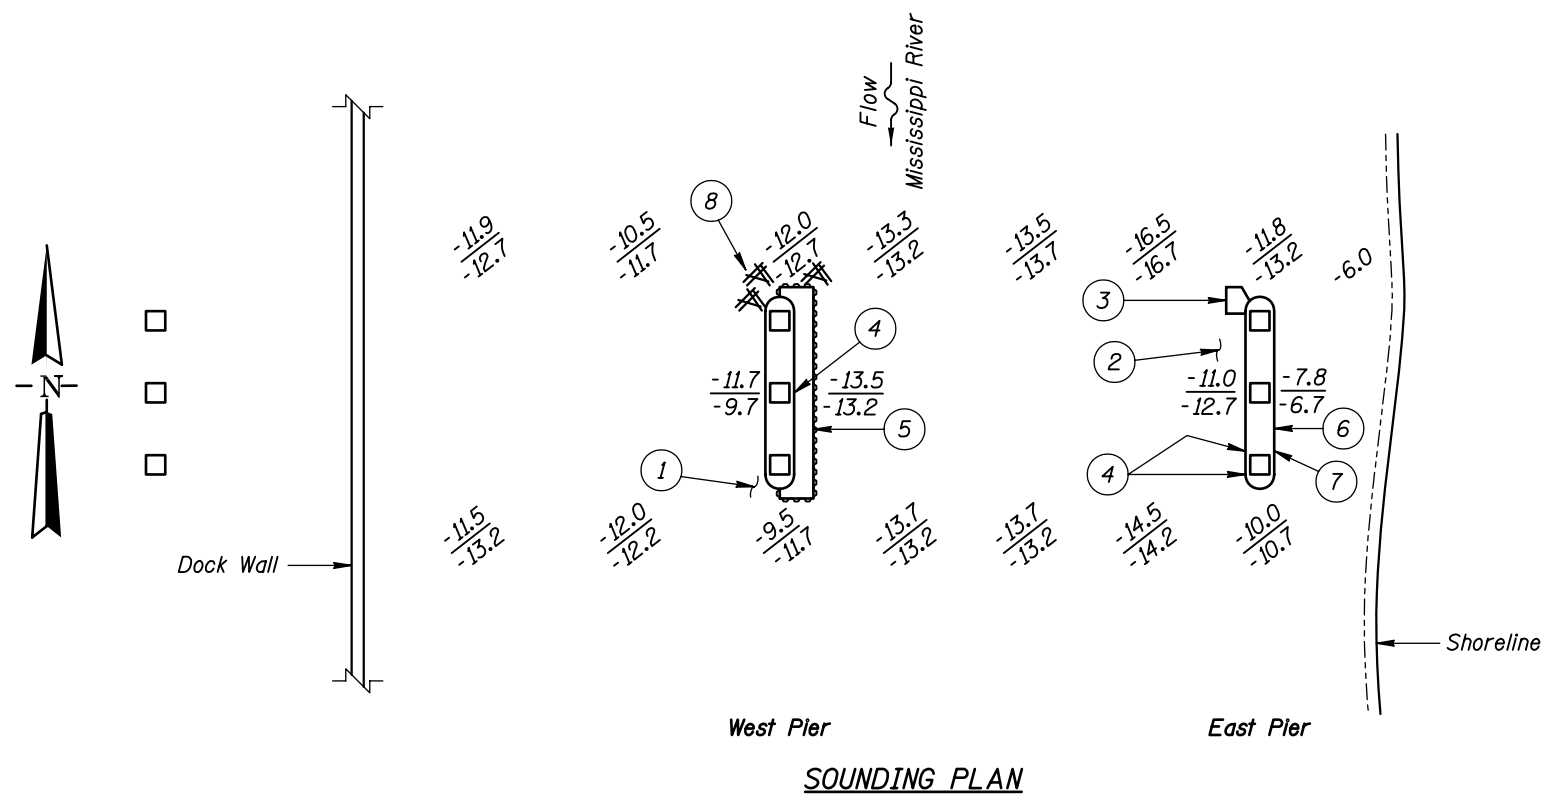
- 1 The channel bottom around the West Pier consisted of 2 to 3 foot diameter riprap along the upstream nose. The west side of the pier consisted of sand and gravel.

- 2 The channel bottom all around the East Pier consisted of 2 to 3 foot diameter riprap.
- 3 Footing exposure at the northwest corner of the East Pier, 4 feet wide by 10 feet long, with 1 foot of vertical exposure.

- 4 Vertical hairline crack with efflorescence from the top of the web wall to the waterline with 1/16 inch maximum width.
- 5 Footing exposure all along the east face of the West Pier with 3 feet maximum vertical exposure and protruding reinforcing steel.

- 6 Horizontal hairline cracks in random areas along the west face of East Pier.
- 7 A spall was observed along a joint at 1 foot below the waterline down 2 feet and was 2 inches wide with up to 1 inch of penetration.

- 8 Minor accumulation of 4 to 6 inch diameter timber debris around the upstream nose of the West Pier. Sheet piling was observed along the edge of the footing and reinforcing steel was protruding from the top of the footing.

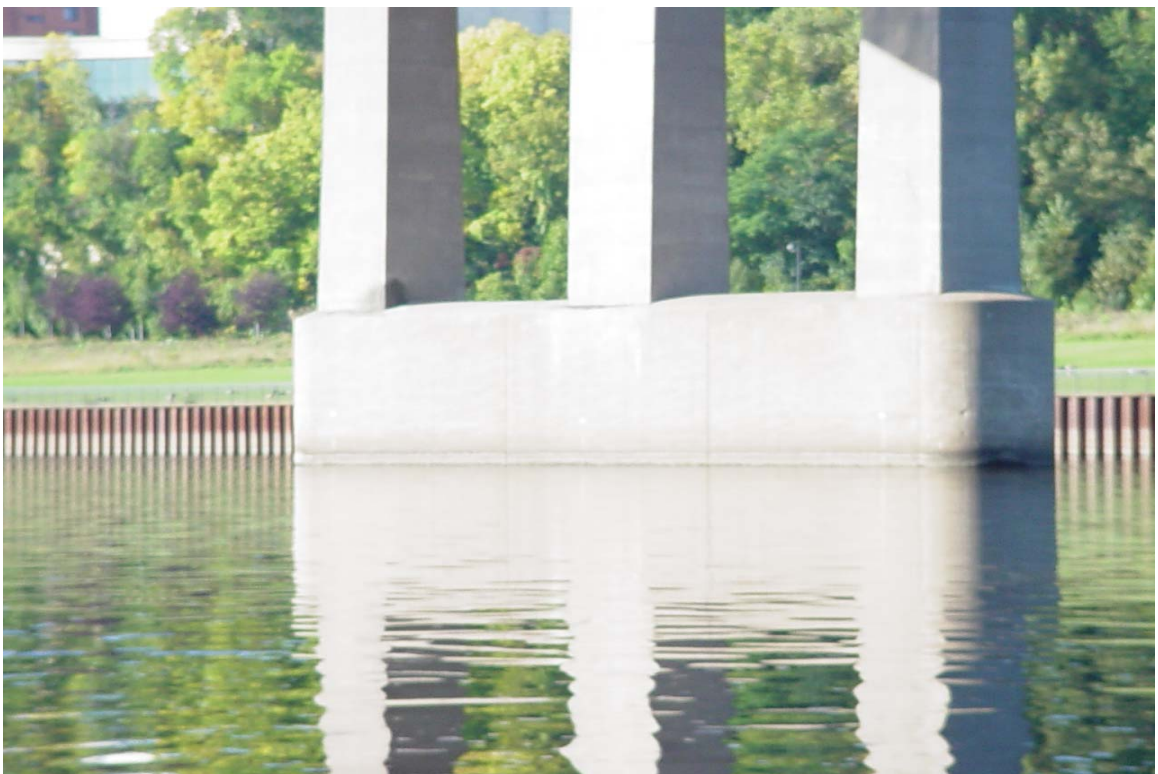
- (A) All along the east side of the West Pier, the footing was exposed with a maximum vertical face exposure of 3 feet. Sheet piling was observed along the edge of the footing and reinforcing steel was protruding from the top of the footing.
- (B) The footing of the East Pier was exposed at the northwest corner, over an area 4 feet wide by 10 feet long, with a maximum vertical exposure of 1 foot.
- (C) A minor accumulation of 4 to 6 inch diameter timber debris was observed around the upstream nose of the West Pier.

Photograph 2. View of West Pier, Looking Southwest.

- (A) No plans for the structure were available at the time of the inspection. It is recommended that existing plans be reviewed to determine the foundation type and depth at both piers in regard to the footing exposure. Normally, the foundations of bridges on the Mississippi River are deep and/or founded on piling, which would suggest no reason for concern at this time, if that is confirmed to be the case. If not, countermeasures could be warranted, such as placing riprap around the exposed footing at both piers to prevent further exposure.

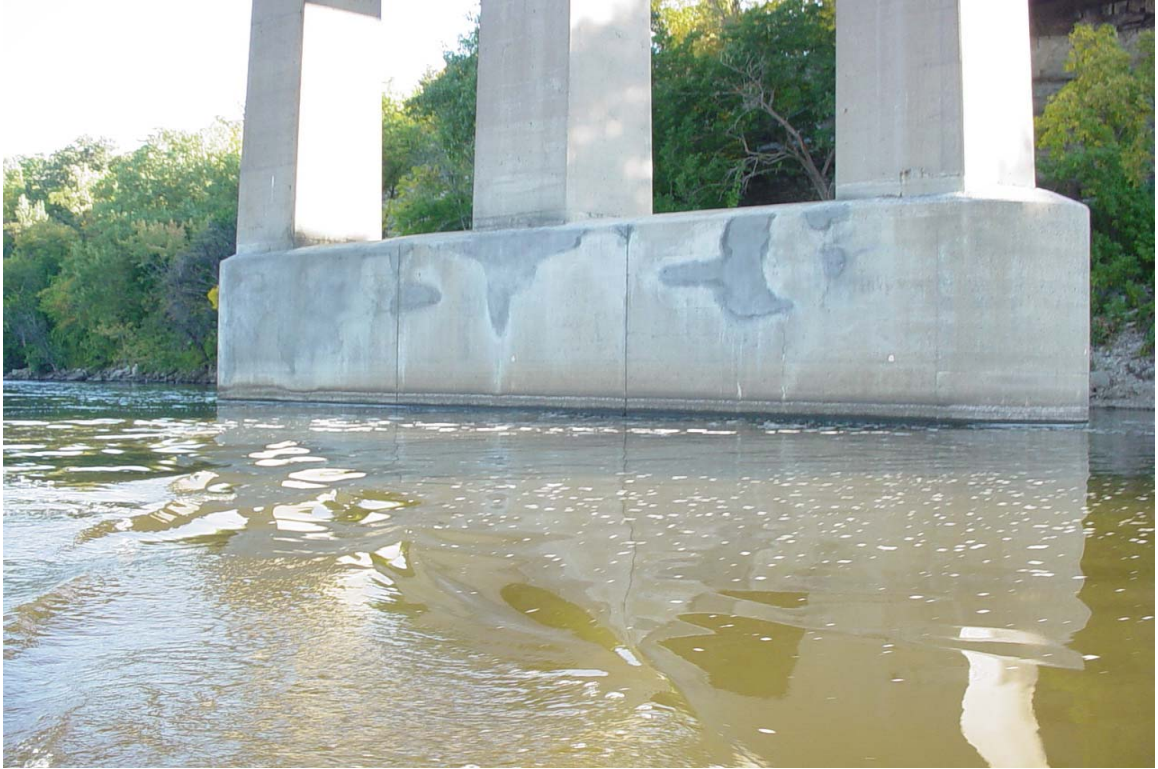
Photograph 3. View of East Pier, Looking Northeast. Note the Spall Repair.
