UNDERWATER BRIDGE INSPECTION REPORT

STRUCTURE NO. 27538
CSAH NO. 52 (HENNEPIN AVENUE)
OVER THE
EAST CHANNEL OF THE MISSISSIPPI RIVER
DISTRICT 5 - HENNEPIN COUNTY

PREPARED FOR THE
MINNESOTA DEPARTMENT OF TRANSPORTATION
BY
COLLINS ENGINEERS, INC.
JOB NO. 5221 (CEI 119)

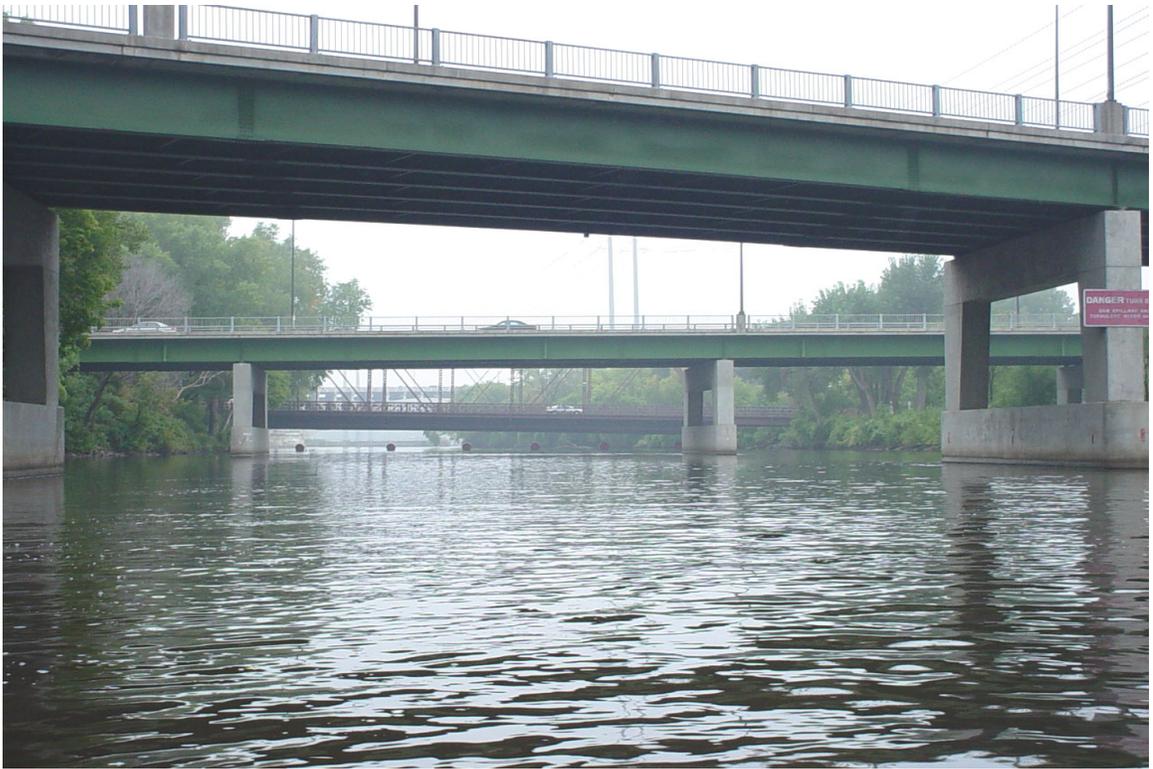
Photograph 1. Overall View of Structure, Looking East.

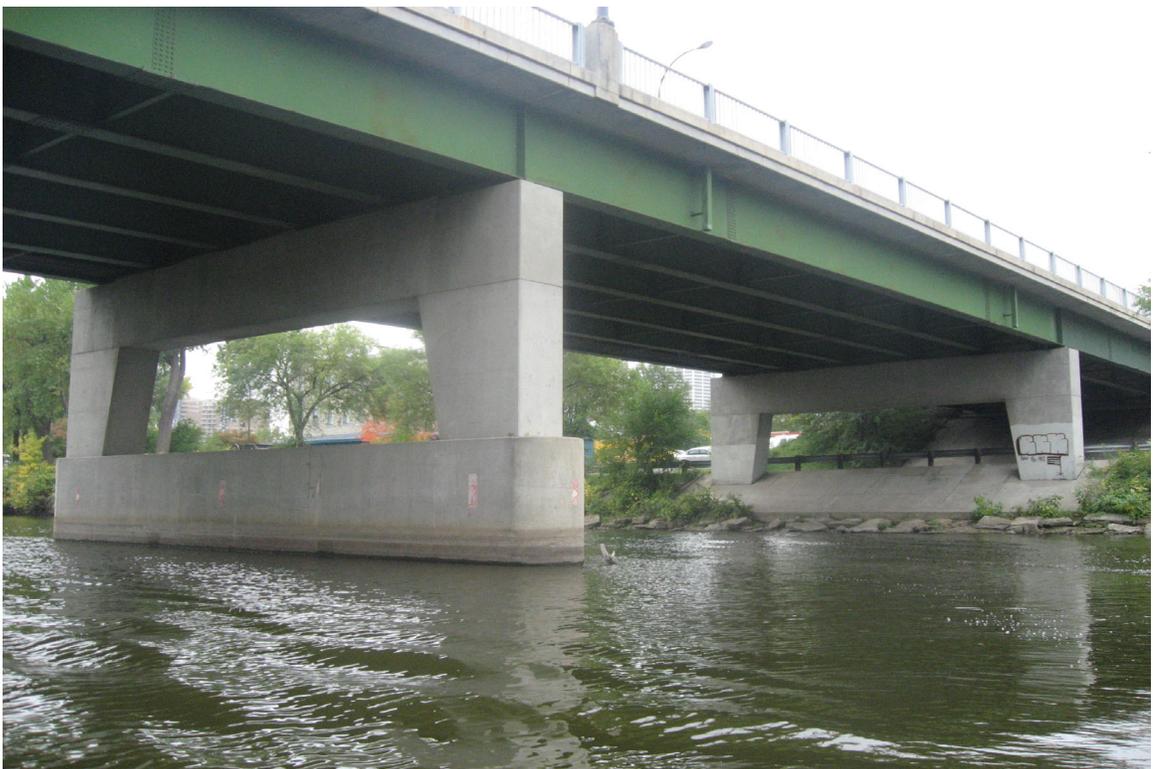
Photograph 2. View of Pier 2, Looking Southwest.

- Light accumulation of timber debris, mainly smaller branches, was observed on the channel bottom at the upstream nose of Pier 2. A 1-foot-diameter log was observed along the West face of Pier 2.

- The concrete at Piers 1 and 2 exhibited minor scaling with up to 1/8 inch penetration.
- Vertical cracks (1/16 inch maximum width) were observed at both faces of Pier 2 (4 on each face) extending from channel bottom to top of the pier shaft.

- Scour depression 3-foot-diameter and 1-foot-deep was observed at the upstream east corner of Pier 2. A 3 inch layer of silty sand was found on top of footing. No footing exposure was observed.

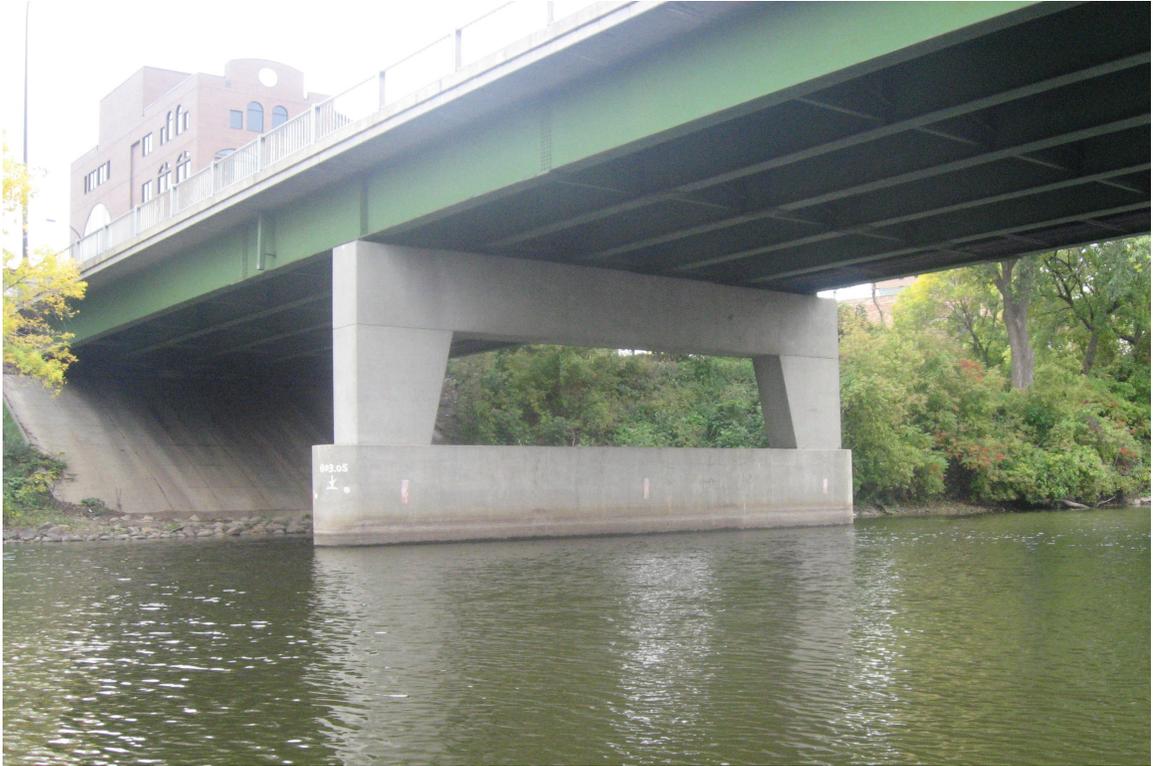
Photograph 3. View of Pier 3, Looking Southeast.

- Vertical cracks (1/16 inch maximum width) were observed at east face of Pier 3 (5 cracks) and west face of Pier 3 (4 cracks) extending from channel bottom to top of the shaft (typically).

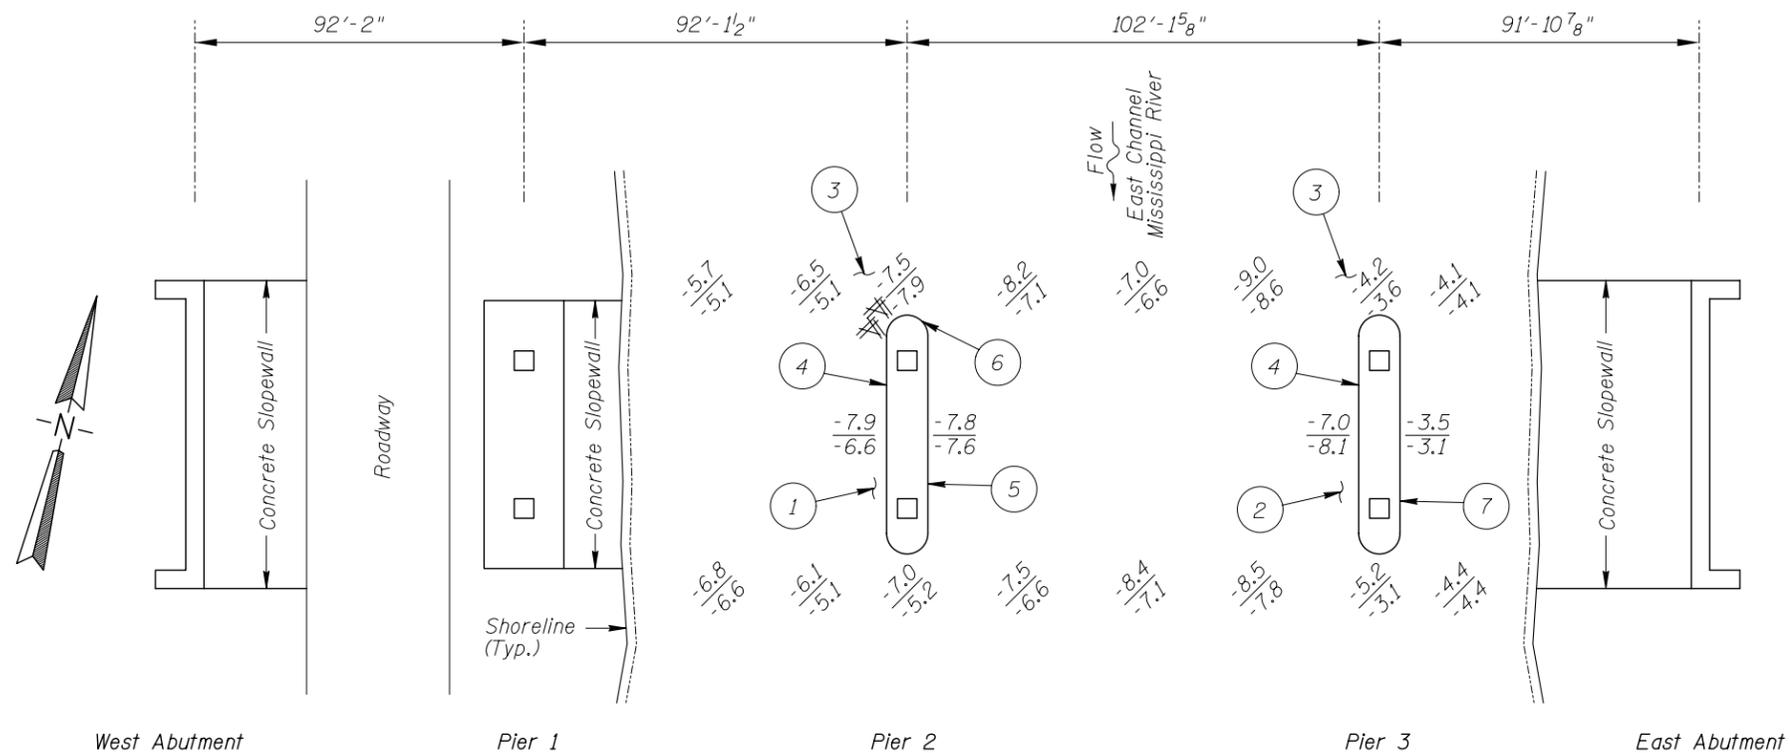
TYPICAL END VIEW OF PIERS 2 AND 3

- The channel bottom material around Pier 2 consisted of silty sand with up to 1 foot of probe rod penetration.
- The channel bottom material around Pier 3 consisted of silty sand with up to 1 foot of probe rod penetration and scattered riprap typically less than 1 foot in diameter except at the pier noses where the riprap was 2 to 4 feet in diameter.
