UNDERWATER BRIDGE INSPECTION REPORT

STRUCTURE NO. 13505

CSAH 19

SUNRISE RIVER

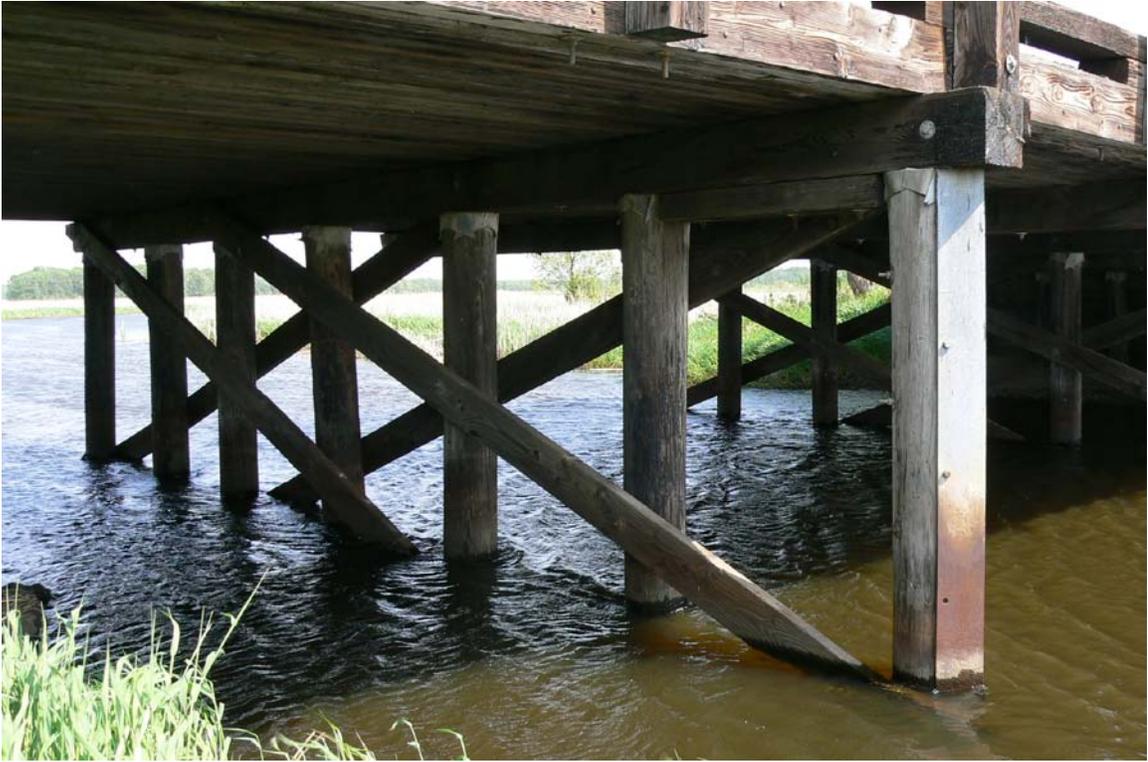
Photograph 1. View of Pier 1, Looking Northeast.

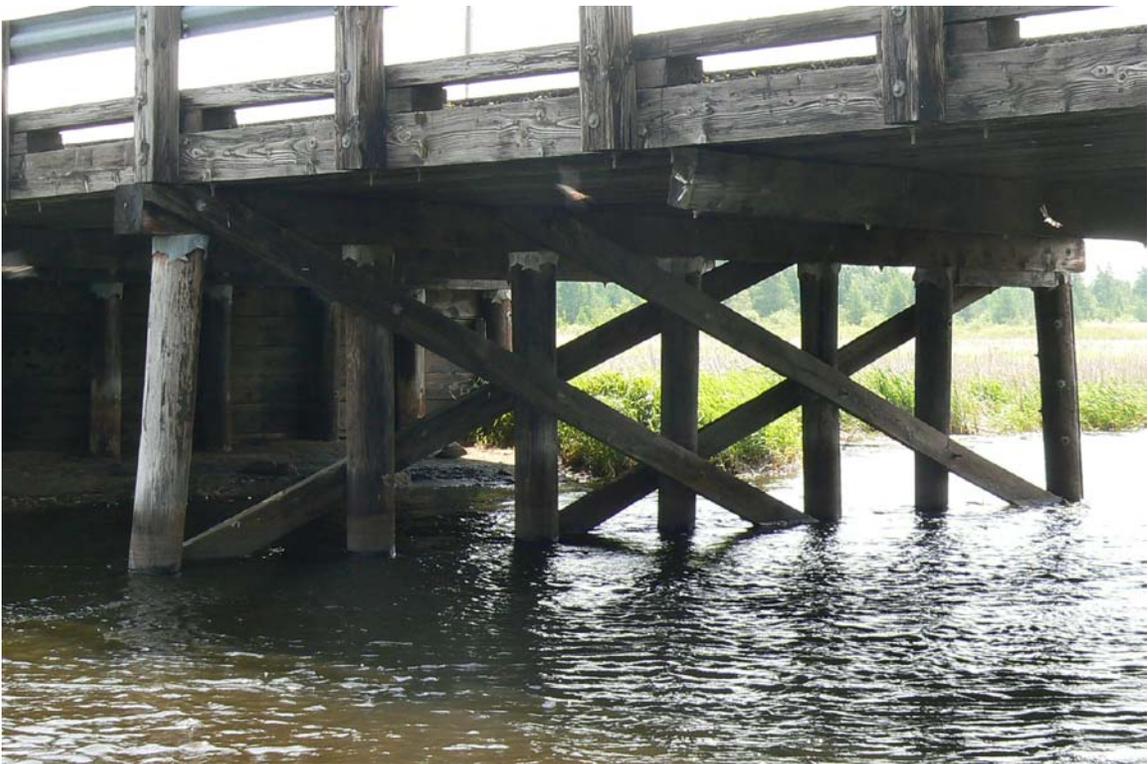
Photograph 2. View of Pier 2, Looking Southeast.

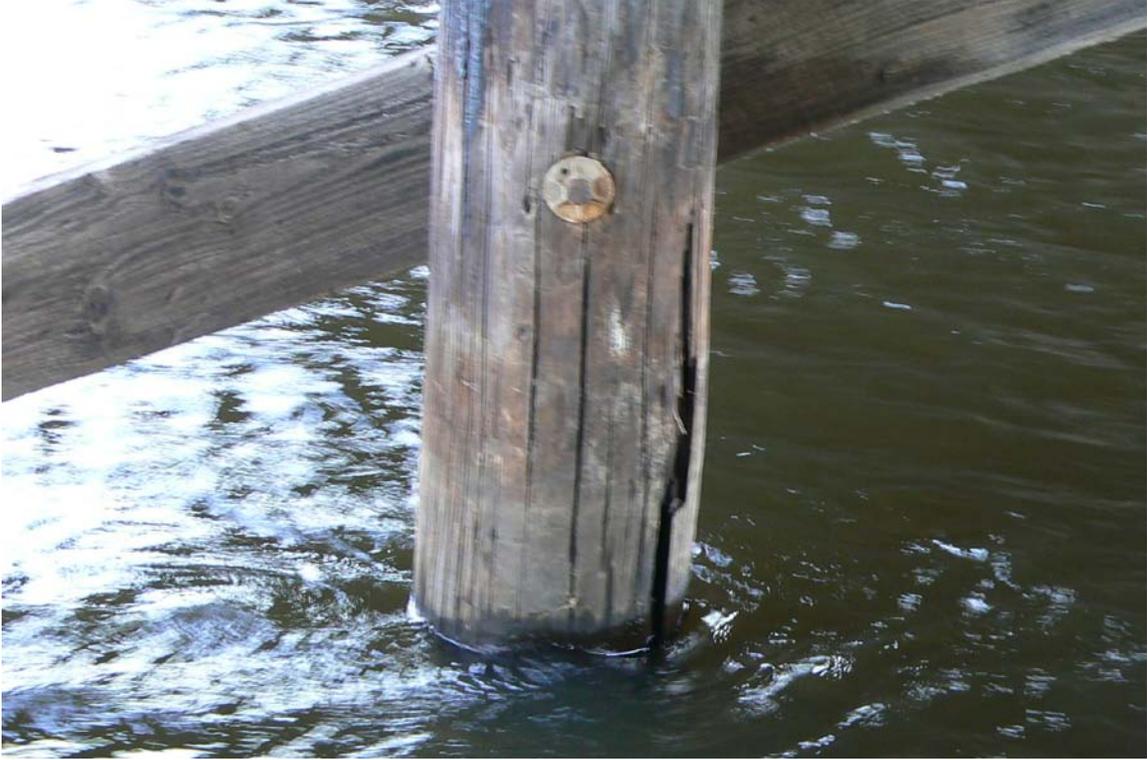
- (A) Channel bottom consisted of sand and cobbles up to 18 inches diameter with no probe rod penetration.
- (B) Timber piles and cross bracing were generally sound with checking typically 1/8 inch wide and up to 1/4 inch wide maximum. Timber typically allowed awl penetrations of 1/8 inch.
- (C) Outer shell splitting was observed on the west face of Pier 1, Pile F as well as the south face of Pier 2, Pile B. The deterioration extended from 2 feet above waterline to 1 foot below waterline and was typically 1/2 inch deep.

Photograph 3. View of timber splitting at Pier 1, Pile F, Looking Southeast.

- (A) Reinspect the submerged substructure units at the normal maximum recommended (NBIS) interval of sixty (60) months.

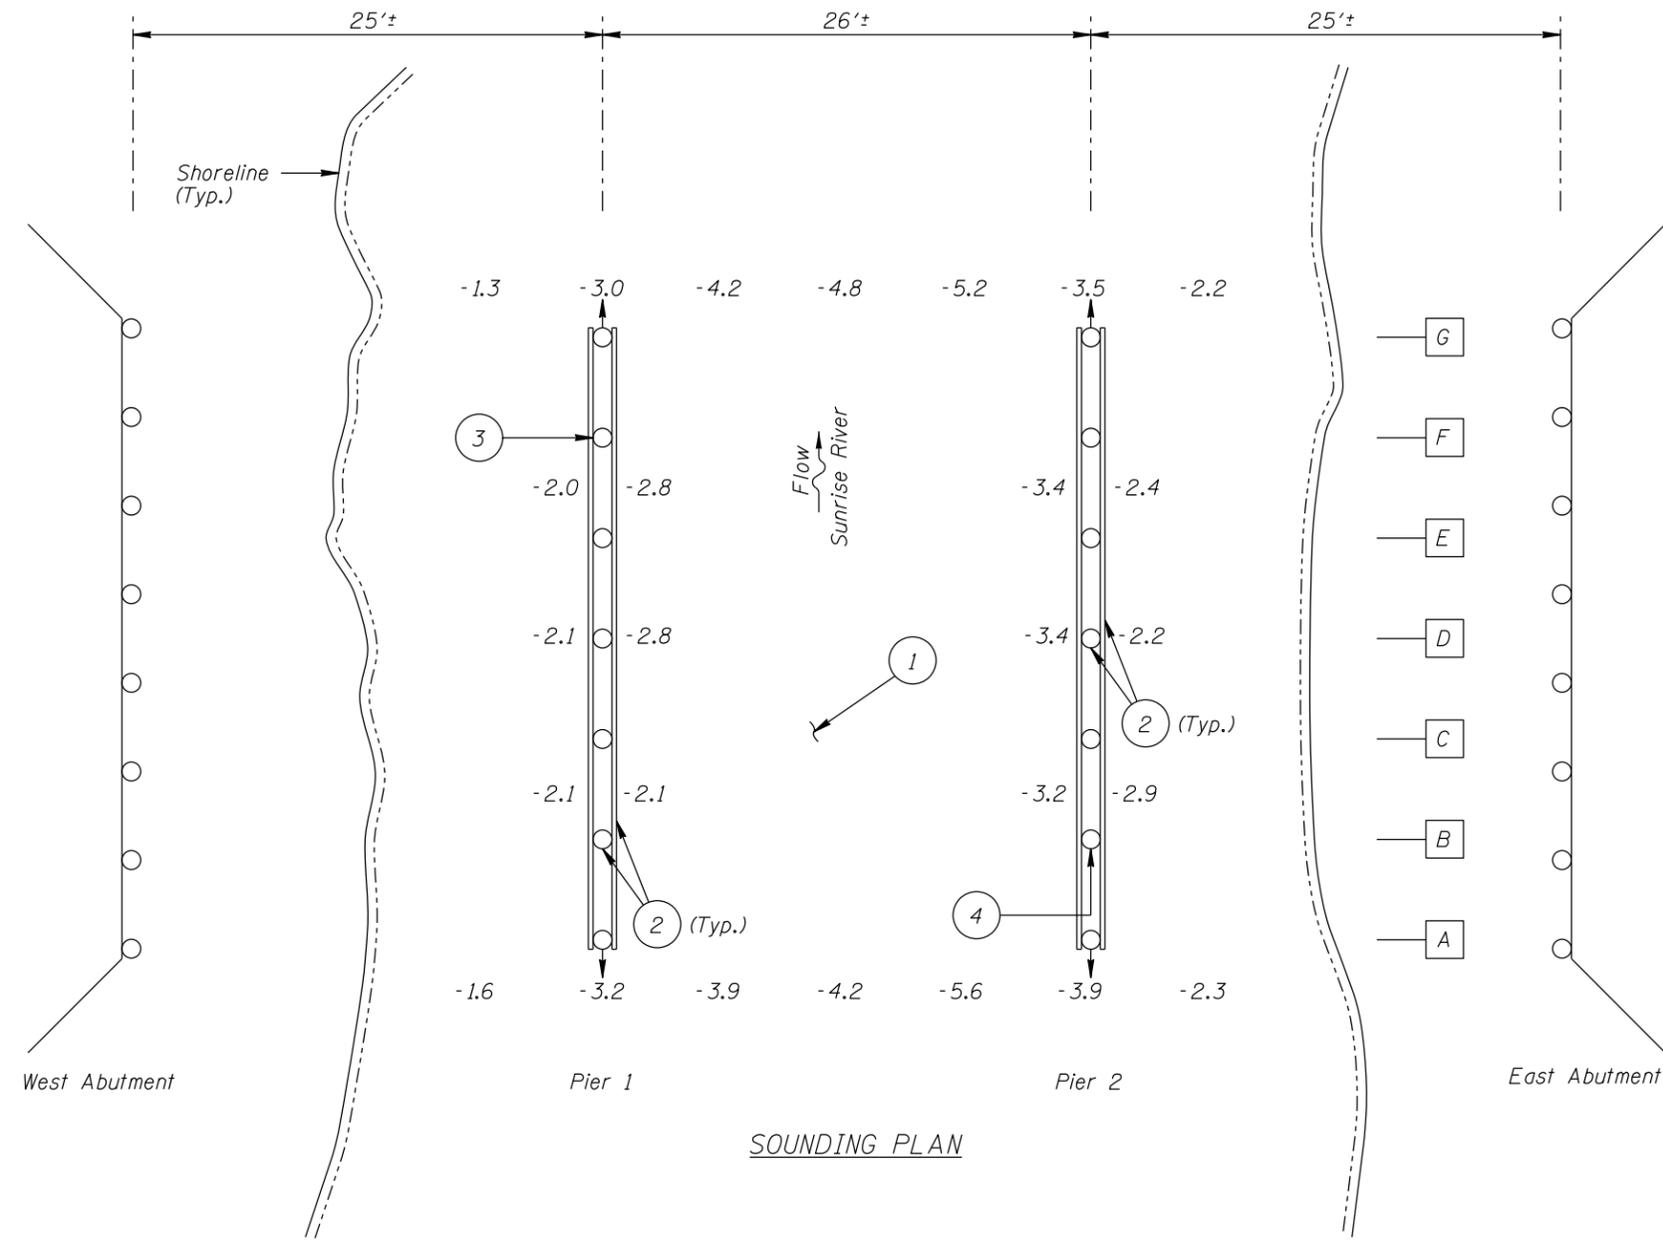
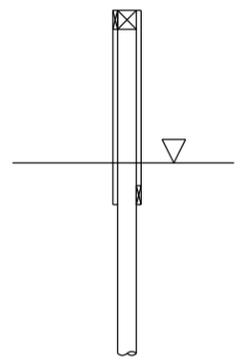
SOUNDING PLAN

- 1 Channel bottom material consisted of sand and cobbles up to 6 inches in diameter with no probe rod penetration.
- 2 Timber piles and cross-bracing were generally sound with typical 1/8 inch wide to 1/4 inch wide maximum checking and 1/8 inch of timber awl penetration.
- 3 Area of minor outer shell splitting located on the west side of Pile F at Pier 1 extended from 2 feet above the waterline to 1 foot below the waterline with up to 1/2 inch of penetration.
- 4 Area of minor outer shell splitting located on the south side of Pile B at Pier 2 extended from 2 feet above the waterline to 1 foot below the waterline with up to 1/2 inch of penetration.
