UNDERWATER BRIDGE INSPECTION REPORT

STRUCTURE NO. 19551

180<sup>th</sup> STREET

VERMILLION RIVER

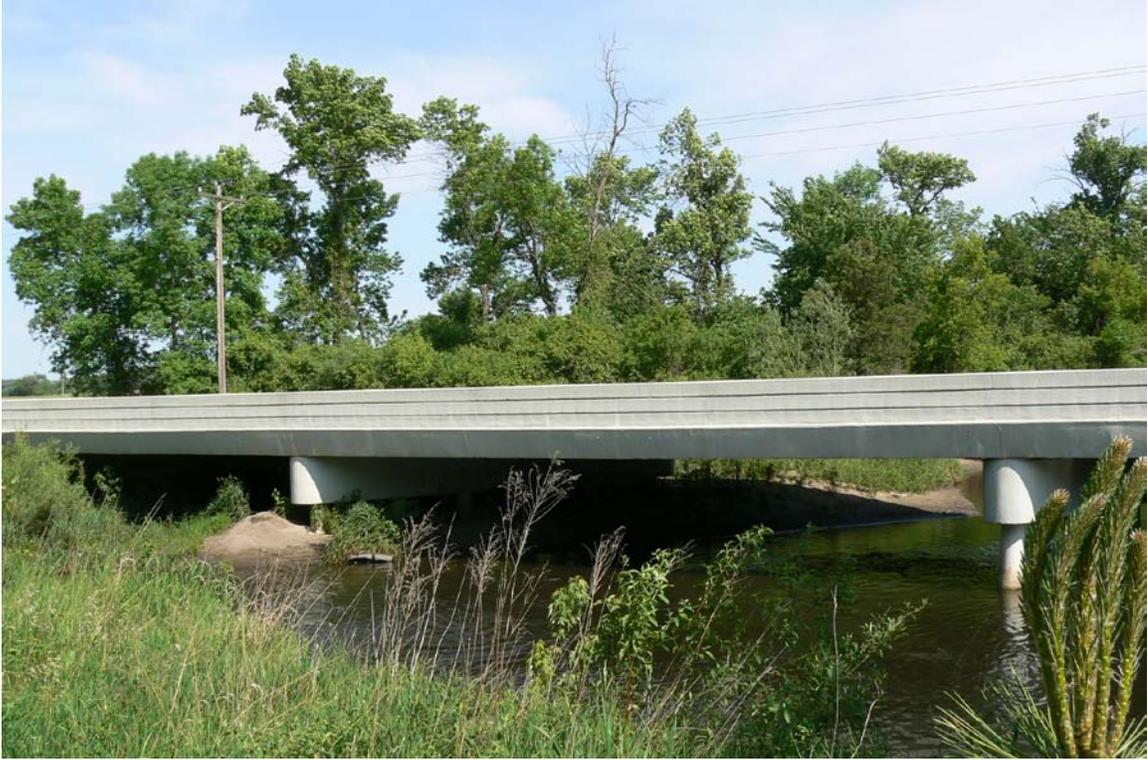
Photograph 1. Overall View of the Structure, Looking North.

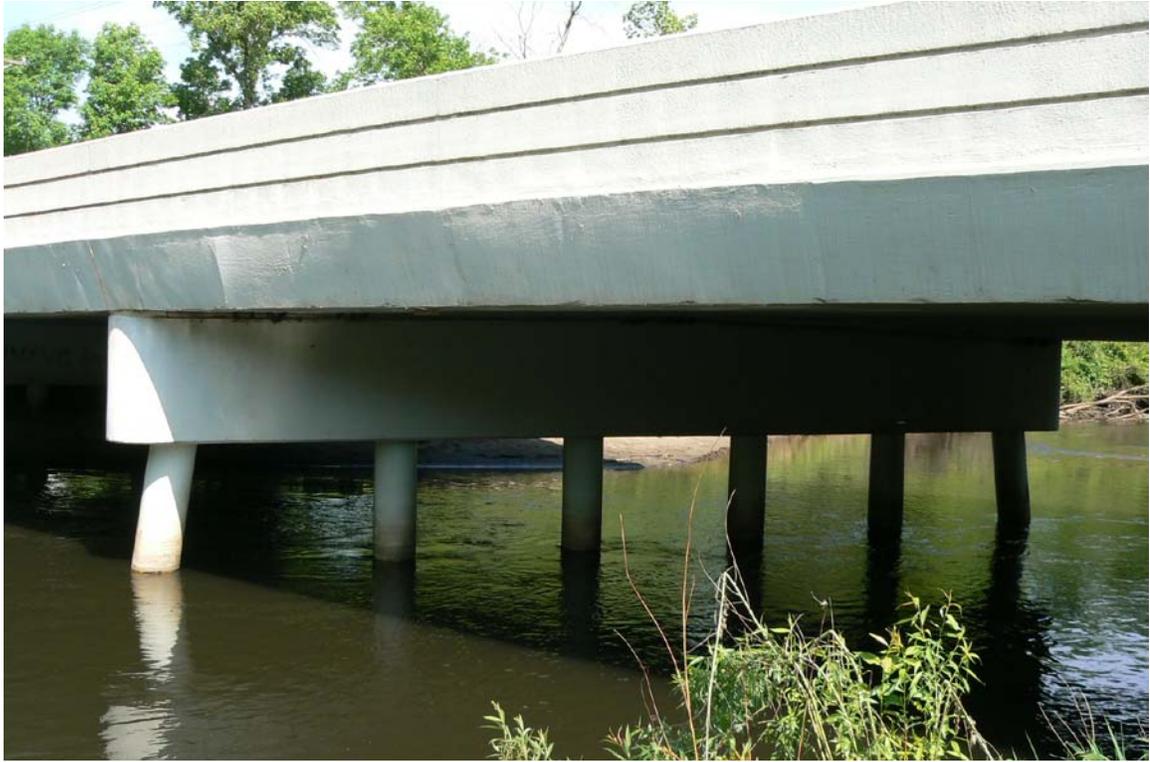
- (A) The steel encased concrete piles were sound with protective coating intact above and below the waterline.
- (B) The channel bottom material consisted of sand with probe rod penetration of up to 4 inches.

Photograph 2. View of Pier 2, Looking Northwest.

- (A) Reinspect the submerged substructure units at the normal maximum recommended (NBIS) interval of sixty (60) months.

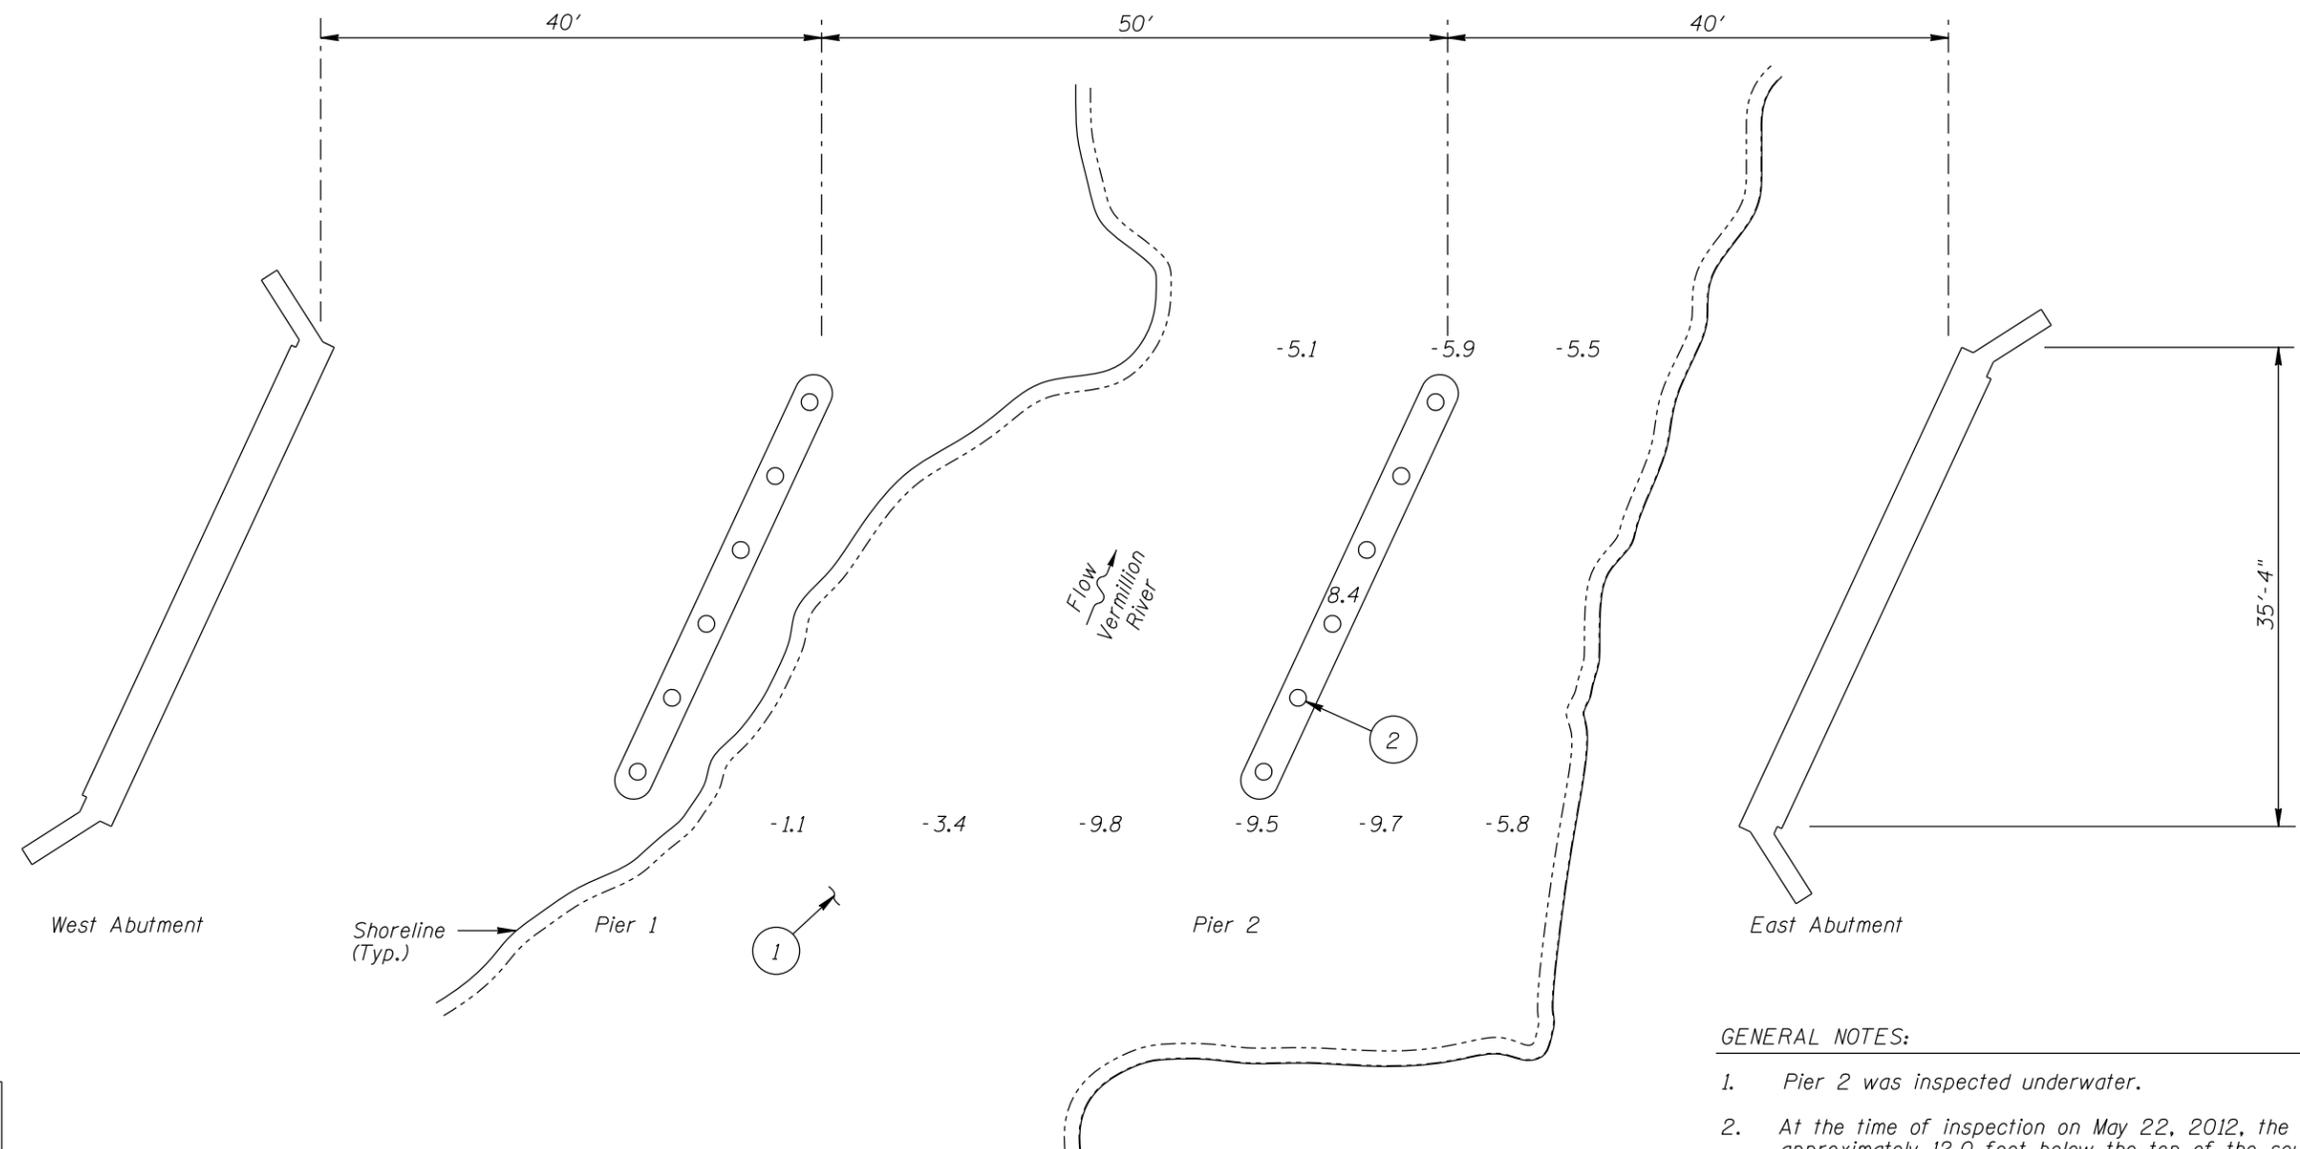
SOUNDING PLAN

- 1 Channel bottom material consists of sand with up to 4 inches of probe rod penetration.
- 2 Steel encased concrete piles were in sound condition with protective coating still intact.
