UNDERWATER BRIDGE INSPECTION REPORT

STRUCTURE NO. 27538
CSAH NO. 52, HENNEPIN AVENUE
OVER THE
EAST CHANNEL OF THE MISSISSIPPI RIVER
HENNEPIN COUNTY

OCTOBER 28, 2012

BY
COLLINS ENGINEERS, INC.

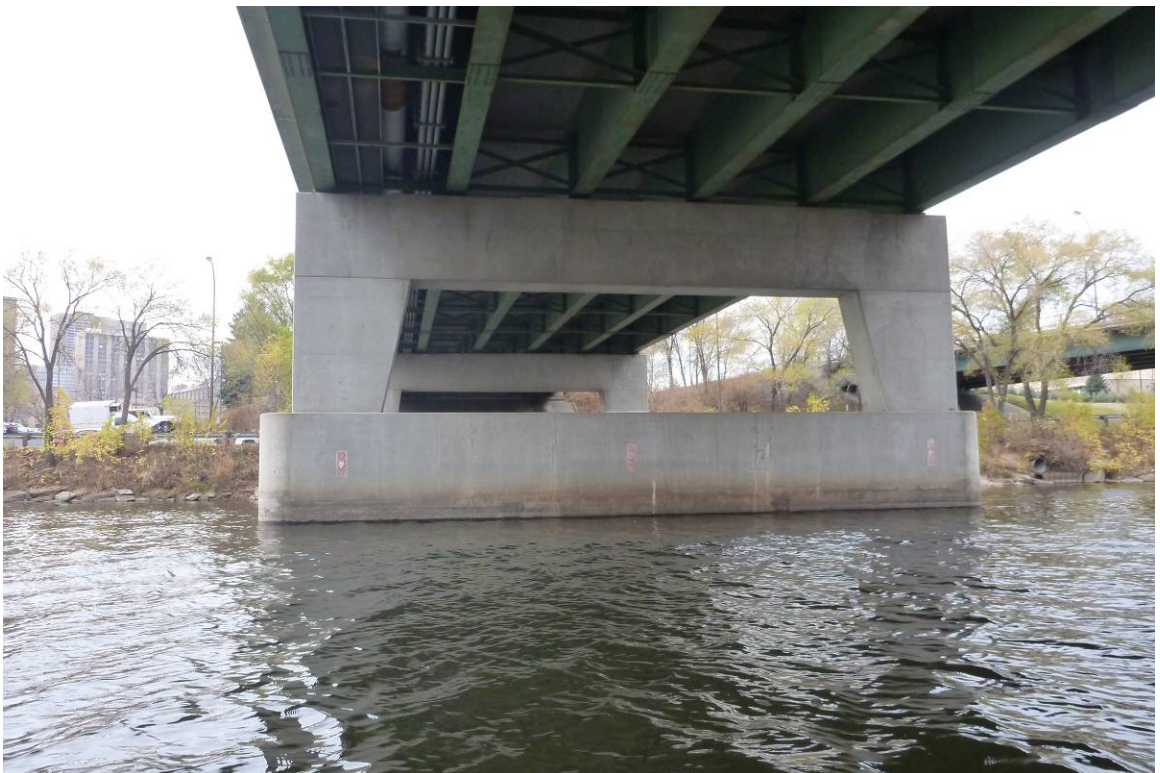
- (C) Light accumulation of timber debris, mainly smaller branches, was observed on the channel bottom at the upstream nose of Pier 2. A 1 foot diameter log was observed along the West face of Pier 2.

- (D) The concrete at Piers 2 and 3 exhibited minor scaling with up to 1/8 inch penetration.
- (E) Vertical cracks (1/16 inch maximum width) were observed on both faces of Pier 2 (4 on each face) extending from channel bottom to top of the pier shaft.

Photograph 2. View of Pier 2, Looking West.

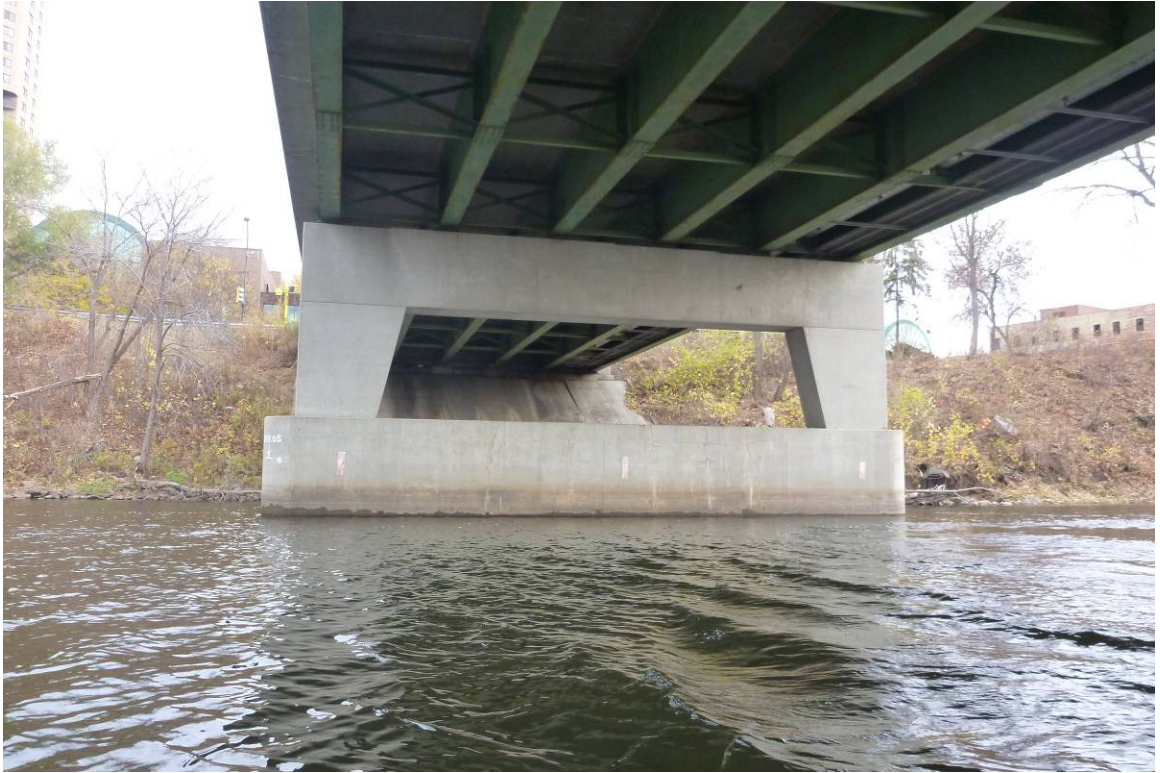
- (F) Vertical cracks (1/16 inch maximum width) were observed on east face of Pier 3 (5 cracks) and west face of Pier 3 (4 cracks) extending from channel bottom to top of the shaft (typically).

Photograph 3. View of Pier 3, Looking East.

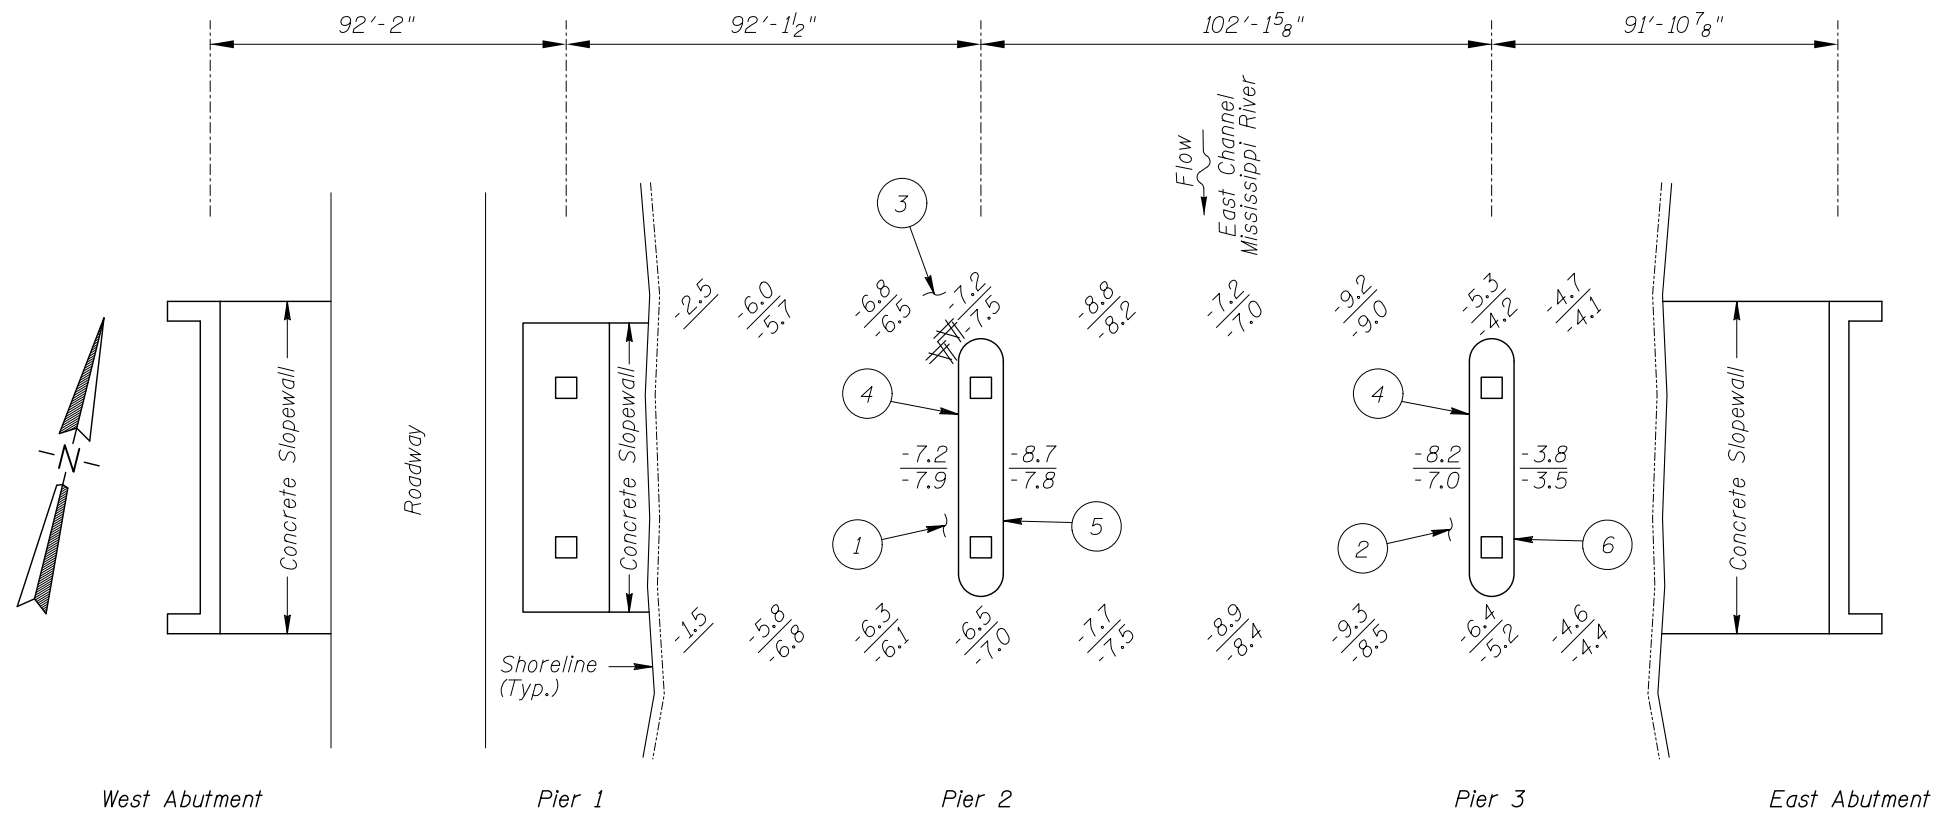
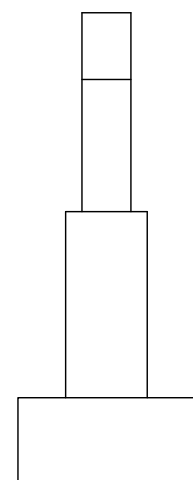
| INSPECTION AND SOUNDING PLAN | | |

- 1 The channel bottom material around Pier 2 consisted of silty sand with up to 1 foot of probe rod penetration.
- 2 The channel bottom material around Pier 3 consisted of silty sand with up to 1 foot of probe rod penetration and scattered riprap typically less than 1 foot in diameter except at the pier noses where the riprap was 2 to 4 feet in diameter.

- 3 Light accumulation of timber debris, mainly smaller branches, was observed on the channel bottom at the upstream nose of Pier 2. A 1-foot-diameter log was observed along the West face of Pier 2.

- 4 The concrete at Piers 2 and 3 exhibited minor scaling with up to 1/8 inch penetration.
- 5 Vertical cracks (1/16 inch maximum width) were observed on both faces of Pier 2 (4 on each face) extending from channel bottom to top of the pier shaft.

- 6 Vertical cracks (1/16 inch maximum width) were observed on east face of Pier 3 (5 cracks) and west face of Pier 3 (4 cracks) extending from channel bottom to top of the shaft (typically).
