UNDERWATER BRIDGE INSPECTION REPORT

STRUCTURE NO. 27611

PLYMOUTH AVENUE

MINNESOTA DEPARTMENT OF TRANSPORTATION
UNDERWATER BRIDGE INSPECTION

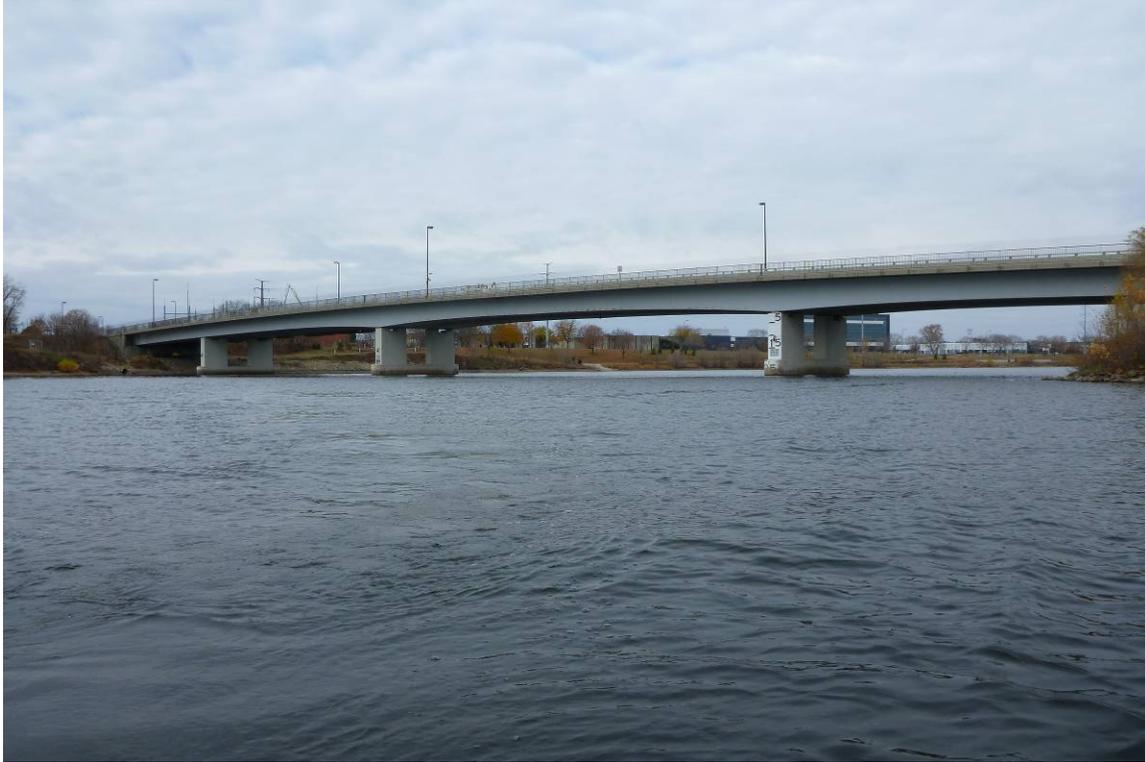
Photograph 1. Overall View of the Structure, Looking Northwest.

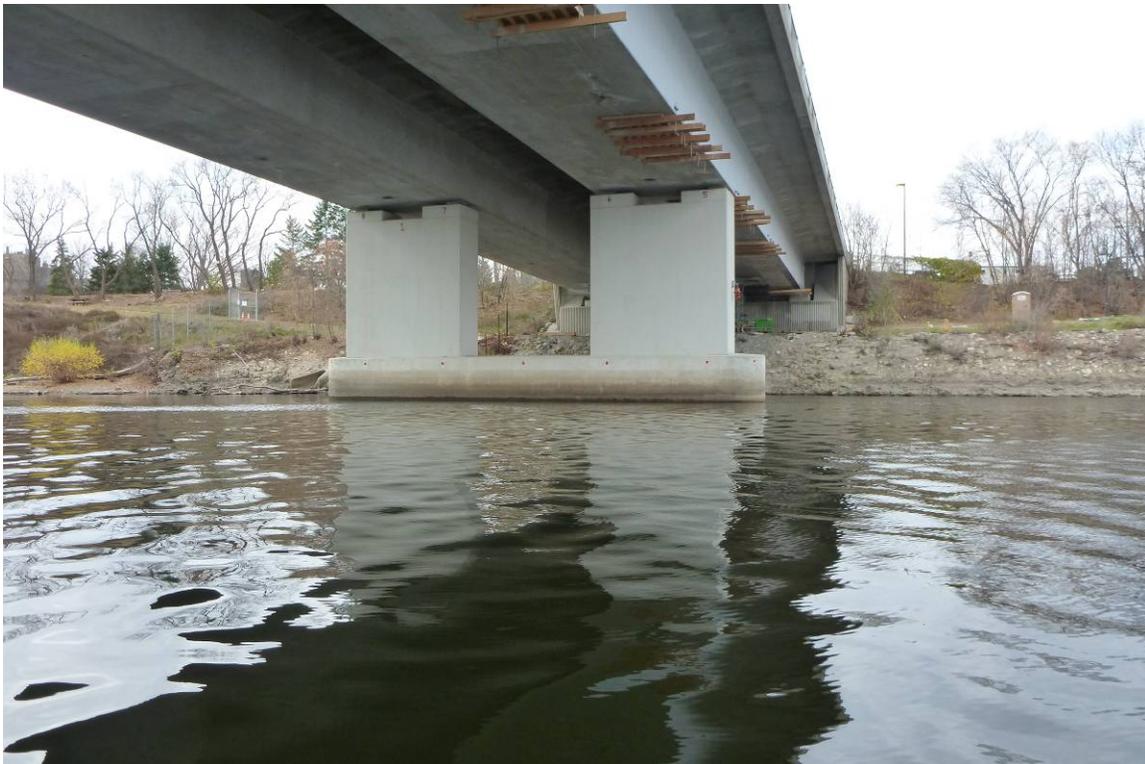
Photograph 2. View of Pier 1, Looking West.

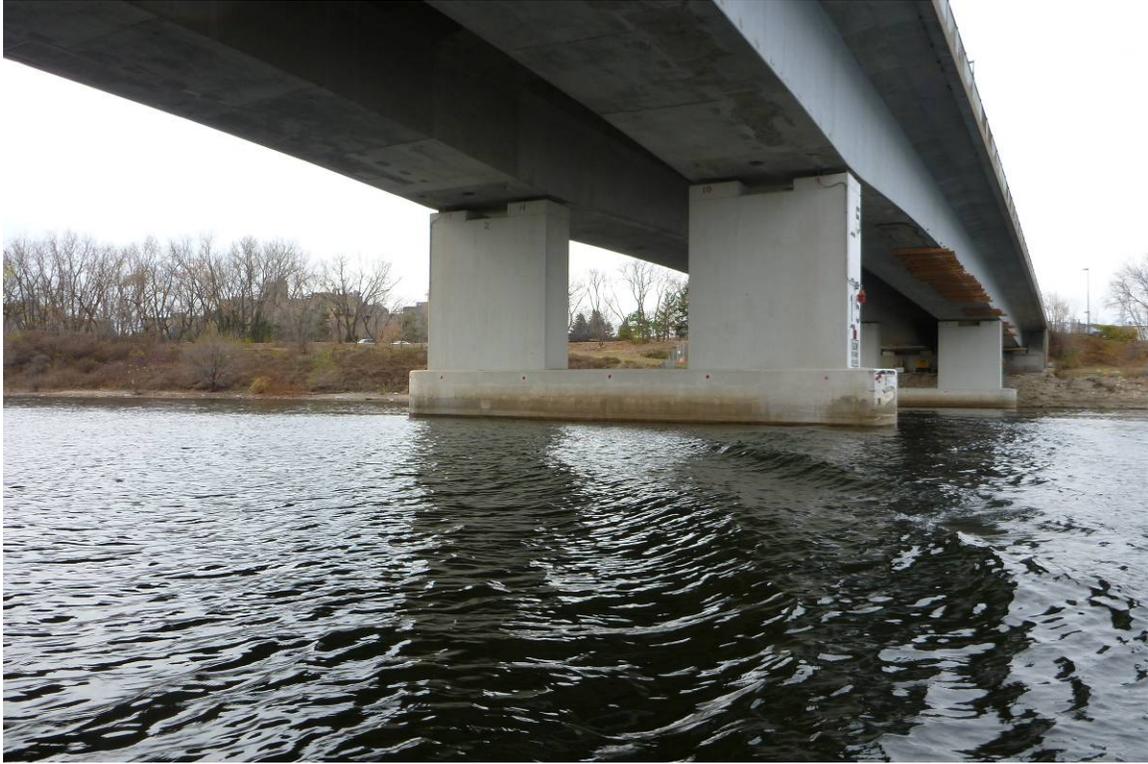
- (C) A vertical hairline crack was observed from the top of the web wall to the waterline on both faces of Piers 2 and 3.
- (D) A scour depression was observed around the upstream nose of Pier 2. The scour had a radius of approximately 5 feet and a maximum depth of 3 to 4 feet. The scour had partially exposed the top of the pier footing at the upstream nose with no vertical face exposure.

Photograph 3. View of Pier 2, Looking West.

- (A) Monitor the footing exposure and scour at Pier 2, and if found to be increasing in the future, countermeasures may become warranted.

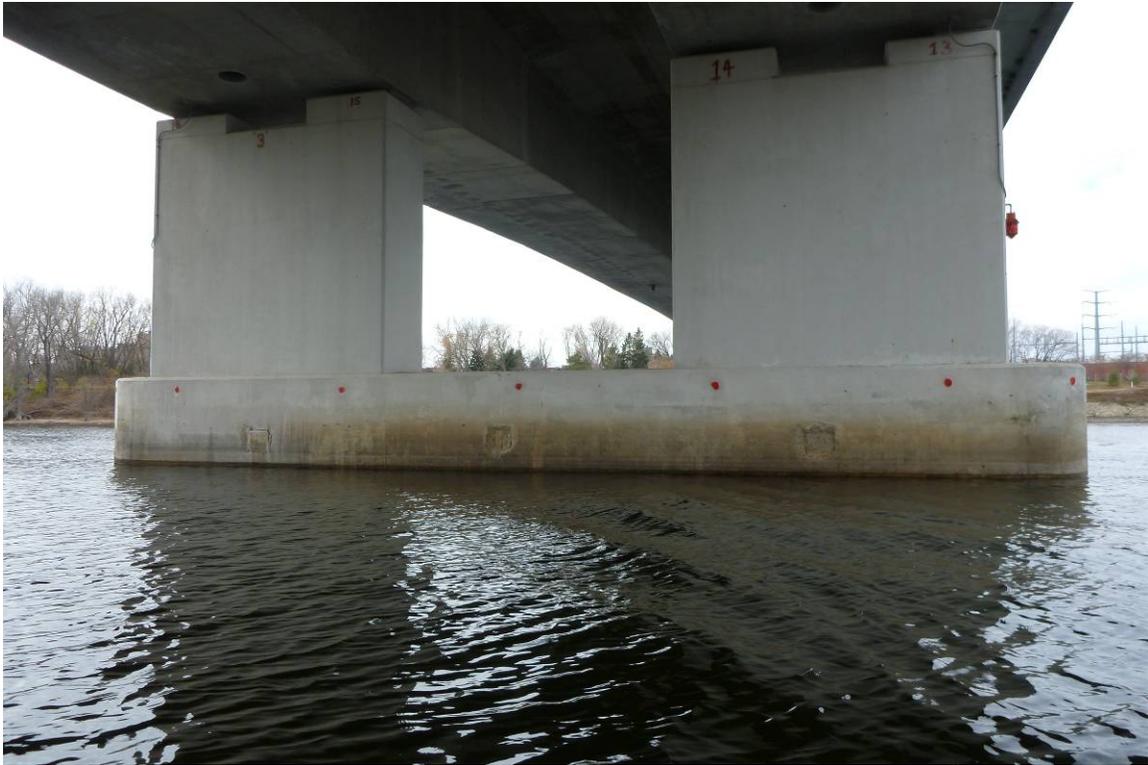
- (A) The channel bottom material consisted of silty sand and gravel allowing up to 8 inches of probe rod penetration and scattered cobbles.
- (B) A light accumulation of timber debris was observed along the east face of Pier 3 from channel bottom up 3 feet. The debris consisted of a 3 foot diameter log and scattered 6 to 12 inch diameter debris.

- (E) At 2 feet above the waterline, at midpoint and both quarter points of east face of Pier 3 there was a 1 square foot area of section loss (construction related) with 2 inches of maximum penetration.

Photograph 4. View of Pier 3, Looking West.

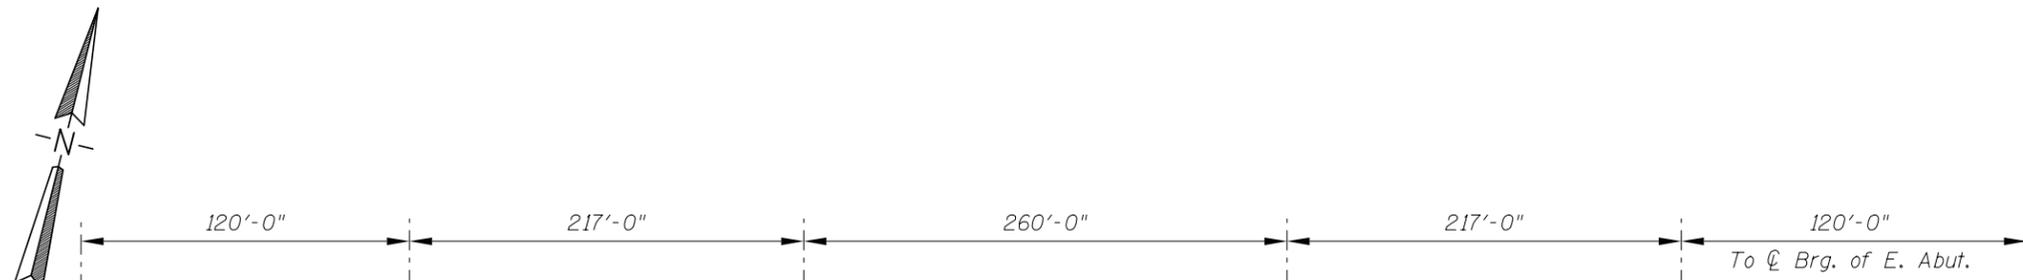
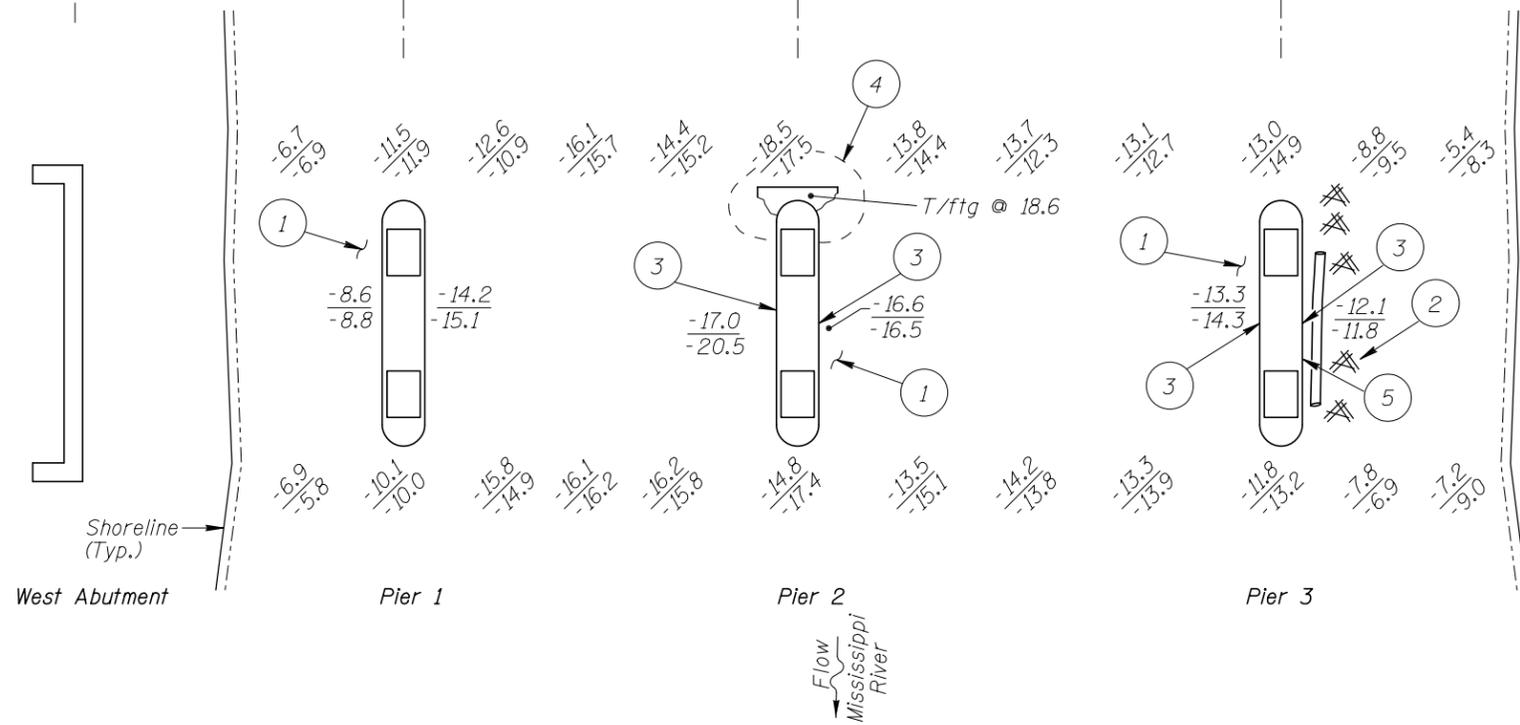
SOUNDING PLAN

- 1 The channel bottom material consisted of silty sand and gravel allowing up to 8 inches of probe rod penetration and scattered cobbles.
- 2 A light accumulation of timber debris was observed along the east face of Pier 3 from channel bottom up 3 feet. The debris consisted of a 2 foot diameter log and scattered 6 to 12 inch diameter drift pieces.

- 3 A vertical hairline crack was observed from the top of the web wall to the waterline.
- 4 A scour depression was observed around the upstream nose of Pier 2. The scour had a radius of about 5 feet and a maximum depth of 3 to 4 feet. The scour had partially exposed the top of the pier footing at the upstream nose with no vertical face exposure.

- 5 At 2 feet above the waterline, at midpoint and both quarter points of east face of Pier 3 there was a 1 square foot area of section loss (construction related) with 2 inches of maximum penetration.

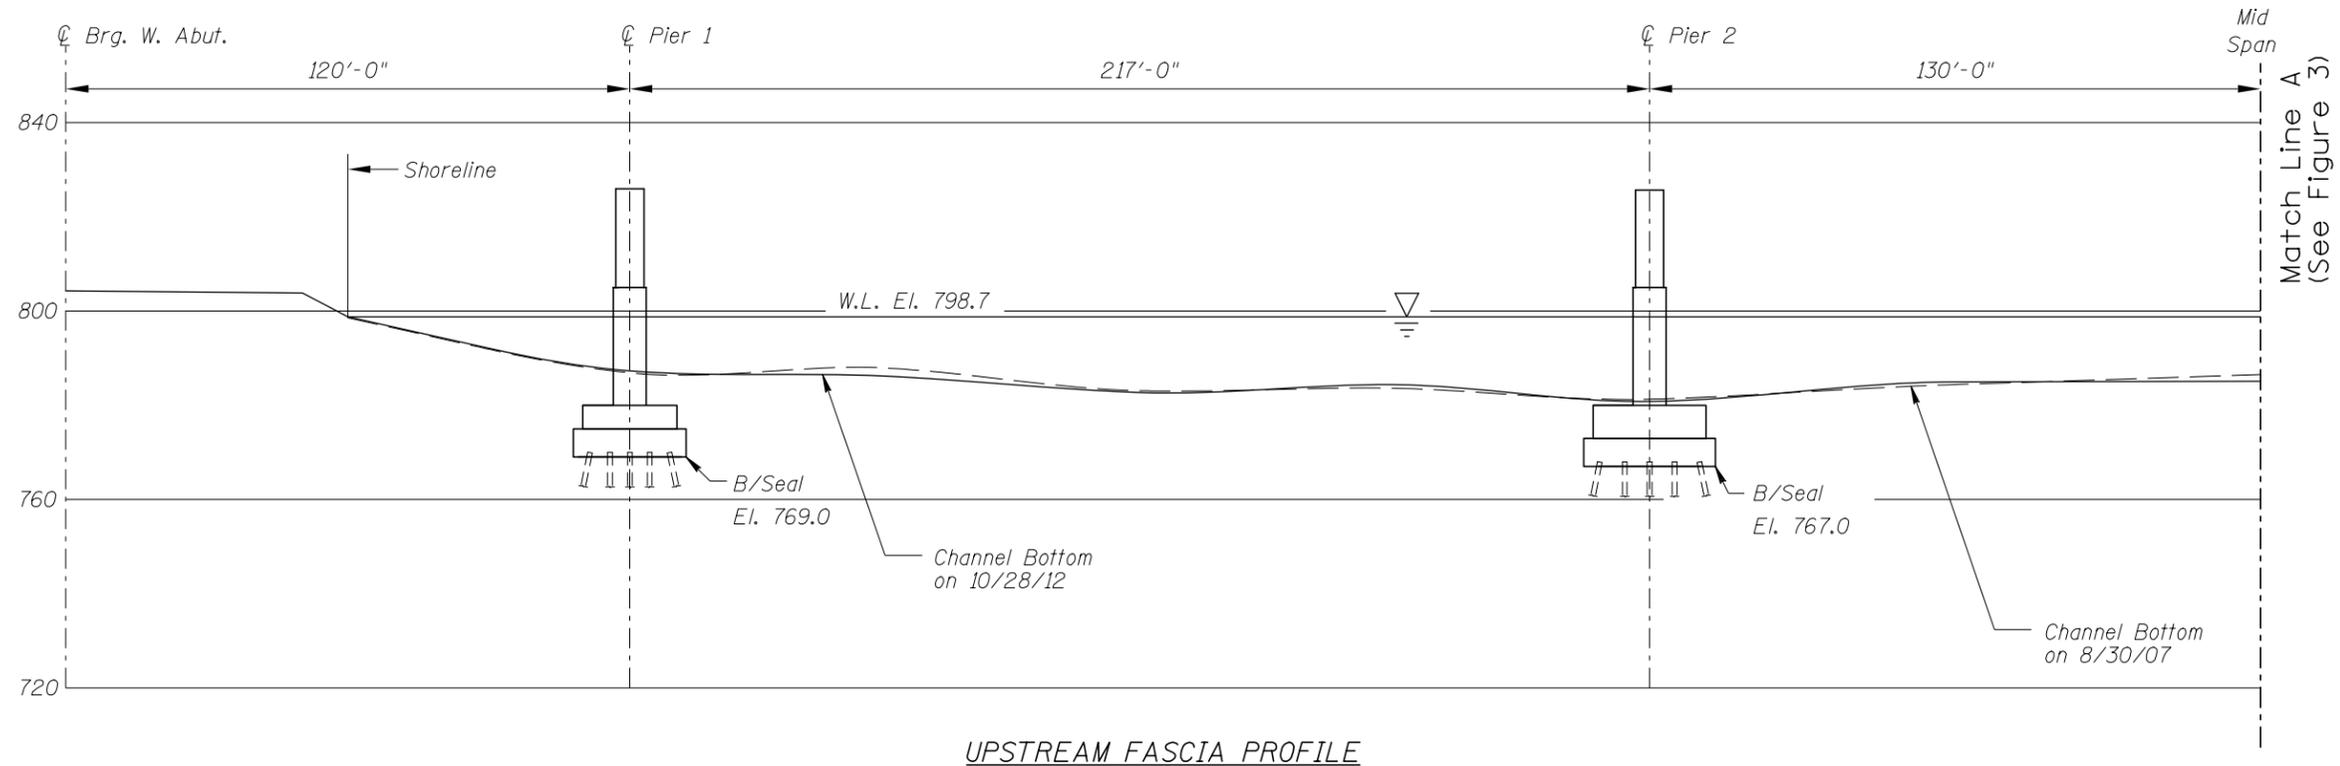
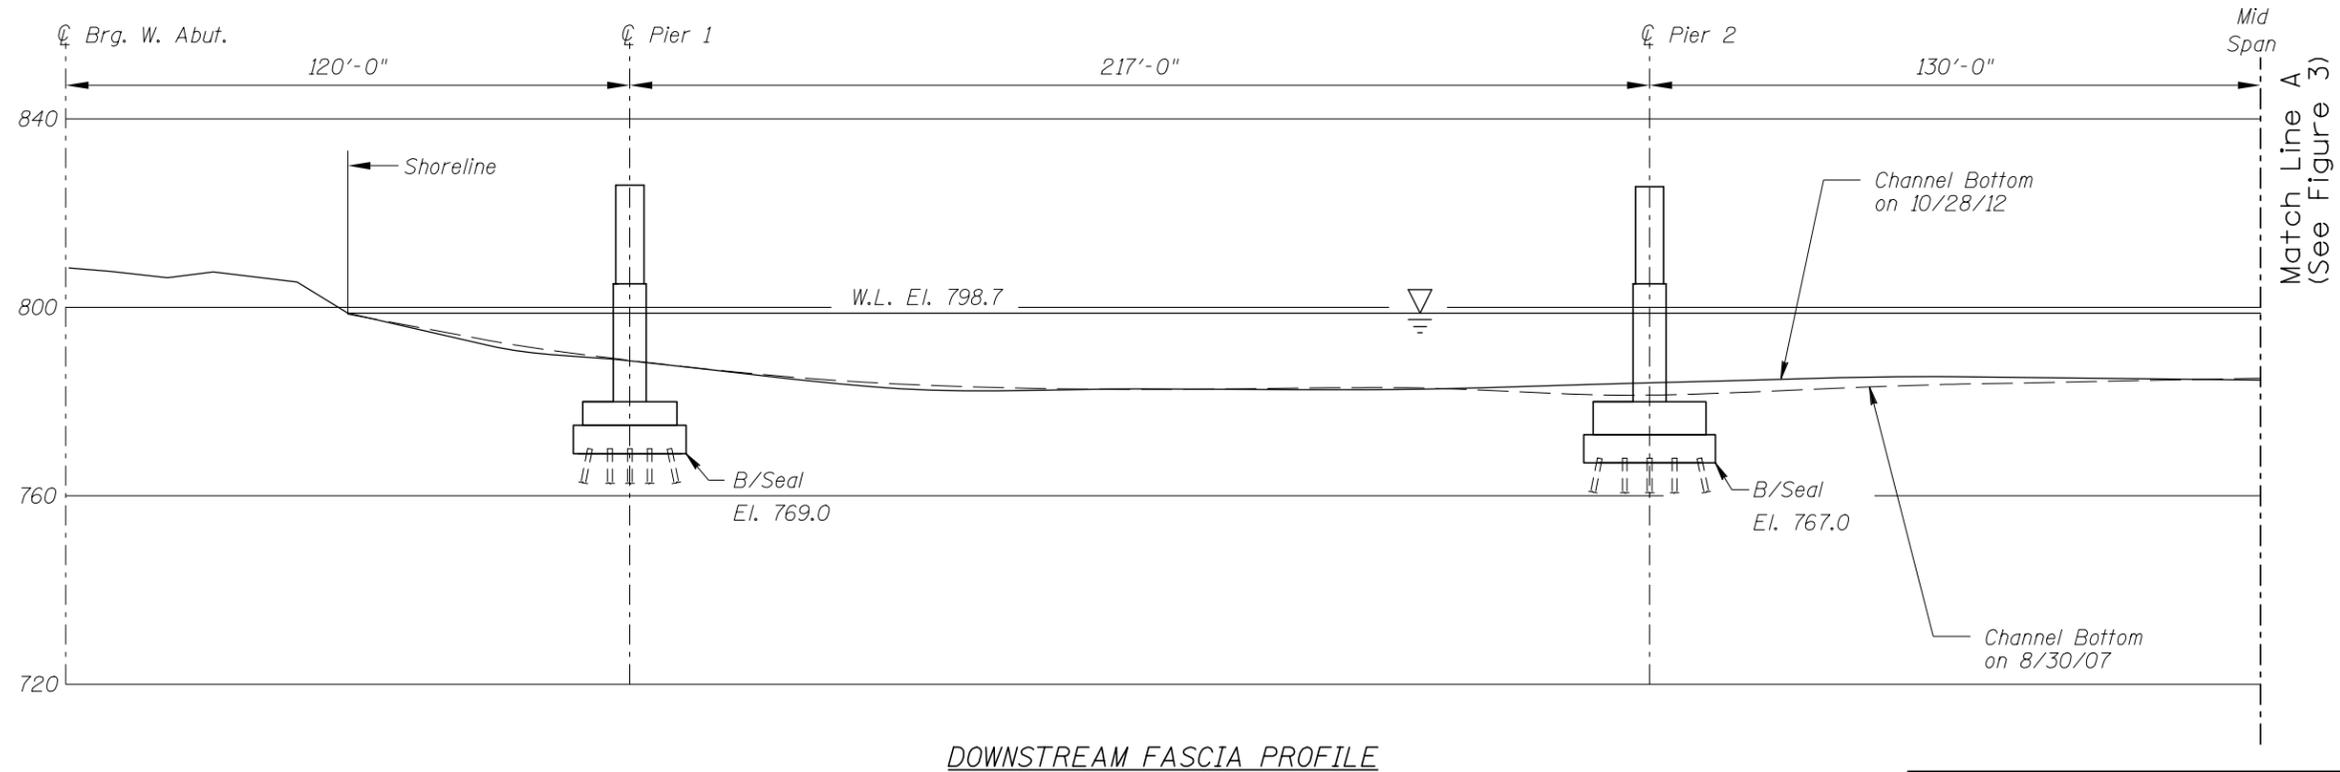
UPSTREAM FASCIA PROFILE

DOWNSTREAM FASCIA PROFILE
