UNDERWATER BRIDGE INSPECTION REPORT

STRUCTURE NO. 4175
PEDESTRIAN WALKWAY (OLD 169)
OVER THE
MINNESOTA RIVER
SCOTT COUNTY

MAY 21, 2012
PREPARED FOR THE
MINNESOTA DEPARTMENT OF TRANSPORTATION
BY
COLLINS ENGINEERS, INC.
JOB NO. 7423

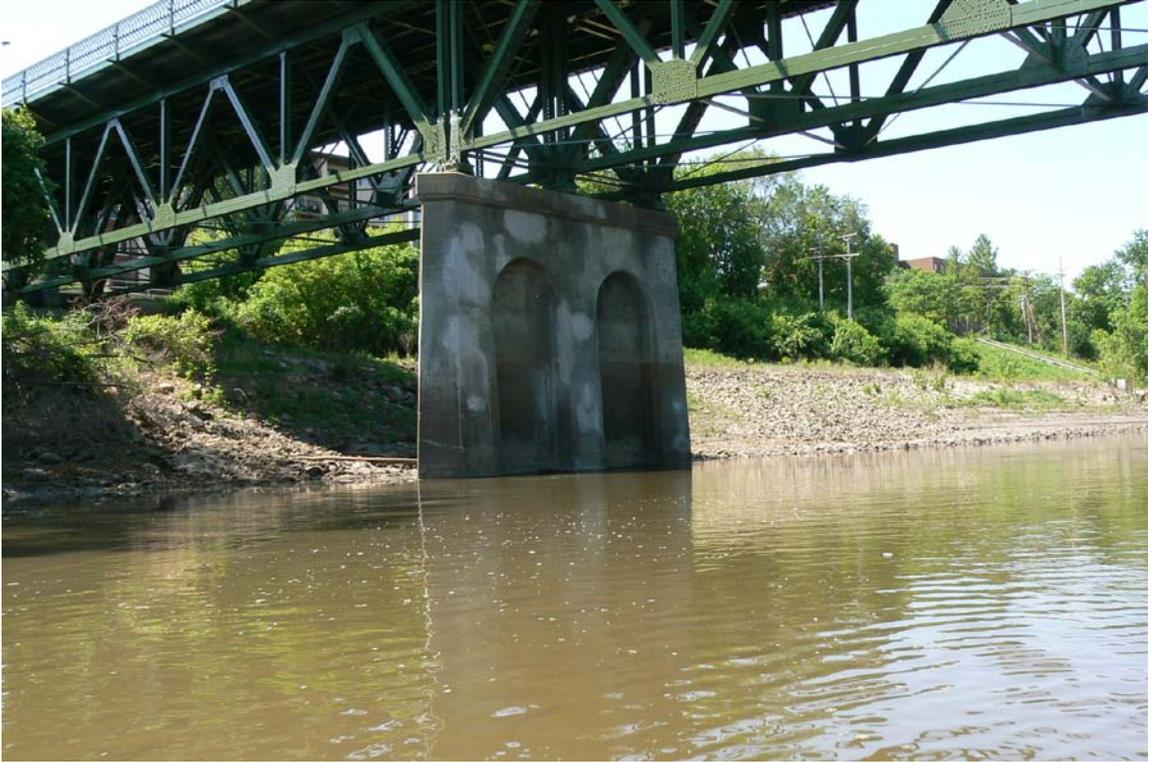
Photograph 1. View of Pier 3 and the South Embankment, Looking Southwest.

- 5 Spalls were observed at the waterline on the downstream nose and midpoint of the north face of Pier 3. The spalls were 6 inches in diameter with a maximum penetration of 1 inch.

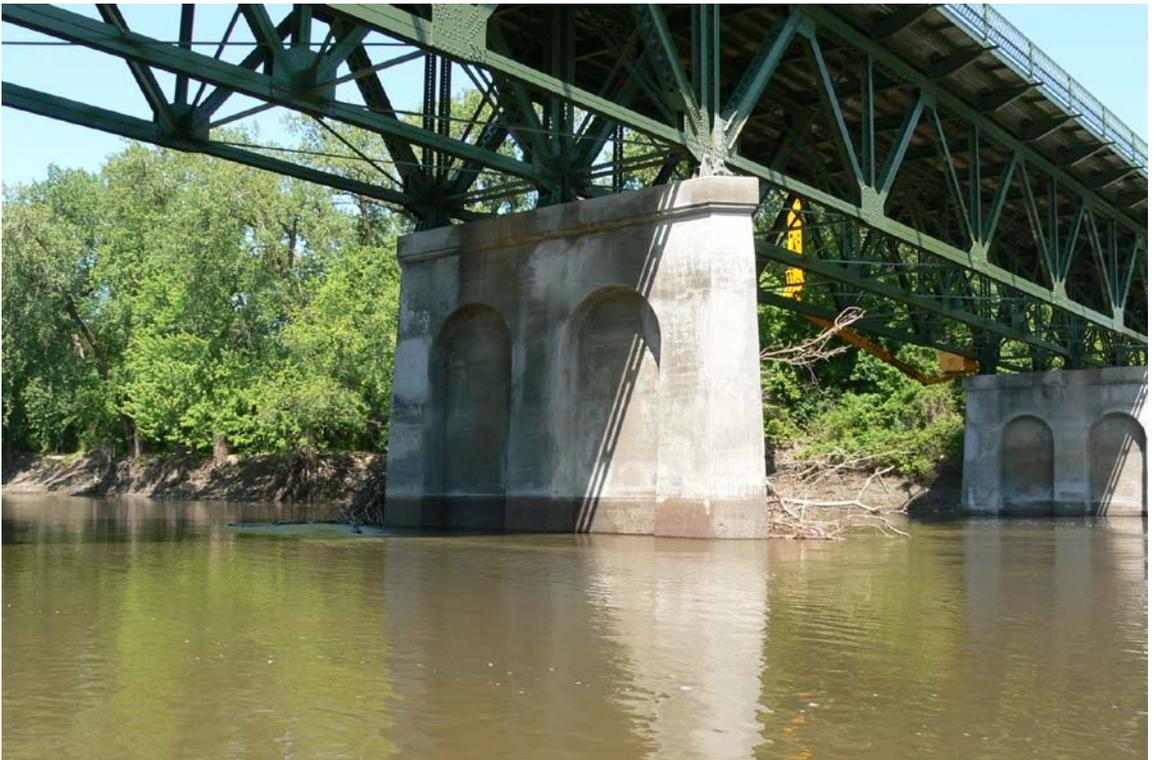
Photograph 2. View of Pier 4, Looking Northwest.

- 1 Channel bottom around the pier was primarily sandy gravel with up to 3 inches of probe rod penetration.
- 2 The footing was exposed around the entire perimeter of the pier with full height (2 feet) of vertical exposure. The second footing step (seal) was exposed around most of the perimeter of the pier except at the downstream nose, with maximum vertical exposure of 6 inches at the upstream nose.

Monitor footing and/or seal exposure during future inspections, and if exposure is found to be increasing to significant extent, countermeasures may become warranted at that time.

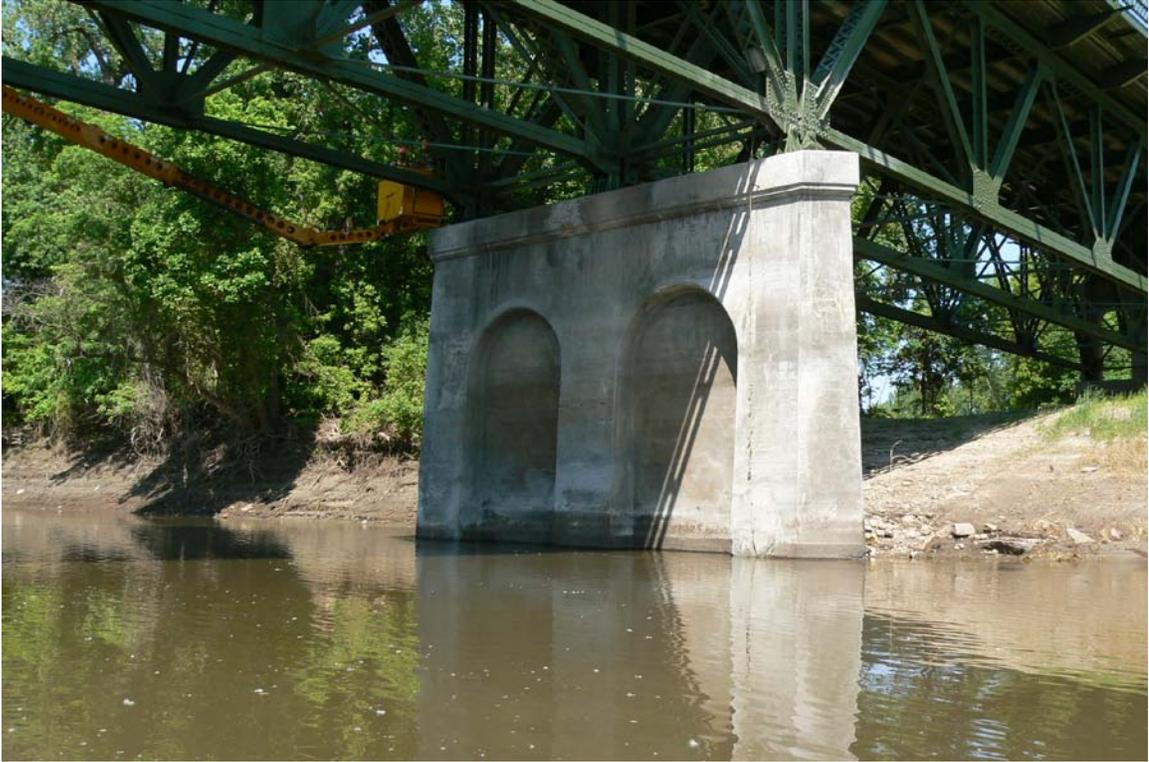
Photograph 3. View of Pier 5 and the North Embankment, Looking Northwest.

- 6 A spall was observed on the downstream quarter-point of the south face of Pier 5 extending from the waterline down 1.5 feet. The spall was 6 inches wide with a maximum penetration of 2 inches.

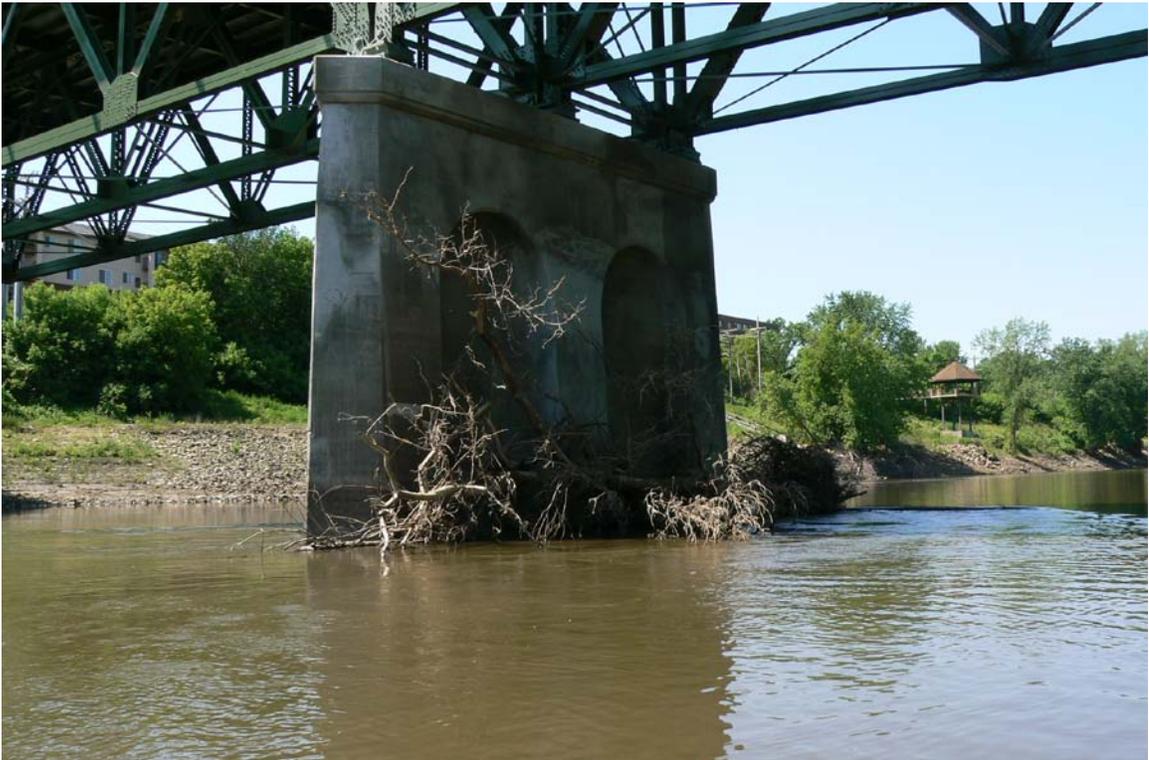
Photograph 4. View of Timber Debris Accumulation along the North Face of Pier 4, Looking Southwest.

- 3 A moderate to heavy accumulation of timber debris, consisting of up to 18 inches diameter pieces of drift, was observed at the upstream nose and along the south and north faces of the pier extending from channel bottom to 10 feet above waterline.

Remove timber debris at Pier 4.

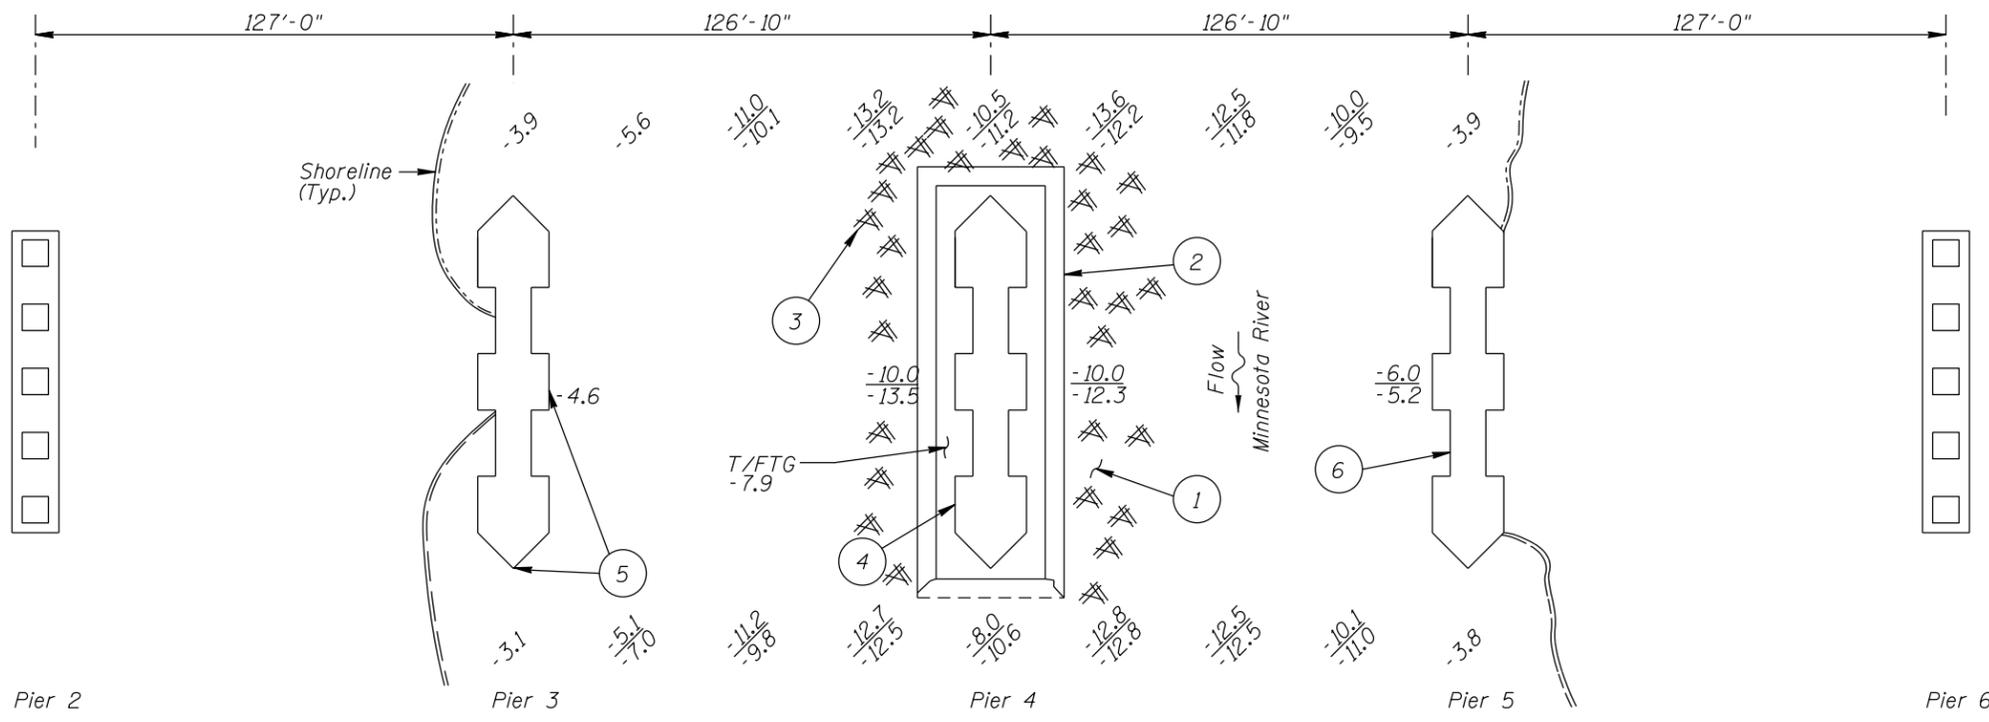
TYPICAL END VIEW OF PIERS

- 4 The concrete exhibited widespread random areas of scaling, up to 1/2 inch deep, and random minor areas of poor consolidation with up to 1 inch deep voided concrete.
