2016 UNDERWATER BRIDGE INSPECTION REPORT

BRIDGE # 19563 CANADA AVE over CANNON RIVER

Date of Inspection: 06/07/2016

Contractor: Collins Engineers, Inc.

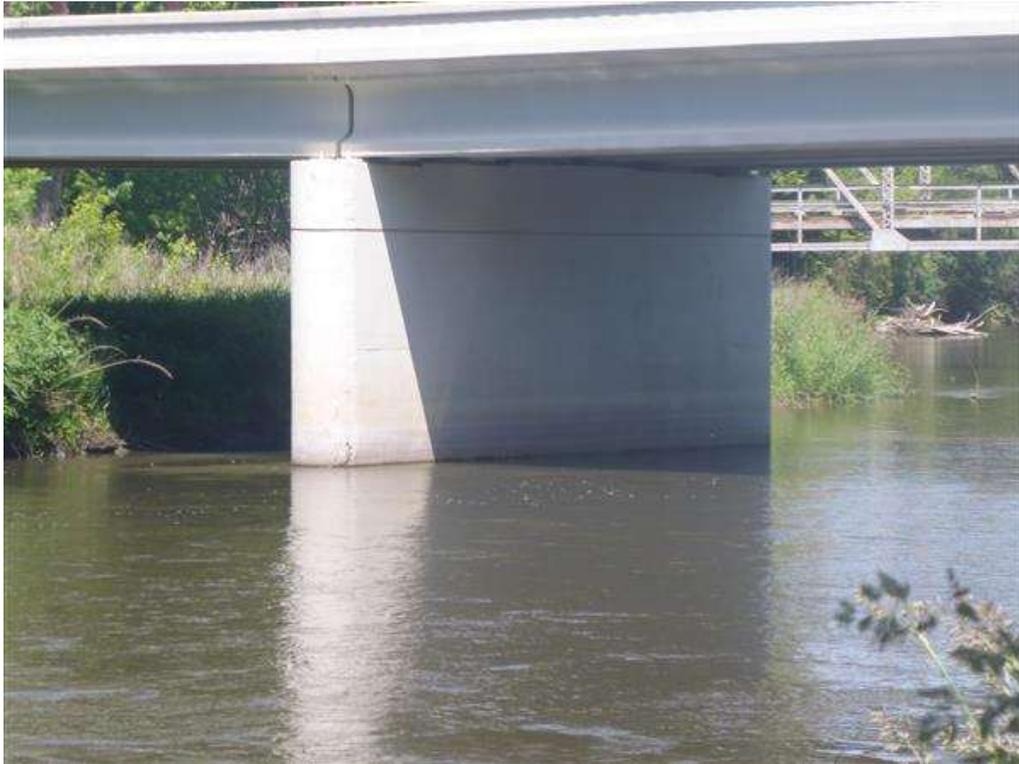
Photo 6 - Pier 2, Looking Northwest

- (A) The concrete surfaces above and below water were typically smooth and sound.
- (B) The channel bottom material along the channel side of both piers consisted of sandy silt and scattered cobbles allowing up to 4 inches of probe rod penetration.
- (C) The channel bottom material along the south side of Pier 1 and the north face of Pier 2 consisted of soft organic silt allowing up to 1 foot of probe rod penetration.
- (D) A 6 foot diameter 1.5 foot deep scour pocket was observed at the upstream nose of Pier 2.

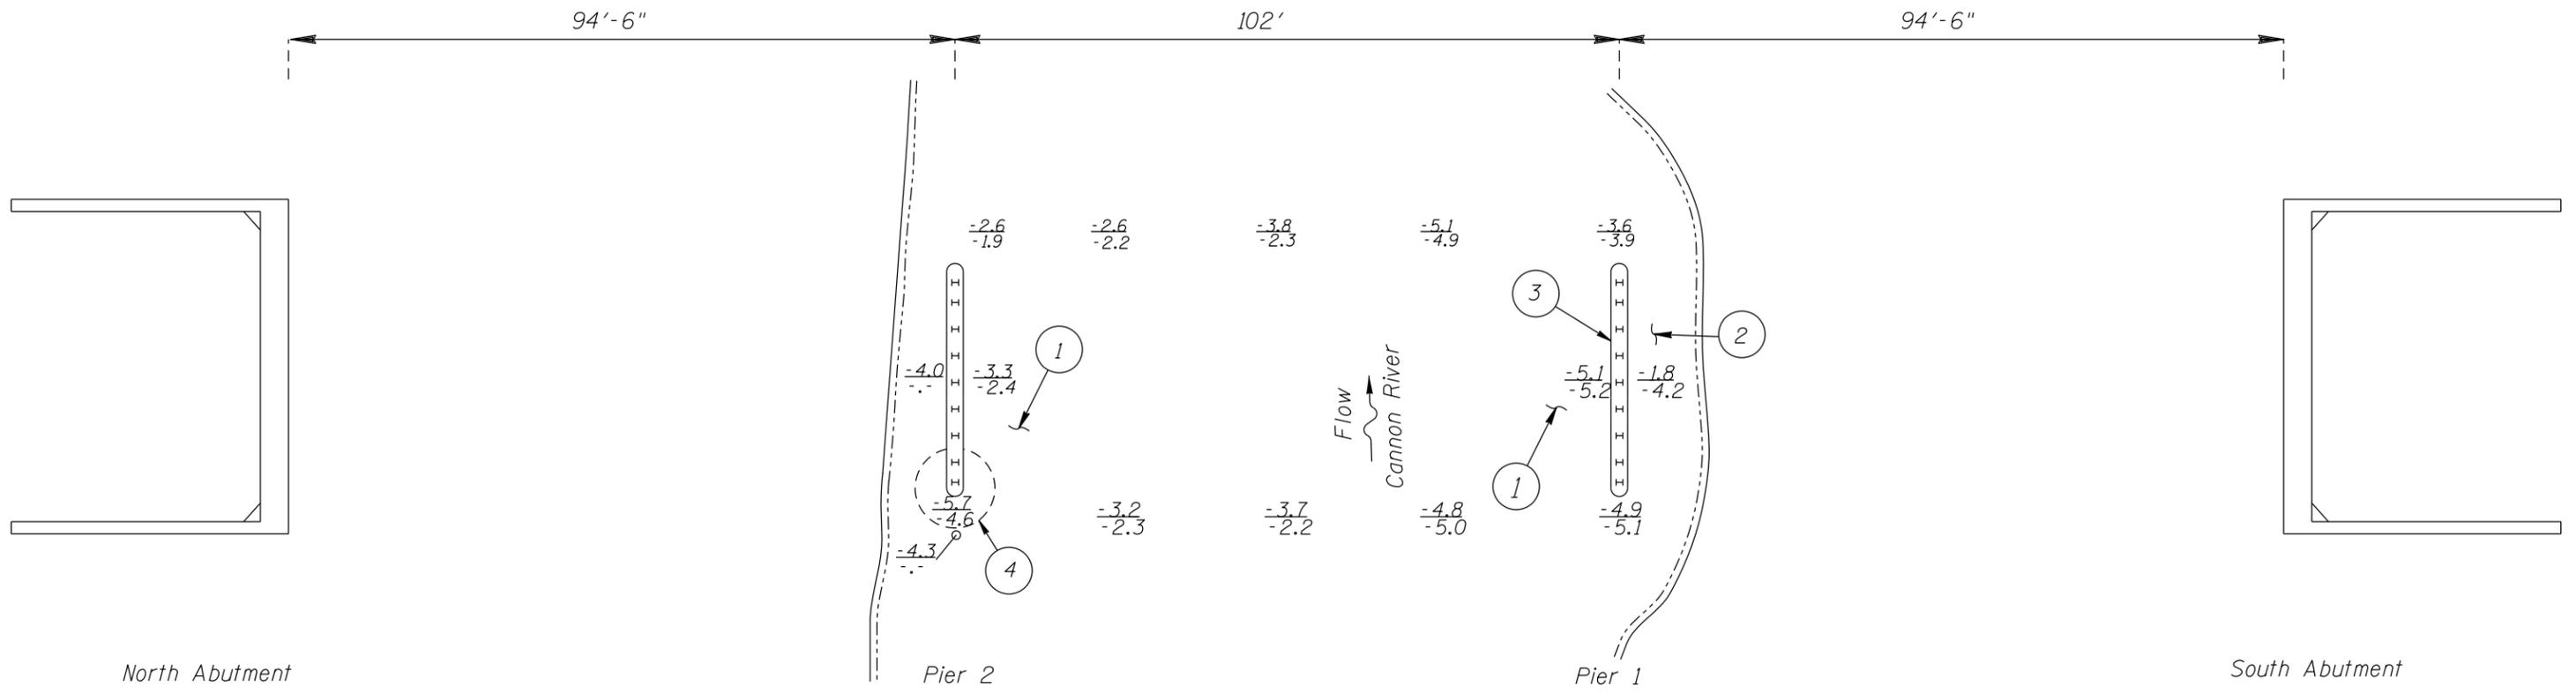
SOUNDING PLAN

- ① The channel bottom material on the channel side of each pier consisted of sandy silt with randomly scattered cobbles allowing up to 4 inches of probe rod penetration.
- ② The channel bottom material along the south face of Pier 1 and the north face of Pier 2 consisted of soft organic silt allowing up to 1 foot of probe rod penetration.
- ③ The concrete surfaces of both piers were smooth and sound.
- ④ A scour depression, measuring approximately 6 feet diameter and 1.5 feet deep, was observed at the upstream nose of Pier 2.
