# 2017 UNDERWATER BRIDGE INSPECTION REPORT

## **BRIDGE # 27537 CR52(1ST AV NE-WB) over MISSISSIPPI RIVER; ST**

**Date of Inspection:** 09/10/2016

Contractor: Collins Engineers Inc.

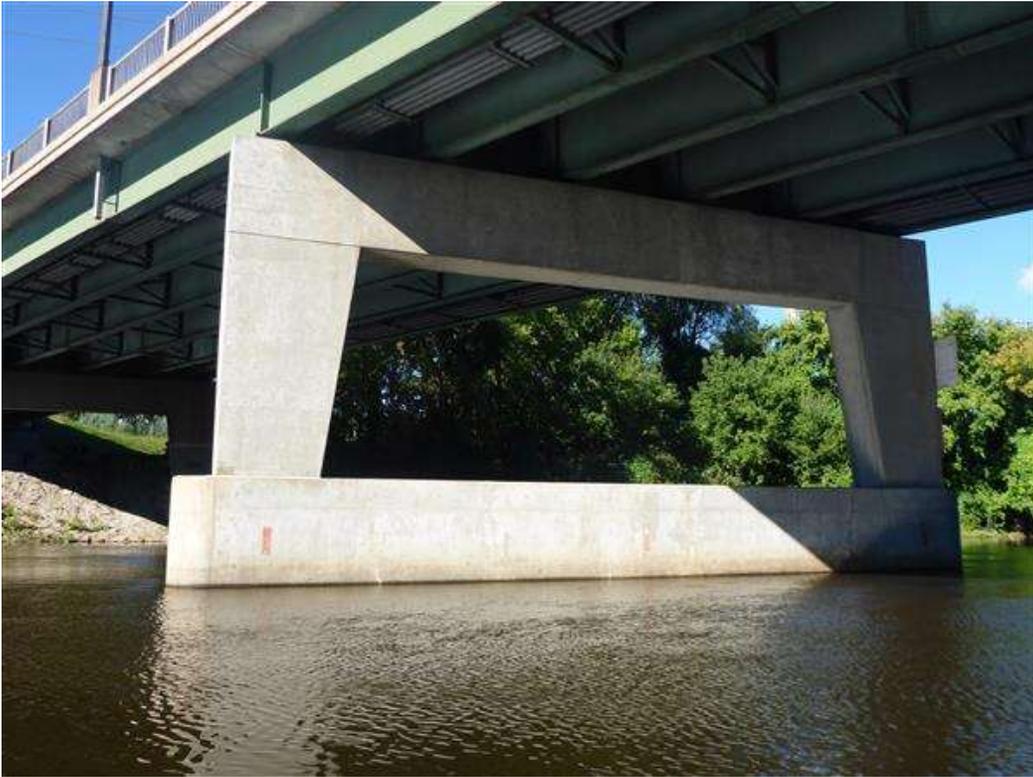
Photo 3 - Pier 2, Looking West.

- 7 Vertical cracks (1/16 inch maximum width) were observed along east face (5 cracks) and west face (3 cracks) of Pier 2, extending from channel bottom to top of pier shaft.

- 8 A light accumulation of timber debris, consisting of 4 inch-diameter branches, was observed at the upstream end of Pier 2.

- (A) Monitor the footing exposure on Pier 3 and vertical cracking in both piers's concrete during future underwater inspections.
- (B) Reinspect the submerged substructure units at the normal maximum recommended (NBIS) interval of sixty (60) months.

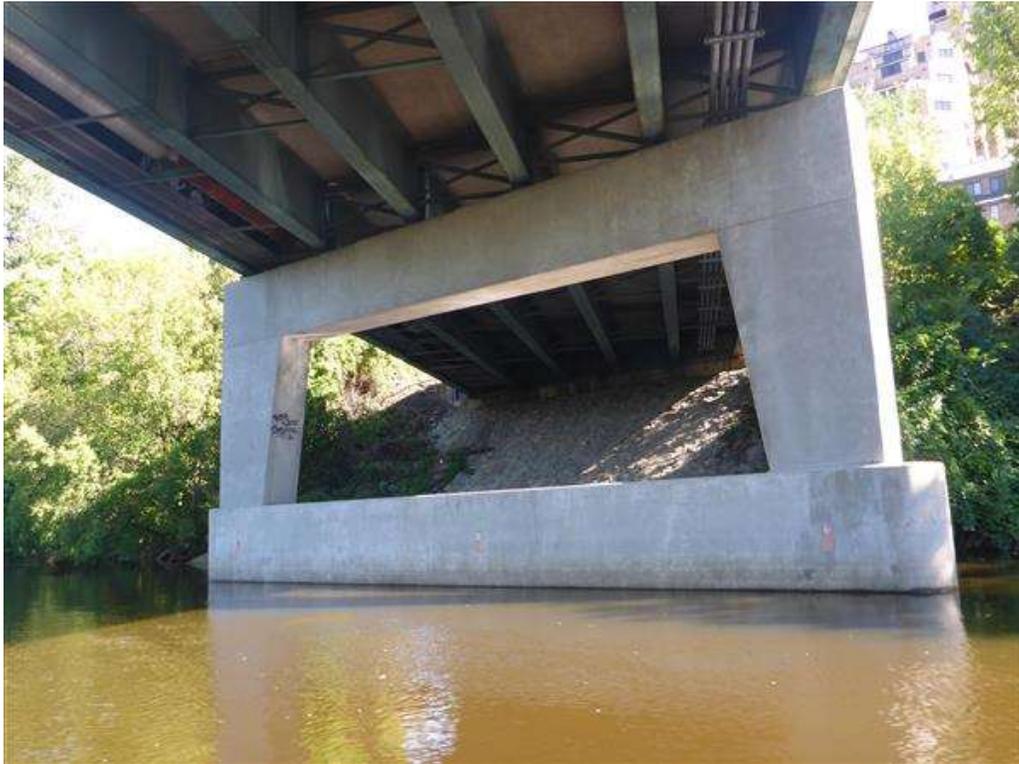
Photo 4 - Pier 3, Looking East.

- 3 A light accumulation of timber debris, consisting of 1 foot-diameter logs and branches, was observed at the upstream end of Pier 3.
- 4 Both embankments were well armored with grouted riprap.

- 5 Vertical cracks 1/16 inch wide were observed along the west face of Pier 3, extending from channel bottom to top of pier shaft.
- 6 Footing exposure (top at 7.4 feet below waterline) was observed along the west face of Pier 3. The footing's surface was rough with some irregularities. Steel sheet piling was observed along footing from the midpoint to the downstream nose with a maximum vertical exposure of 1.5 feet (footing and sheeting).

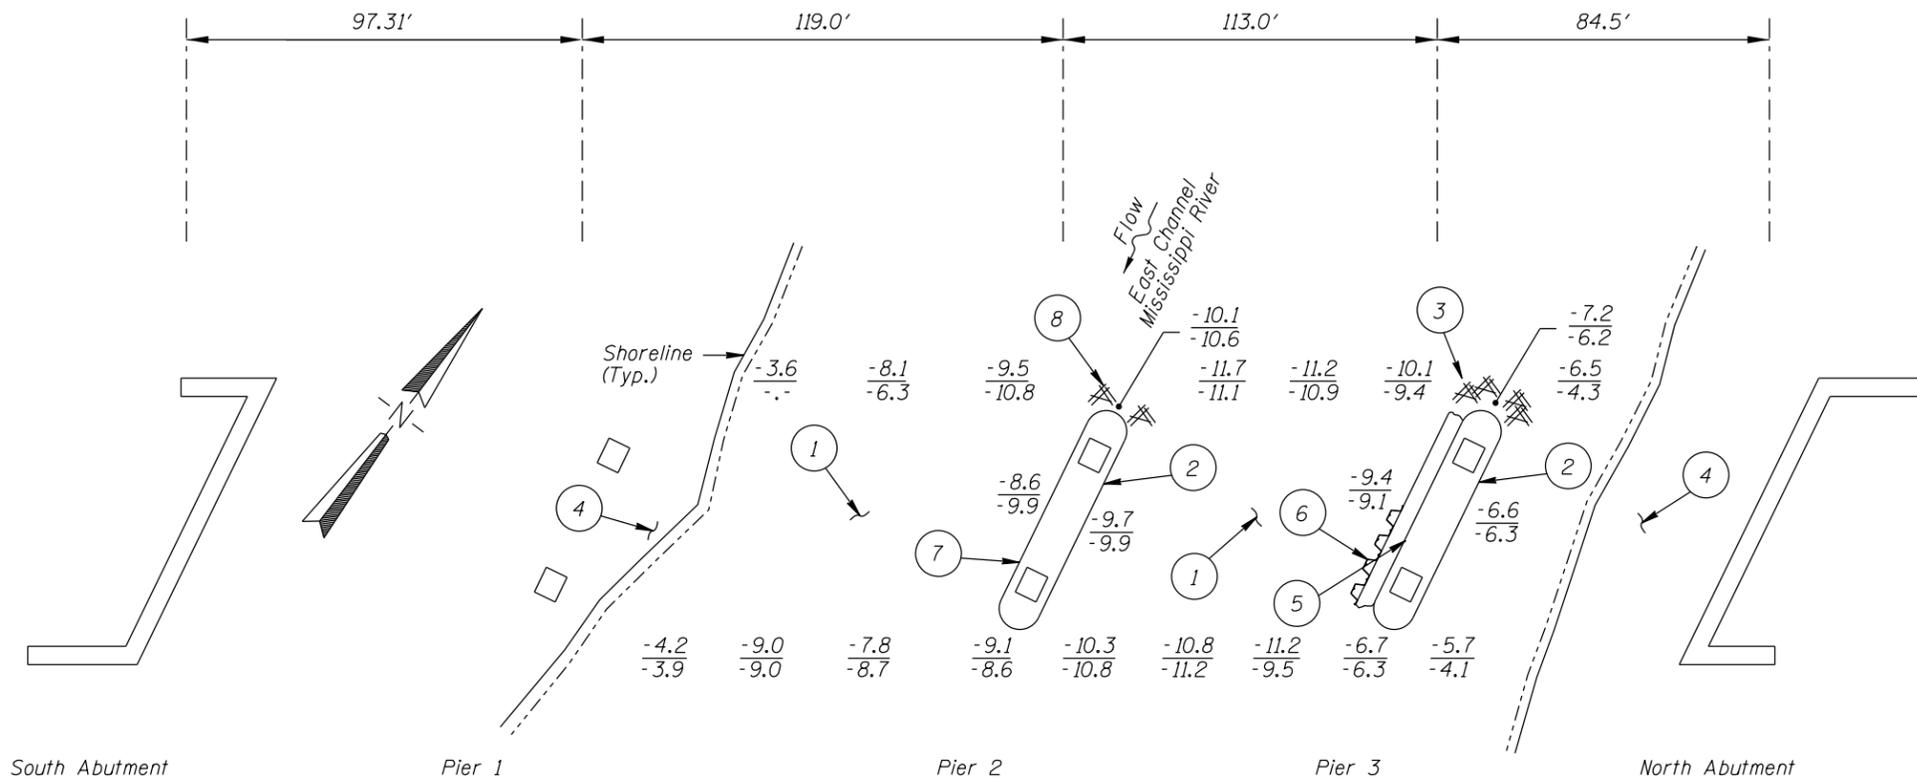
**SOUNDING PLAN**

- 1 The channel bottom consisted of silty sand and scattered cobbles with up to 1 foot of probe rod penetration.
- 2 The concrete piers exhibited light scaling from 1.5 foot above to 1 foot below the waterline.
