# 2016 UNDERWATER BRIDGE INSPECTION REPORT

**BRIDGE # 27549**  
**42nd AVE (CAMDEN) over MISSISSIPPI RIVER; RR**

Date of Inspection: 11/10/2016

Contractor: Collins Engineers, Inc.

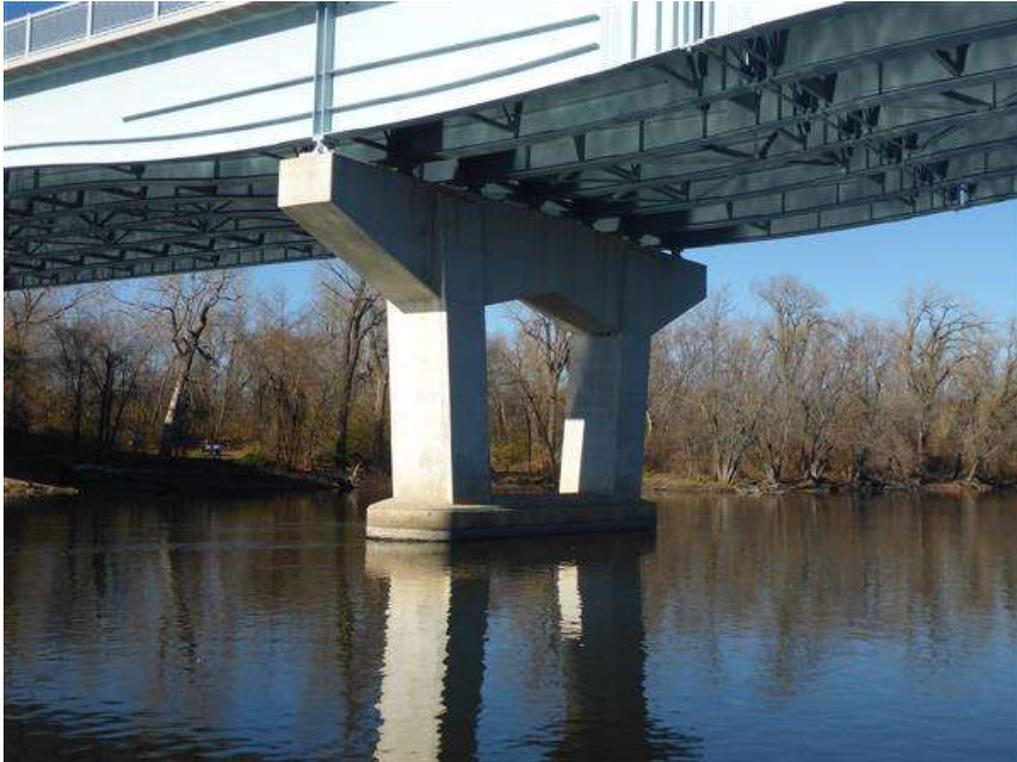
- (B) The top of the footing around the entire perimeter of Pier 9 was exposed with vertical face exposure between 1 foot at the upstream west corner, 4 inches along the downstream face, and a maximum of 2.5 feet along the west face.

- (E) Numerous vertical hairline cracks were observed extending from the top of the webwall to 1 foot below the waterline on both faces of Piers 9 and 10.

- (G) A vertical 1/8 inch wide crack was observed extending from the top of the webwall to the waterline on the west face of Pier 9.
- (A) Overall, the concrete of Piers 9 and 10 was generally smooth and sound with some random minor areas of poor consolidation with 1/4 inch maximum penetration.

Photo 4 - Typical View of Pier 9 Looking Northwest

- (A) Monitor the timber debris at Pier 9 and 10, and if found to be increasing in the future, removal operations may become warranted.
- (B) Monitor the footing exposure at Pier 9 during future underwater inspections.
- (C) Reinspect the submerged substructure units at the normal maximum recommended (NBIS) interval of sixty (60) months.

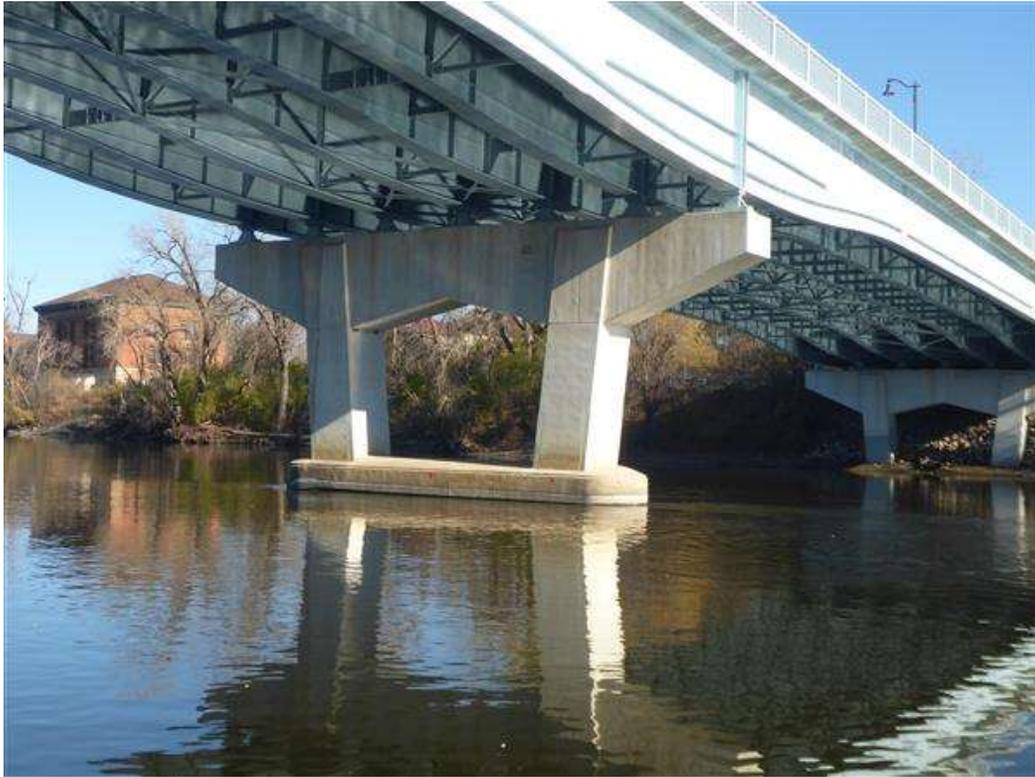
- (F) The channel bottom material around Pier 10 consisted of 1 to 3 foot diameter riprap with sand infilling that allowed up to 8 inches of probe rod penetration.

Photo 5 - Typical View of Pier 10 Looking Northeast

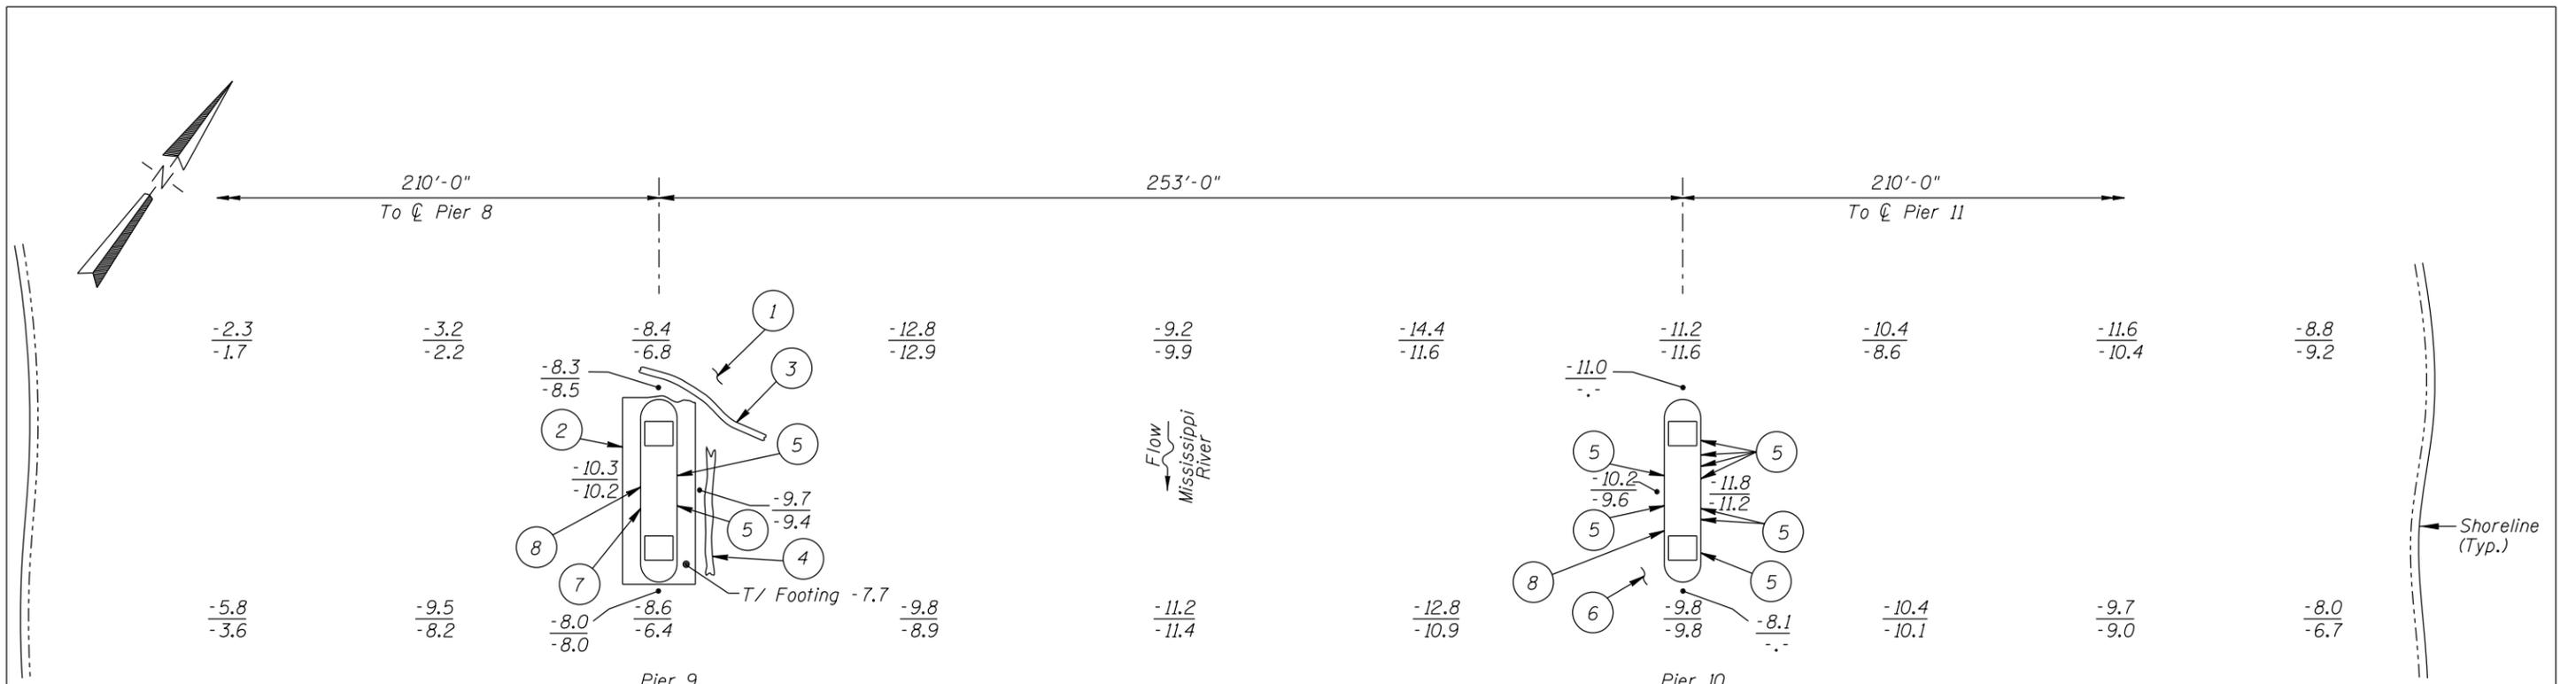
**SOUNDING PLAN**

- 1 The channel bottom material around Pier 9 consisted of riprap up to 1 foot in diameter at the upstream nose and sand infilling around the rest of the pier that allowed up to 1.5 foot of probe rod penetration.

- 2 The top of the footing around the entire perimeter of Pier 9 was exposed with vertical face exposure between 1 foot at the upstream west corner, 4 inches along the downstream face, and a maximum of 2.5 feet along the west face.

- 3 An 18 inch diameter log was observed on the channel bottom at the upstream end of Pier 9.
- 4 Timber debris and a log that was 18 inches in diameter and 30 feet long was observed on the channel bottom along the east face of Pier 9.

- 5 Numerous vertical hairline cracks were observed extending from the top of the webwall to 1 foot below the waterline on both faces of Piers 9 and 10.

- 6 The channel bottom material around Pier 10 consisted of 1 to 3 foot diameter riprap with sand infilling that allowed up to 8 inches of probe rod penetration.

- 7 A vertical 1/8 inch wide crack was observed extending from the top of the webwall to the waterline on the west face of Pier 9.
- 8 Overall, the concrete of Piers 9 and 10 was generally smooth and sound with some random minor areas of poor consolidation with 1/4 inch maximum penetration.
