2016 UNDERWATER BRIDGE INSPECTION REPORT

BRIDGE # 27595 103(CARTWAY RD) over ELM CREEK

Date of Inspection: 05/23/2016

Contractor: Collins Engineers, Inc.

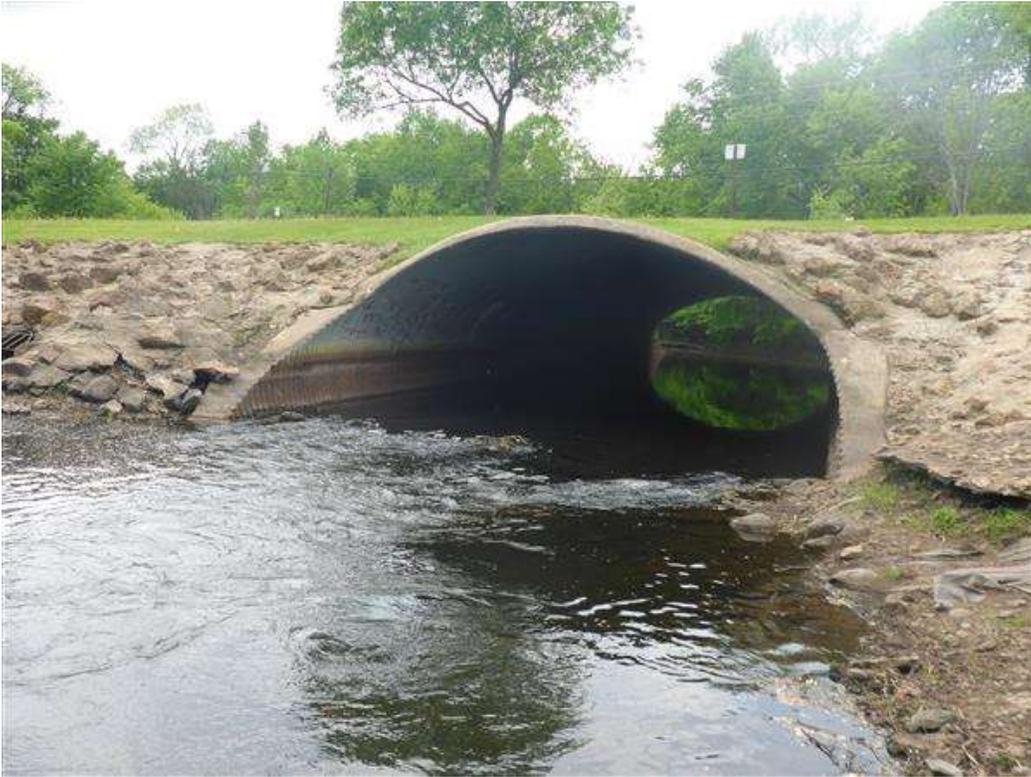
Photo 1 - Downstream Opening Looking West

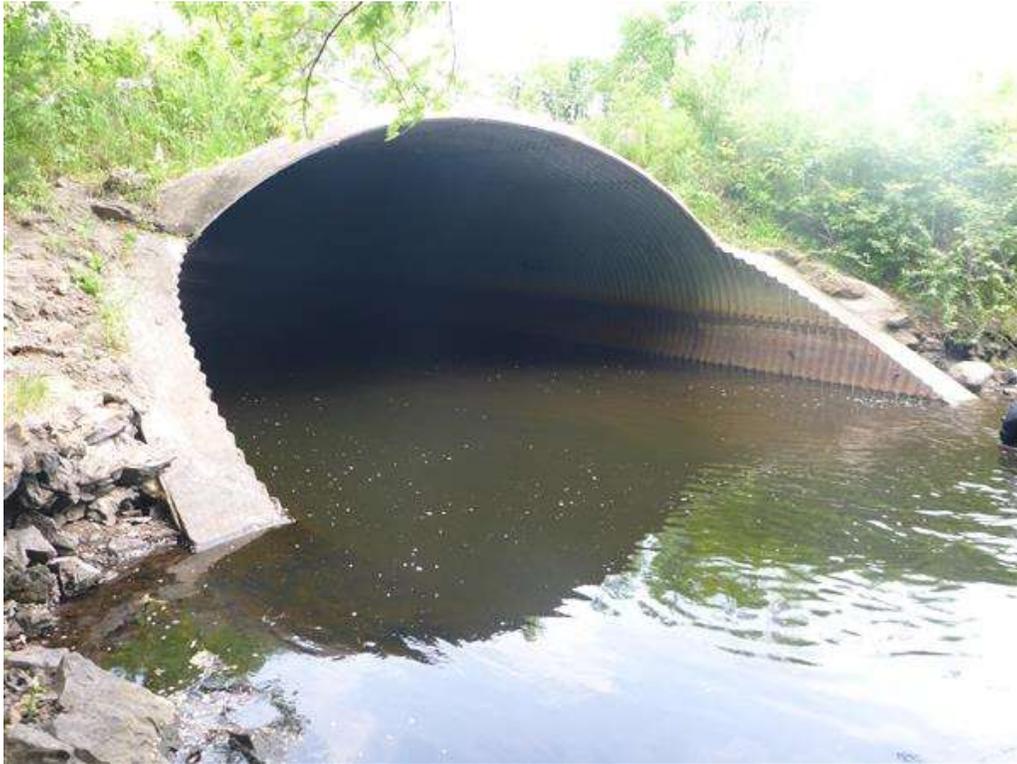
Photo 2 - Upstream Opening Looking East

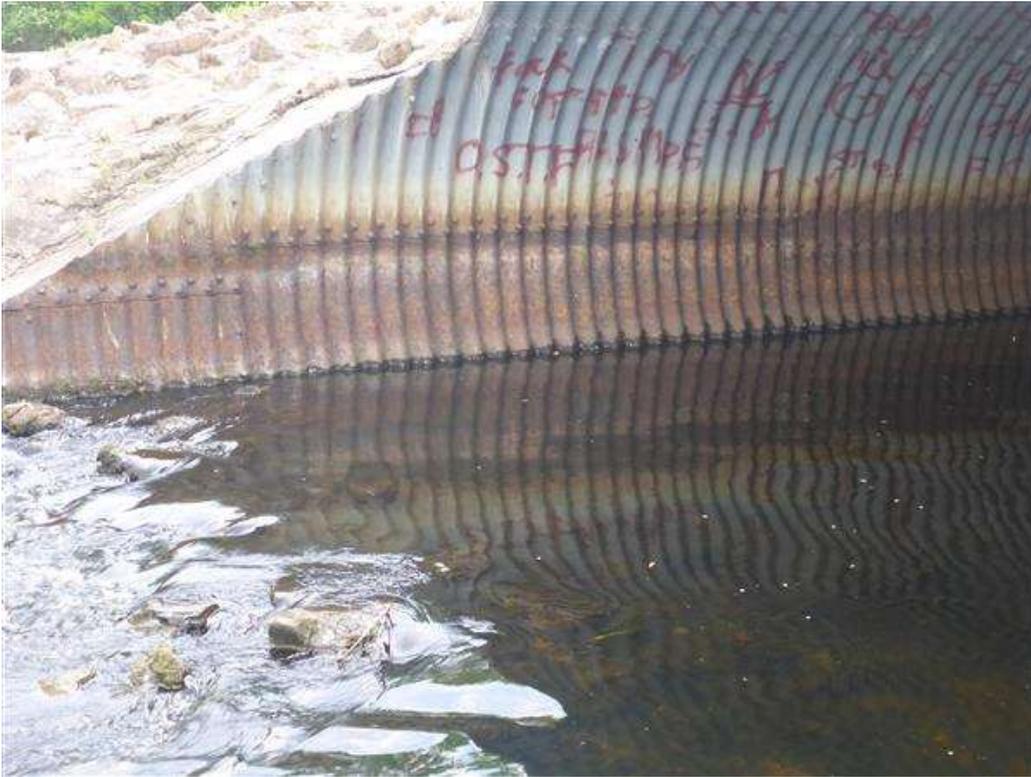
- (A) Corrugated steel pipe exhibited light corrosion from the waterline to the bottom of the pipe.
- (B) The culvert floor was typically covered by a layer of silty sand, stones, and riprap up to 16 inches in diameter.
- (C) Portions of the corrugated steel pipe floor were clean of any debris and/or infill.
- (D) A 6 foot diameter scour hole was found just east of the riprap at the east end.
- (E) The southern edge of the east end was undermined at the waterline with penetration up to 1 foot.

Photo 3 - Typical Condition of Culvert Barrel at Waterline

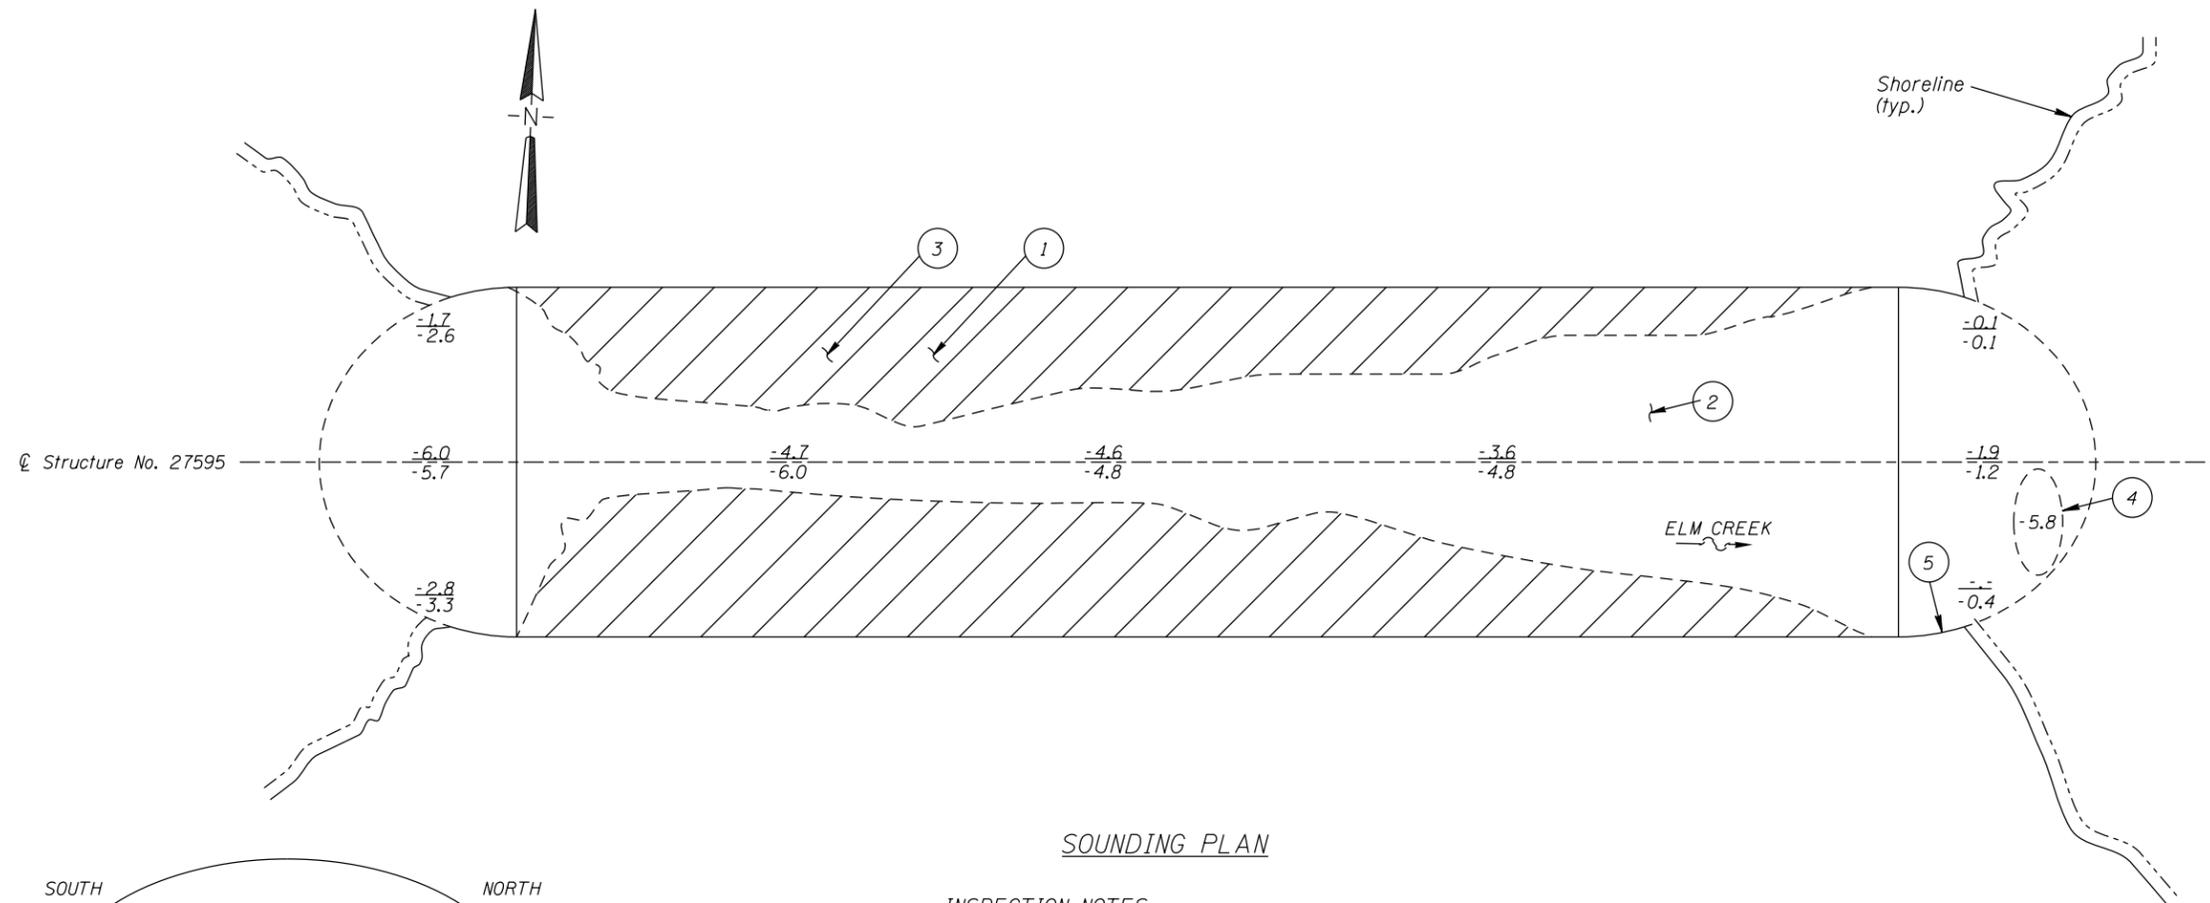
SOUNDING PLAN

- 1 Corrugated steel pipe exhibited light corrosion from the waterline to the bottom of the pipe.
- 2 The culvert floor was covered by a layer of silty sand, stones, and riprap up to 16 inches in diameter.
- 3 The corrugated steel pipe floor was clean of any debris and/or infill.
- 4 A 6 foot diameter scour hole was located just East of the riprap at the East end.
- 5 The southern edge of the East end was undermined at the waterline with penetration up to 1 foot.

- (A) Reinspect the submerged substructure units at the normal maximum recommended (NBIS) interval of sixty (60) months.
