# 2016 UNDERWATER BRIDGE INSPECTION REPORT

## **BRIDGE # 27A63 Minnetonka Blvd over Carsons Bay**

**Date of Inspection:** 09/13/2016

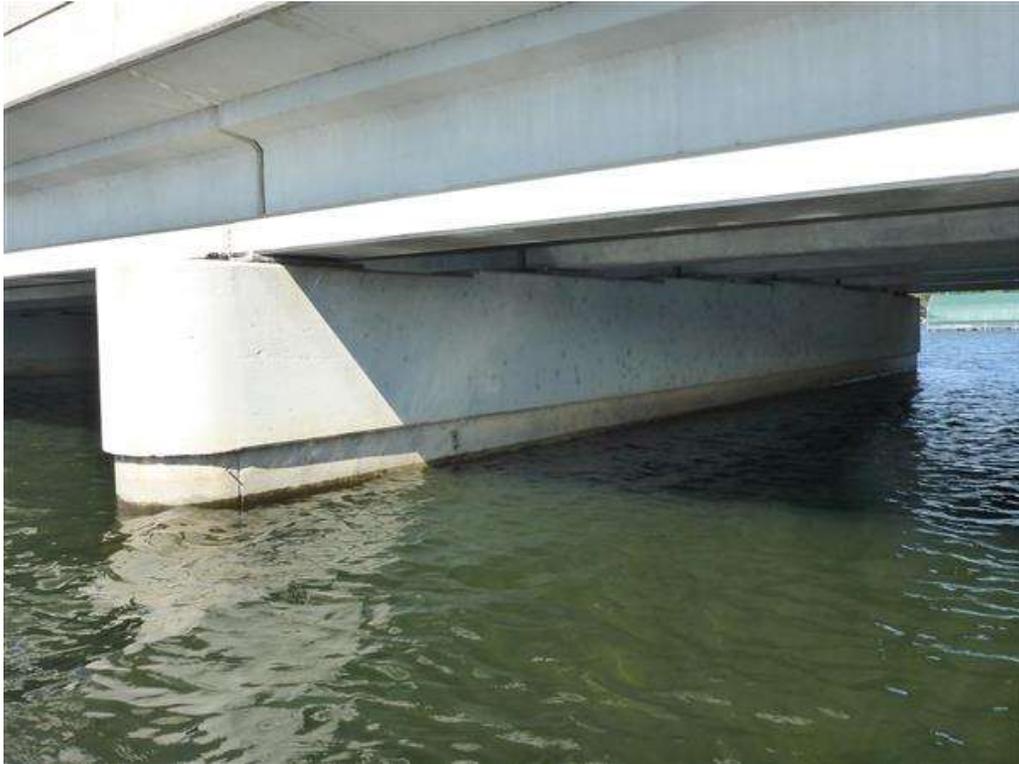
Photo 4 - Pier 1, Looking Northeast.

- (E) Spall observed on the north nose of Pier 1 at the waterline, measuring 6 feet long by 4 feet high with up to 4 inches of penetration.
- (F) Spall with exposed reinforcement observed wrapping around the south nose of Pier 1 at the waterline, measuring 6 feet long by 3 feet high with up to 6 inches of penetration.

- (G) Spall with exposed reinforcement observed at the midpoint on both the east and west faces of Pier 1 at the mud line, measuring 4 feet long by 1 foot high with up to 6 inches of penetration.

- 5 Spall observed on the north nose of Pier 1 at the waterline, measuring 6 feet long by 4 feet high with up to 4 inches of penetration.
- 6 Spall with exposed reinforcement observed wrapping around the south nose of Pier 1 at the waterline, measuring 6 feet long by 3 feet high with up to 6 inches of penetration.

- 7 Spall with exposed reinforcement observed at the midpoint on both the east and west faces of Pier 1 at the mud line, measuring 4 feet long by 1 foot high with up to 6 inches of penetration.

- (A) Monitor the scour at Piers 2, 3 and 4 during future underwater inspections.
- (B) Monitor areas of spalling and scaling during future inspections.
- (C) Reinspect the submerged substructure units at the normal maximum recommended (NBIS) interval of sixty (60) months.

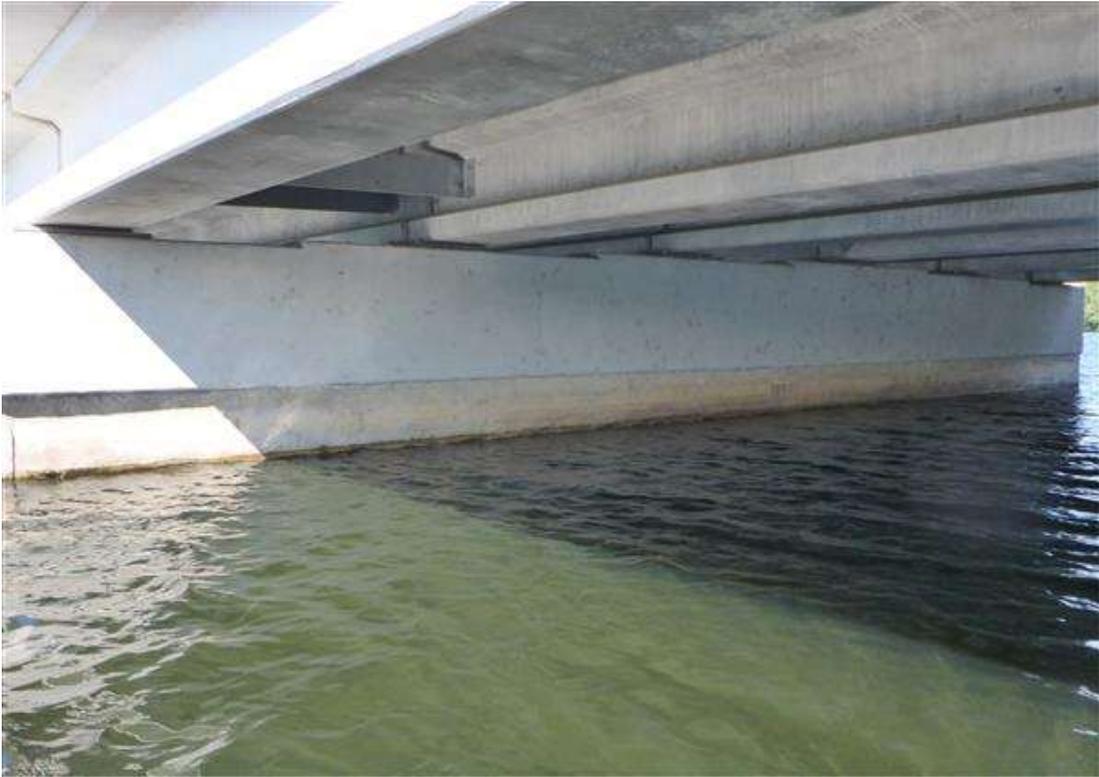
Photo 5 - Pier 2, Looking Northeast.

- (C) Spall observed on the northwest corner of Pier 2, 4 feet below the waterline, measuring 5 feet long by 4 feet high with up to 6 inches of penetration.

- (D) Moderate scaling observed on the west face of Pier 2, 2 feet above the mud line, measuring 5 feet long by 2 feet high with up to 4 inches of penetration. Scaling defect was 5 to 10 feet from the northern nose of Pier 2.

- (J) Scour observed on the south nose of Pier 2, with a 4 foot diameter and 3 foot depth.
- (K) Scour observed on the north nose of Pier 3, with a 5 foot diameter and 3 foot depth.

- 3 Spall observed on the northwest corner of Pier 2, 4 feet below the waterline, measuring 5 feet long by 4 feet high with up to 6 inches of penetration.

- 4 Moderate scaling observed on the west face of Pier 2, 2 feet above the mud line, measuring 5 feet long by 2 feet high with up to 4 inches of penetration. Scaling defect was 5 to 10 feet from the northern nose of Pier 2.

- 10 Scour observed on the south nose of Pier 2, with a 4 foot diameter and 3 foot depth.
- 11 Scour observed on the north nose of Pier 3, with a 5 foot diameter and 3 foot depth.

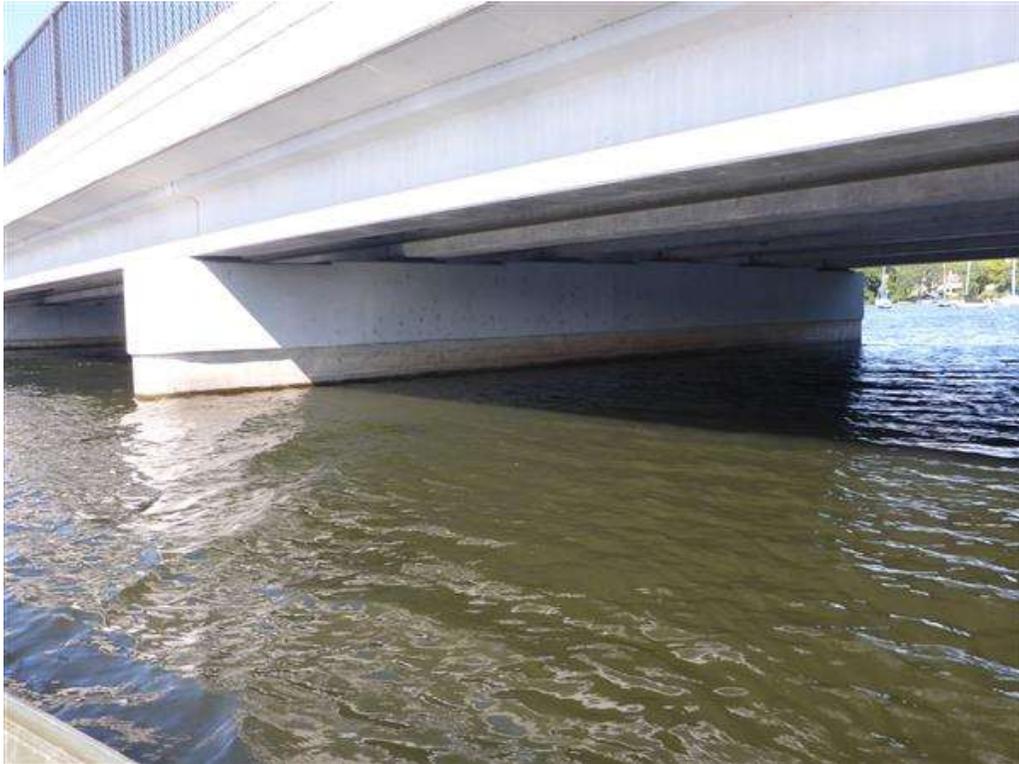
Photo 6 - Pier 3, Looking Northeast.

- (A) Spall observed on the south end of Pier 3 at the waterline, measuring 1 foot long by 3 feet high with up to 2 inches of penetration.
- (B) Spall observed on the north end of Pier 3 at the waterline, measuring 1 foot long by 1 foot high with up to 2 inches of penetration.

- 1 Spall observed on the south end of Pier 3 at the waterline, measuring 1 foot long by 3 feet high with up to 2 inches of penetration.
- 2 Spall observed on the north end of Pier 3 at the waterline, measuring 1 foot long by 1 foot high with up to 2 inches of penetration.

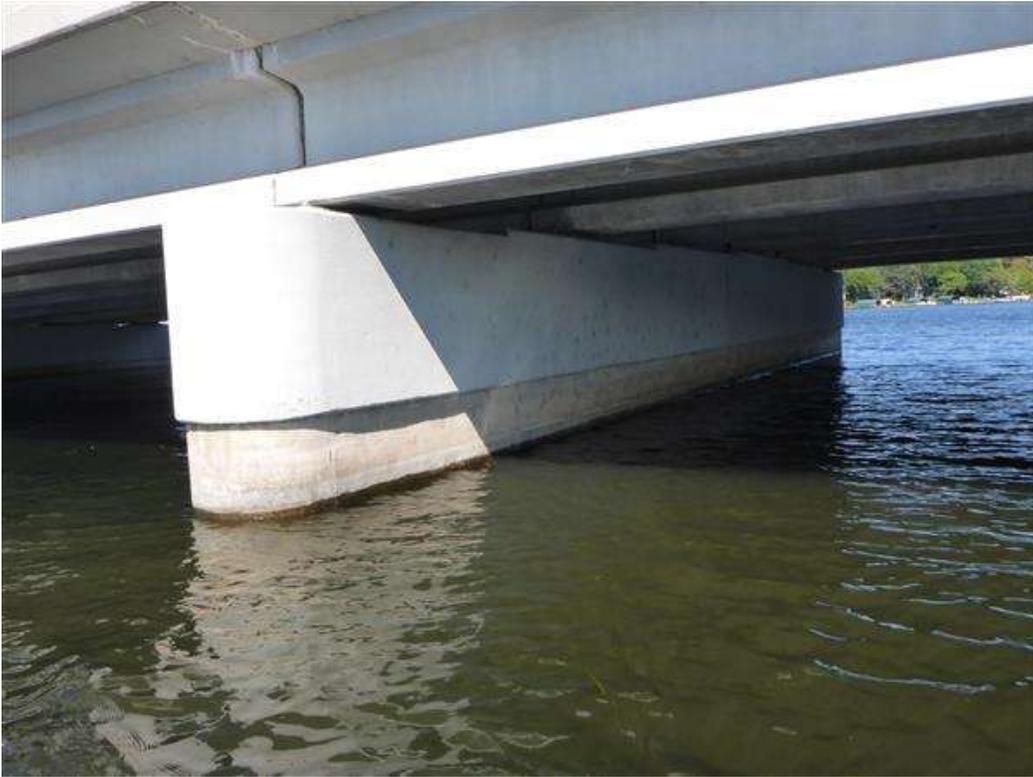
Photo 7 - Pier 4, Looking Northeast.

- (H) Random scaling observed on east abutment's west face, with up to 2 inches penetration measured.
- (I) Spall observed on the east face of Pier 4, 10 to 15 feet from the north nose at the mud line, measuring 1 square foot with up to 4 inches of penetration.

- (L) Scour observed around the entire perimeter on Pier 4, with a 4 foot diameter and 3 foot depth.

- 8 Random scaling observed on east abutment's west face, with up to 2 inches penetration measured.
- 9 Spall observed on the east face of Pier 4, 10 to 15 feet from the north nose at the mud line, measuring 1 square foot with up to 4 inches of penetration.

- 12 Scour observed around the entire perimeter on Pier 4, with a 4 foot diameter and 3 foot depth.
