2016 UNDERWATER BRIDGE INSPECTION REPORT

BRIDGE # 3575 CSAH 42(FORD PKY) over MISS R; MISS BL

Date of Inspection: 11/04/2016

Contractor: Collins Engineers, Inc.

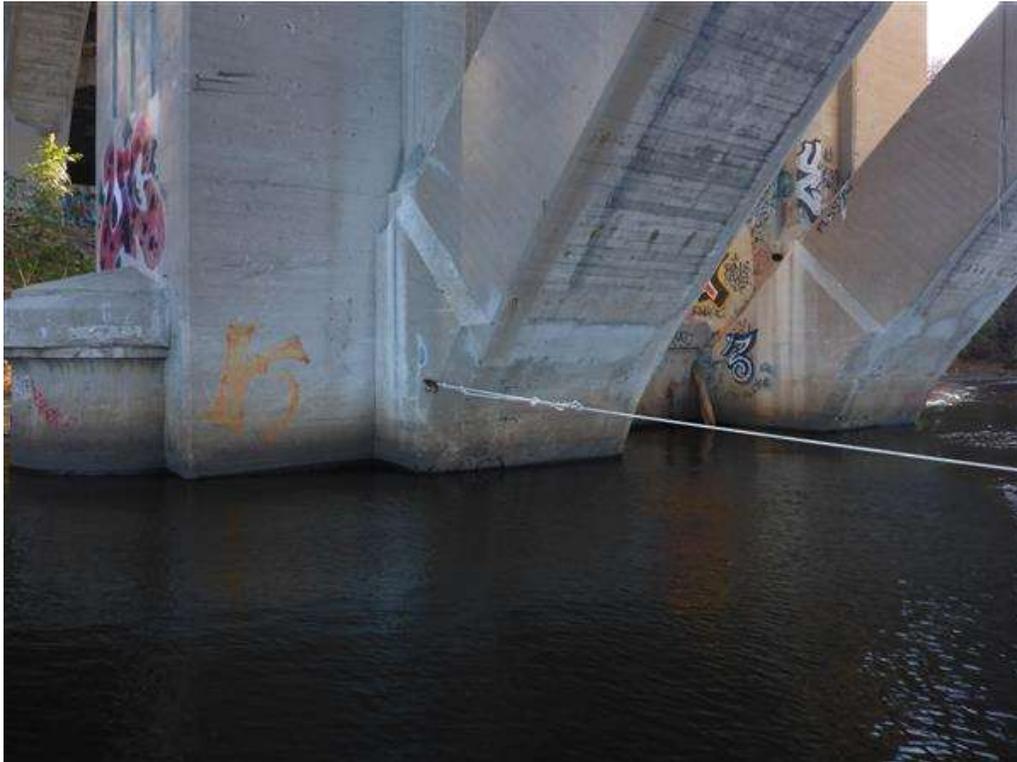
Photo 4 - Typical View of Pier 7 Looking Southeast

(A) Overall, the concrete was satisfactory condition with light to moderate scaling around the perimeter of the piers, with random areas of section loss (1 to 3 inches of penetration typical), from 2 feet above to 2 feet below the waterline.

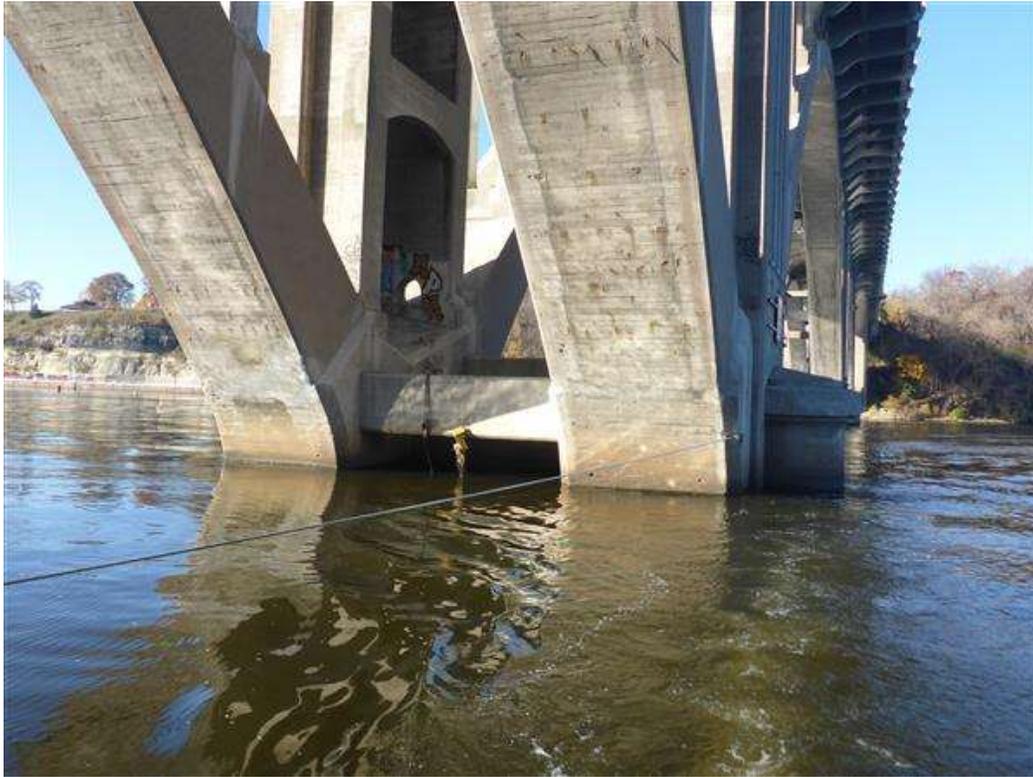
Photo 5 - Typical View of Pier 8 Looking Southwest

(C) The footing was exposed around the upstream third of Pier 8 and along the upstream face of Pier 9. Timber formwork was encountered along the footings of Piers 8 and 9. The exposed portion of the footings exhibited widespread heavy scaling with 1 to 2 feet of penetration and a maximum vertical face exposure of 6 feet (full height) at Pier 8. No vertical face exposure at Pier 9.

(D) The footing at the northeast corner of Pier 8 was undermined, with a cavity measuring 3 feet long by 1 foot high with up to 1 foot of horizontal penetration.

(E) A void was found in the side of the footing, measuring 2 feet in diameter with 3 feet of penetration, located at the northeast corner of Pier 8.

(A) Monitor footing exposures at Piers 8 and 9 and undermining and voiding at Pier 8 during future underwater inspections for further vertical face exposure and/or undermining. The extent of footing exposure/undermining does not appear to be structurally significant at this time since the piers are founded on deep driven caissons (as per bridge plans).

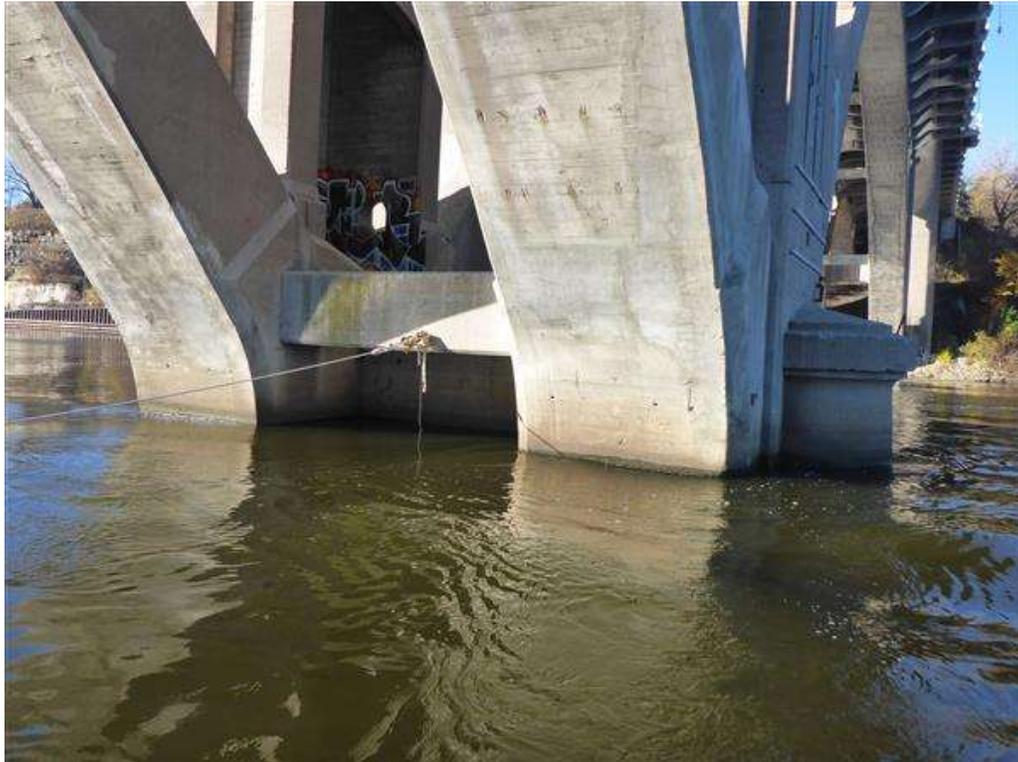
Photo 6 - Typical View of Pier 9 Looking Southwest

(H) Localized scour depressions were observed around the upstream end of Piers 8 and 9 with typical depths of 5 to 10 feet, and concrete rubble with protruding reinforcing steel was found on the base of the scour depression.

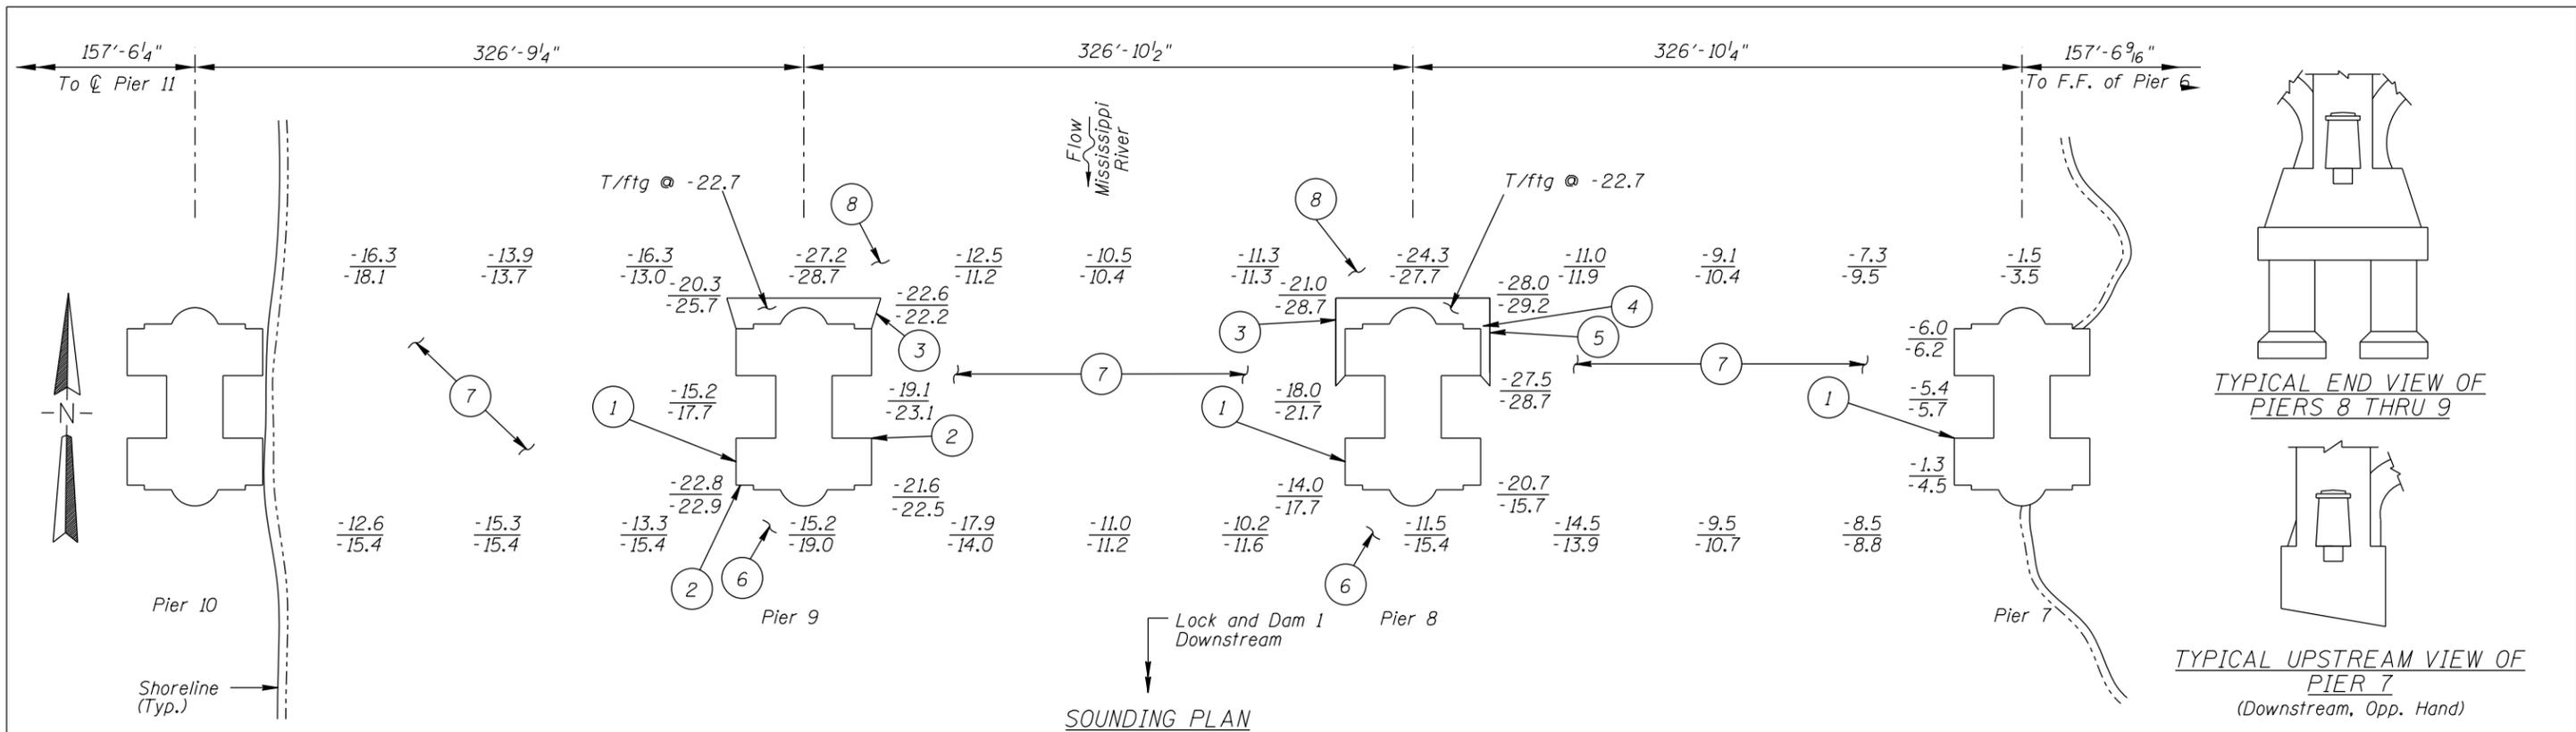
SOUNDING PLAN

- 1 Overall, the concrete was satisfactory condition with light to moderate scaling around the perimeter of the piers, with random areas of section loss (1 to 3 inches of penetration typical), from 2 feet above to 2 feet below the waterline.

- 2 An area of concrete was spalled, 2 feet by 2 feet with 2 inches of penetration, at 3 feet below the waterline.
- 3 The footing was exposed around the upstream third of Pier 8 and along the upstream face of Pier 9. Timber formwork was encountered along the footings of Piers 8 and 9. The exposed portion of the footings exhibited widespread heavy scaling with 1 to 2 feet of penetration and a maximum vertical face exposure of 6 feet (full height) at Pier 8. No vertical face exposure at Pier 9.

- 4 The footing at the northeast corner of Pier 8 was undermined, with a cavity measuring 3 feet long by 1 foot high with up to 1 foot of horizontal penetration.

- 5 A void was found in the side of the footing, measuring 2 feet in diameter with 3 feet of penetration, located at the northeast corner of Pier 8.
- 6 Areas of silty sand deposition (infilling) were located at the downstream ends of Piers 8 and 9 covering the footings.

- 7 The channel bottom consisted of gravel and sand with scattered concrete rubble, reinforcing steel and riprap around the substructure units. The concrete rubble had protruding reinforcing steel and appeared to have been placed / dropped as part of bridge rehabilitation.
- 8 Localized scour depressions were observed around the upstream end of Piers 8 and 9 with typical depths of 5 to 10 feet, and concrete rubble with protruding reinforcing steel was found on the base of the scour depression.

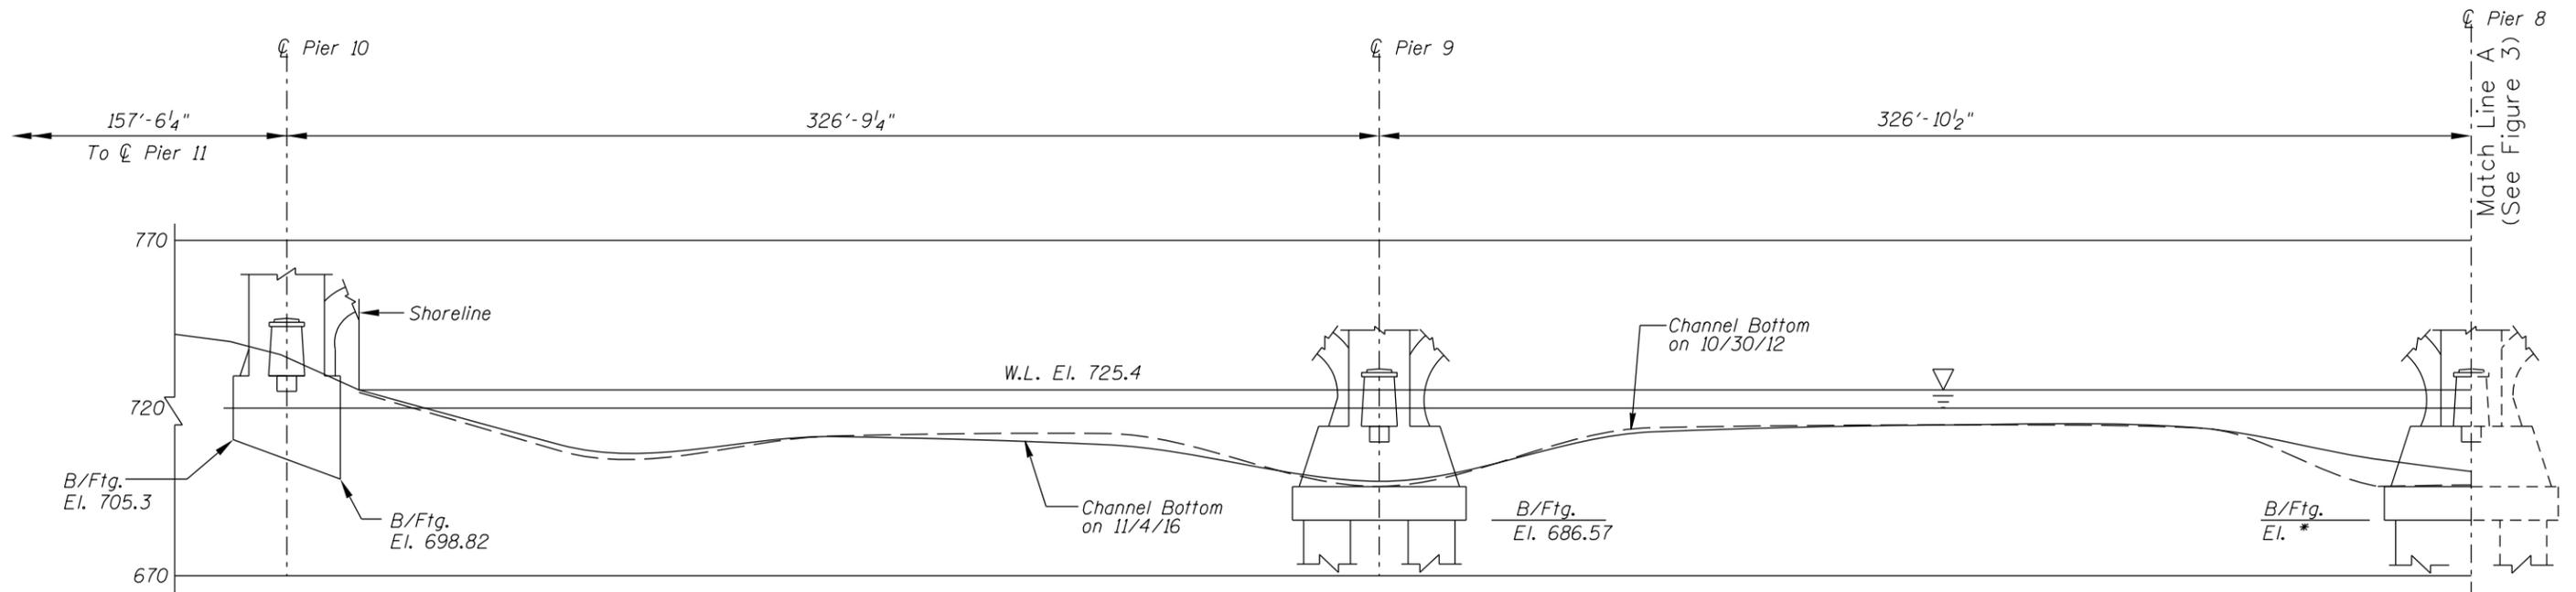
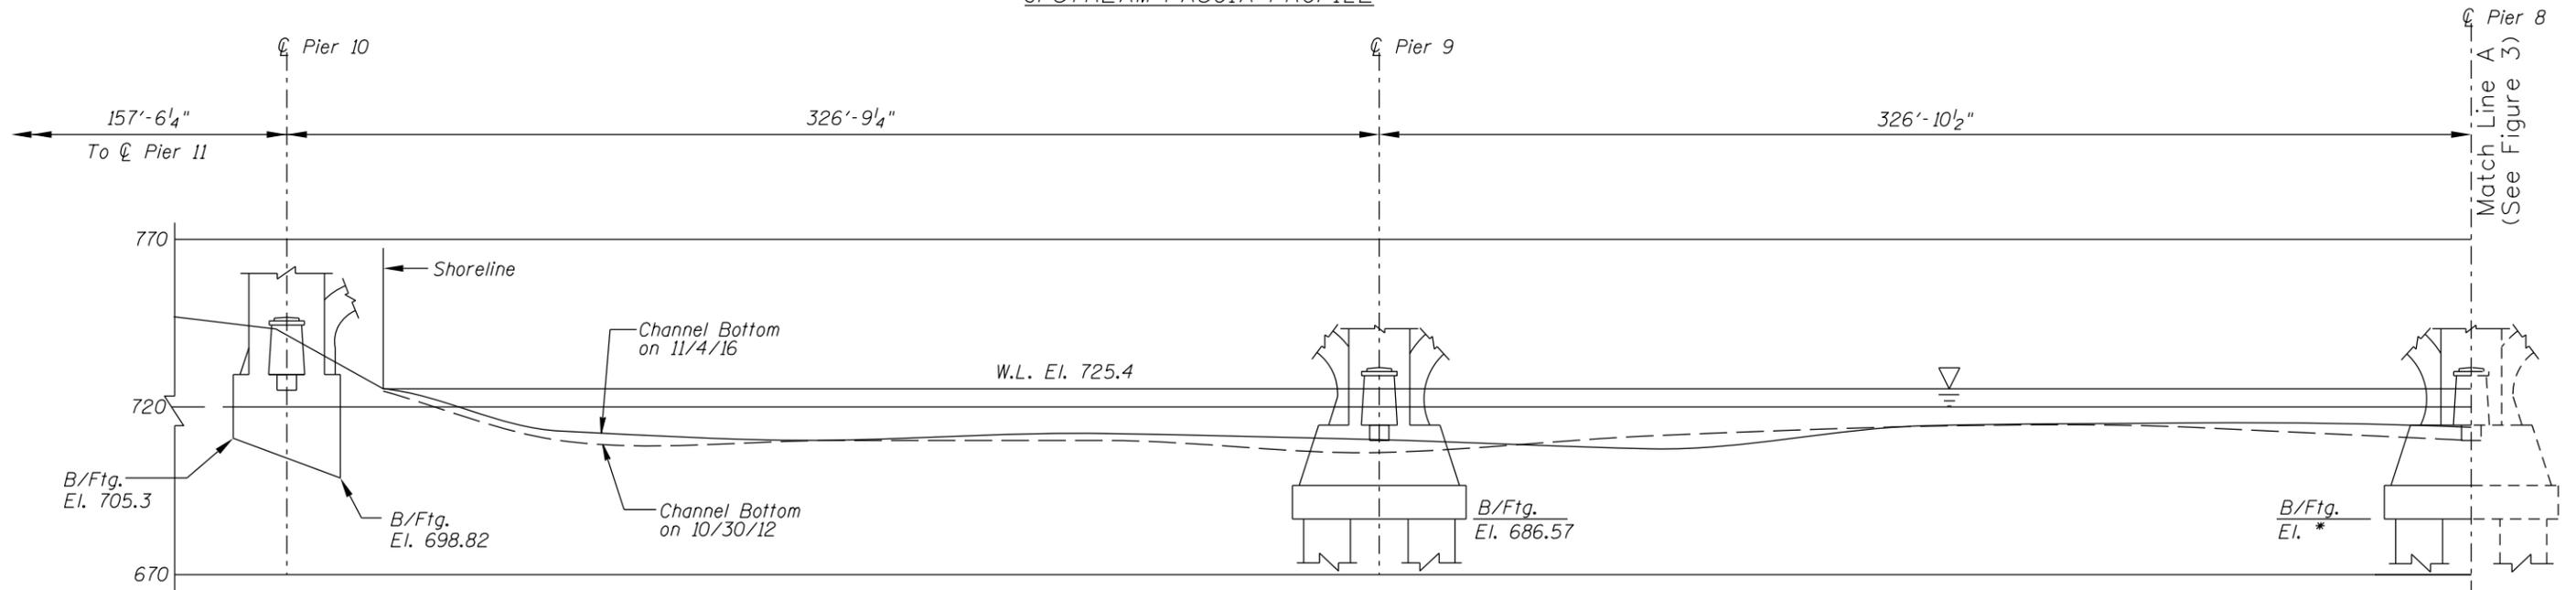
* The bottom of footing elevation noted on the Design Plans does not correspond to the soundings and/or undermining detected at the time of the underwater inspection.

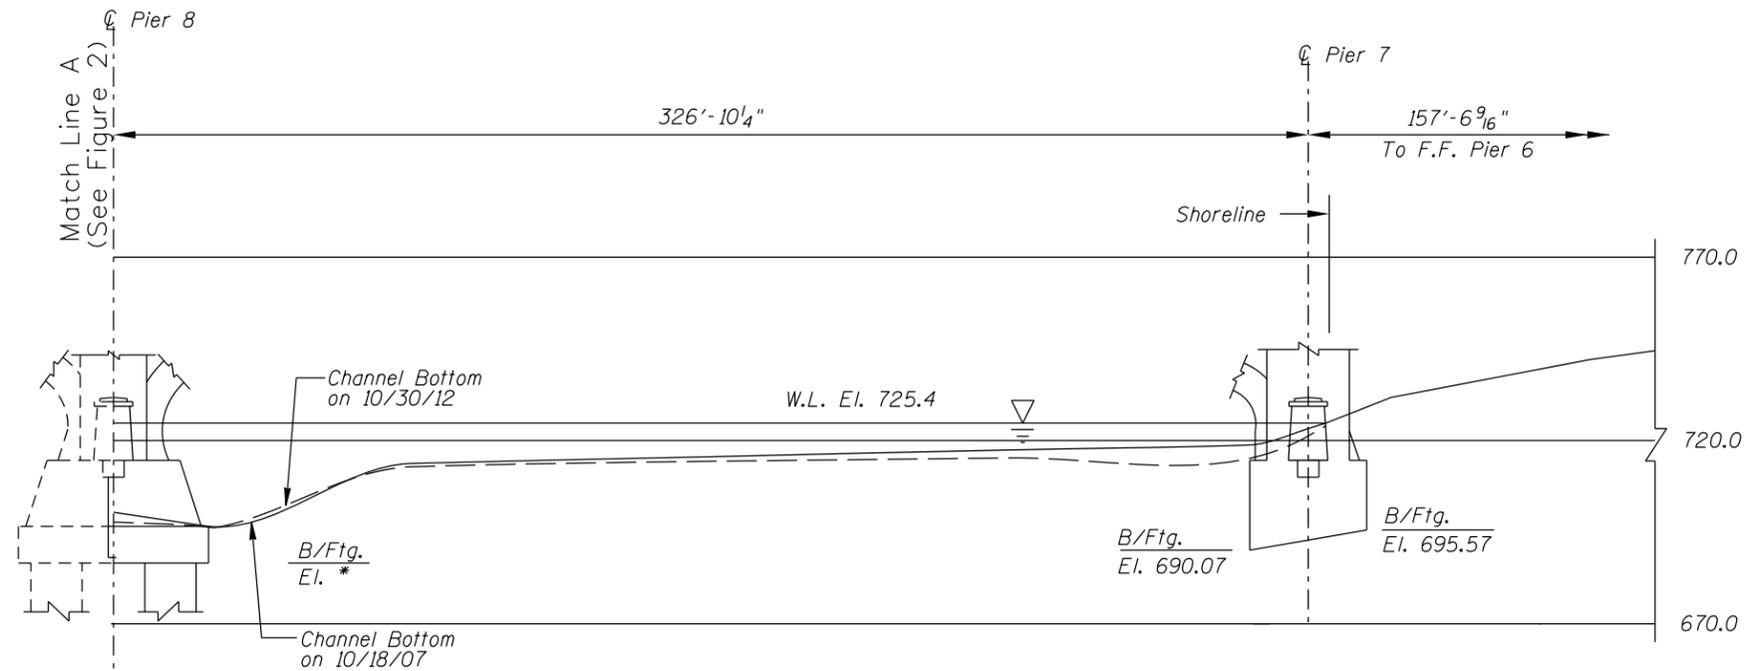
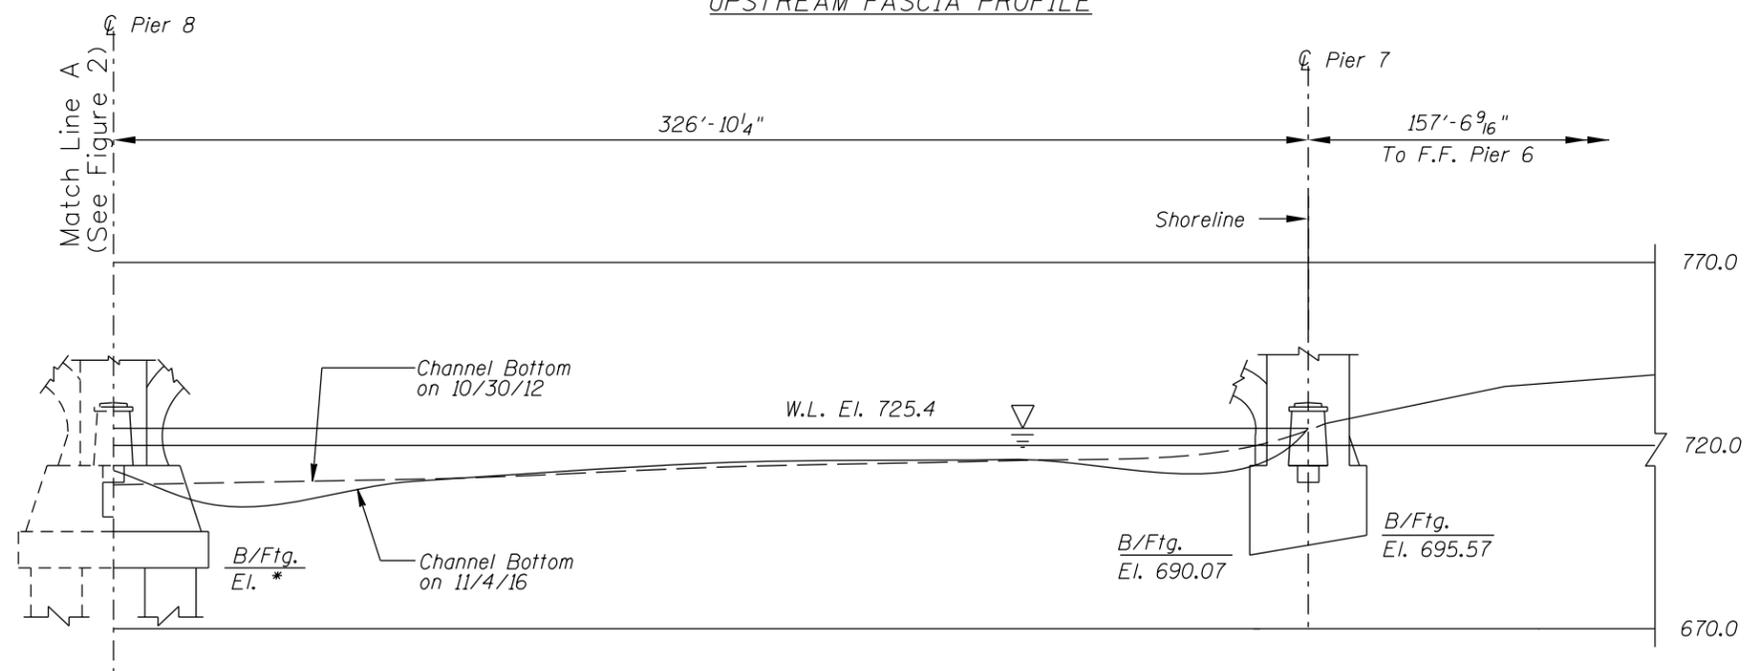
* The bottom of footing elevation noted on the Design Plans does not correspond to the soundings and/or undermining detected at the time of the underwater inspection.
